ABOUT ADSP-21266 SILICON ANOMALIES

These anomalies represent the currently known differences between revisions of the SHARC ADSP-21266 product and the functionality specified in the ADSP-21266 data sheets and the Hardware Reference books.

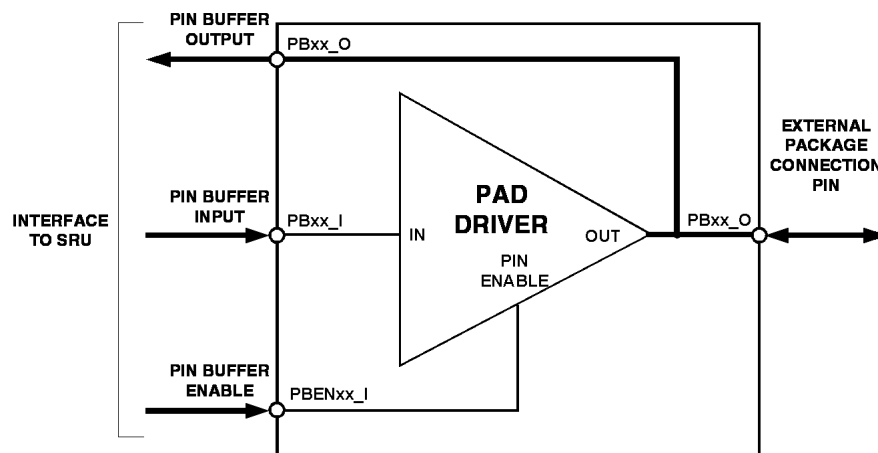
5. 06000018 - Pin Sensitivity (RD_B, DAI_P[20:1]):**DESCRIPTION:**

There is some sensitivity to noise on the RD_B, SPORTx_CLK, and SPORTx_FS signals of the ADSP-2126x processors. This has the potential to cause errors during parallel port read operations including booting, and sport issues when the sport is driving the sport clock & frame sync and an external device is driving the data. (The SPORT signals are routed through the signal routing unit (SRU) to the DAI_P[20:1] pins.)

1. In certain cases, by programming the SRU CLK and FS registers, the reflection sensitivity issue in these signals can be avoided. Consider this Sport Clock example: (The Frame Sync configuration is analogous) In its default routing, the SRU maps the signal from the DAI pin (PBxx_O) back to the Sport Clock Input (SPORTxCLK_I), as well as routing the sport clk output (SPORTxCLK_O) to the Pin Buffer Input (PBxx_I). This connection of PBxx_O to SPORTxCLK_I opens a vulnerability to a glitch coming in even though the Sport is driving the clock as an output.

By programming the Signal Routing Unit (SRU) to remove this input path, we can avoid this vulnerability.

In the figure, by default SPORTxCLK_I would be connected to PBxx_O and SPORTxCLK_O would be routed to PBxx_I. The workaround is to leave the routing of SPORTCLKx_I to PBxx_I as before, providing the sport clock off-chip, but also routing it directly back to SPORTCLKx_I to give the state machine it's signal. This effectively closes off the external access to SPORTCLK_I. For more information about the SRU, consult the DAI Chapter of the ADSP-2126x Hardware Reference Manual.

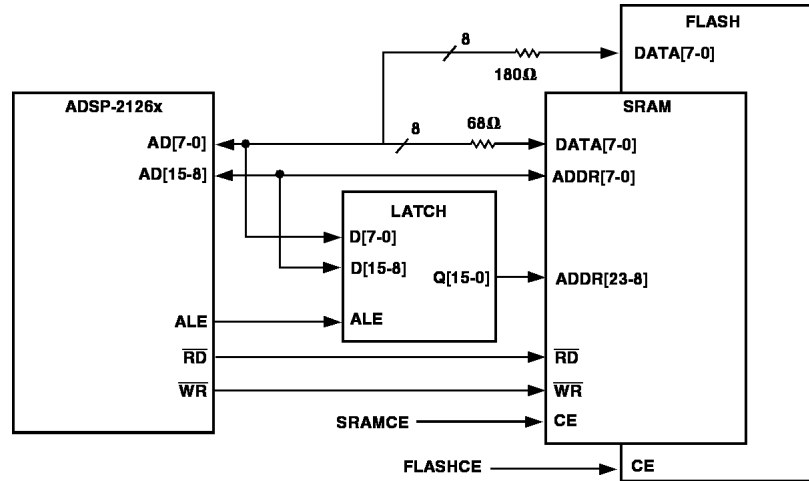
Memory Read—Parallel Port 8-Bit:

A bus contention issue has been identified on the ADSP-2126x Parallel Port. When crossing an external memory address page while using DMA-READ transfers, an ALE cycle is inserted to update the upper address bits held by the external latch. When the Parallel Port transitions from a Read-cycle to an ALE cycle, insufficient time was provided to allow the external SRAM or FLASH to tri-state its bus. The bus tri-state from /OE de-assertion timing is typically longer for Flash than for SRAM devices, this necessitates a separate examination for both the SRAM and FLASH cases. (Timing information assumes a 200 MHz core clock rate)

A typical 8ns SRAM will require 5-7ns to tri-state from /OE de-assertion. The ADSP-2126x only provides for approximately 4.0 ns; therefore, a 3.0ns contention possibility exists. At this time the recommended work-around is to place series resistors before the SRAM data lines, as shown in the diagram below. This resistor will limit the maximum pin current to about 22mA, while still providing sufficiently fast rise-fall rates to meet timing requirements. Our recommendation is 68-Ohms. This option will operate at full speed and require no software changes.
