ABOUT ADSP-21365 SILICON ANOMALIES

These anomalies represent the currently known differences between revisions of the SHARC® ADSP-21365 product(s) and the functionality specified in the ADSP-21365 data sheet(s) and the Hardware Reference book(s).

NR003042N

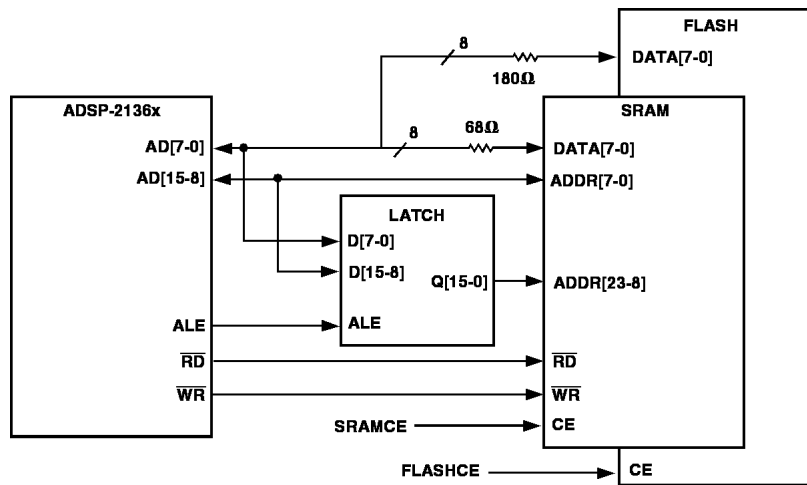
Memory Read—Parallel Port 8-Bit:

A bus contention issue has been identified on the ADSP-2136x processor's Parallel Port. When crossing an external memory address page while using DMA-READ transfers, an ALE cycle is inserted to update the upper address bits held by the external latch. When the Parallel Port transitions from a Read-cycle to an ALE cycle, insufficient time was provided to allow the external SRAM or FLASH to tri-state its bus. The bus tri-state from /OE de-assertion timing is typically longer for Flash than for SRAM devices, this necessitates a separate examination for both the SRAM and FLASH cases.

A typical 8ns SRAM will require 5-7ns to tri-state from /OE de-assertion. The ADSP-2136x only provides for approximately 4.0 ns; therefore, a 3.0ns contention possibility exists. At this time the recommended work-around is to place series resistors before the SRAM data lines, as shown in the diagram below. This resistor will limit the maximum pin current to about 22mA, while still providing sufficiently fast rise-fall rates to meet timing requirements. Our recommendation is 68-Ohms. This option will operate at full speed and require no software changes.
