ADSP-2187L Anomaly List for Revisions 0.0-1.1

The list below represents the known anomalies and workarounds for the ADSP-2187L. The silicon revision of a particular device can be found on the chip, as shown below:

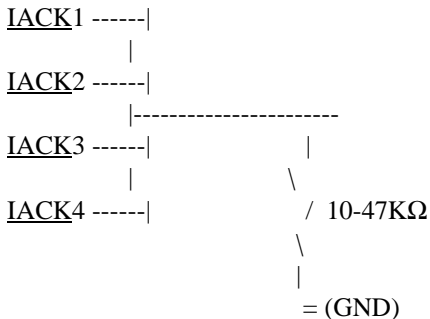
The design change modifies the IACK pin from an open drain requiring a pull up resistor to an open source requiring a pull down resistor. This means:

With this scheme, all IACK lines will be floating in the acknowledge state. The pull down resistor will pull the floating lines low. When any of the processors become busy, its IACK line will go active high, pulling all the IACK lines hi. Depending upon the resistor value being used 100-500 μ A will flow through the resistor.

The IACK lines of all the processors can be wire OR'ed and a pull down resistor should be used. A resistor in the range of 10K Ω to 47K Ω is recommended.
