Integrated Precision Battery Sensor for Automotive System

Silicon Anomaly

ADuC7034

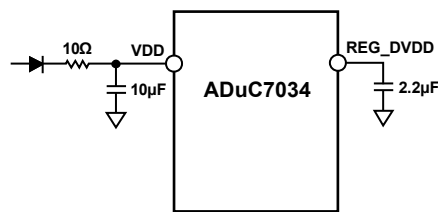
Figure 1. External Power Supply Decoupling Components

Issue: Under particular conditions, the POR does not release the reset signal, that is, the ASIC remains in reset until a power cycle occurs. This POR issue only occurs under three specific and coincident power-on conditions:

- Fast ramp on VDD, nominally faster than 100 μ s from V_{INIT} to 12 V
- Initial value of VDD (V_{INIT}) = \sim 1.2 V
- Voltage on REG_DVDD at the time VDD ramp is reapplied = \sim 175 mV

Workaround: As previously noted, a fast VDD ramp (that is, ramping from \sim 1.2 V to 12 V in $<$ 100 μ s) is required as one of the conditions to initiate the reported POR issue. Analog Devices recommends careful selection of external power supply decoupling components to ensure that the VDD supply ramp rate can always be guaranteed to be $>$ 100 μ s under all VBAT power-on conditions. Specifically, Analog Devices recommends using a 10 Ω series resistor (1% tolerance maximum) and a 10 μ F decoupling capacitor (20% tolerance maximum) to ground on the VDD line between the reverse protection diode and the VDD, as shown in Figure 1.
