Safety-Related Service Notes

BENCH BRIEFS
1ST QUARTER 1992
Volume 32 Number 1

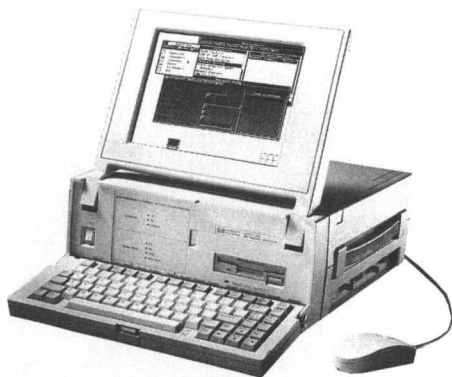
HP 4980A/81A/82A Network Advisors

Serial Numbers Affected
0000A00000 / 3121A00223

Some instruments in the above serial number range have inadequate grounding of the rear panel to the mainframe chassis. This problem is resolved by adding grounding wire harness, HP P/N J2176-61602. Order Safety Service Notes 4980A-02-S, 4981A-02-S and 4982A-02-A for more information.

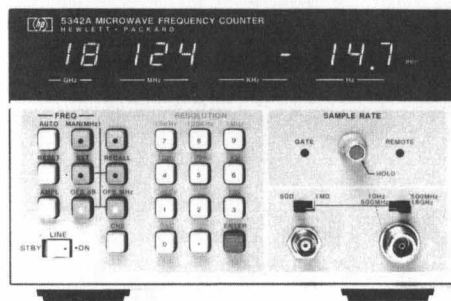
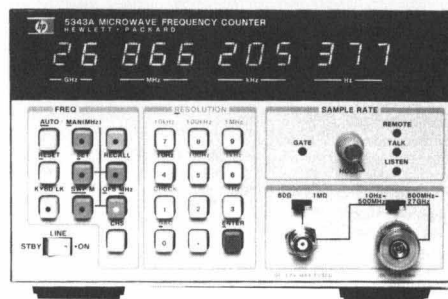
HP 5342A/43A Microwave Frequency Counters

Serial Numbers Affected

5342A 0000A00000 / 2636A10914
5343A 0000A00000 / 2636A02416

The framework of the counters within the serial number ranges above does not ensure that the front and rear castings will remain in parallelism. If this condition exists, lifting the counter with the top handle could pull the top panel off the instrument allowing it to fall.

HP is providing a new support strut, top cover, and metric screws to fix the problem. For more information order Safety Service Notes 5342A-58A-S and 5343A-31A-S.
