## Fixing an HP 3314A function generator - Part 1

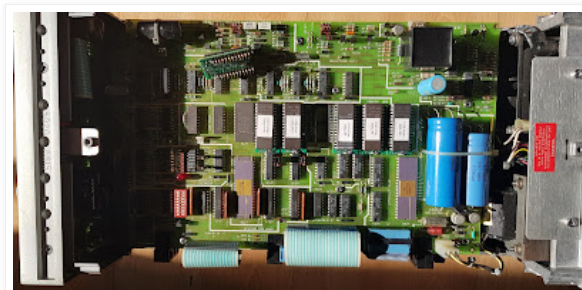
When it arrived, I took a closer look. I immediately noticed something rattling inside, and this is what I saw after I had opened it up.

One of the EPROMs was loose and bouncing around inside the case. I first thought that it may be that simple, but a closer look provided a much gloomier forecast. The EPROMs were in fact in a small [adapter boards](#), so someone has been here before. The adapter boards by themselves are not a problem, the [Mostek ROMs](#) in these units are known to fail and can quite easily be replaced by 2764 EPROMs, using an adapter to fix the pinout differences.

However, the soldering job on these adapters were horrible. There were large blobs of solder everywhere, sockets being melted, bodge wires going over and under sockets, etc. So I was not too optimistic, when I reseated the EPROM. Especially that I noticed that two EPROMs had some of their pins crushed when they were apparently misaligned during insertion. See pin 19 of U208 in the above picture. Someone was very careless in the past. I fixed those, fortunately without breaking the bent pins.

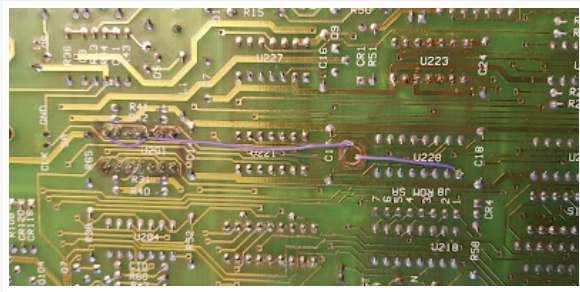
The previous owner had butchered the PCB for the U201, the 74s74. (I'm not sure what he was using, a flamethrower and some blacksmith tools maybe.) Anyway a trace was broken at one of the pins and replaced with a jumper wire. Which became pinched under one of the screws holding down the board and got grounded. No wonder the clock was a flat-liner. I guess this worked for some time while the insulation got chewed up, or the screw was finally tightened, so this is why the previous repairer did not notice it.

I redid the soldering and patched the trace, so got rid of the long wire. Immediately I had nice clock, but still no sign of life.
