## Fixing an HP 3314A function generator - Part 2.

Continuing with the repair of the HP 3314A function generator that was "repaired" by a previous owner. I left off at the decision of checking everything that was done to it.

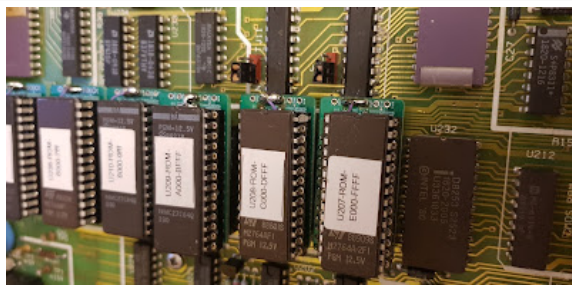
First I had to clean up. 5 of the 6 EPROM adapter boards were soldered into the instrument and for some unknown reason 1 was in a socket. I started beeping out the connection between the EPROMs for the data and address lines, and sure enough, found several where there were no connection. Not very surprising, given what I have seen with the 74S74 IC in the clock generator circuit. Also, some of the adapter boards were bad, there was no connection between some of the pins, there were cold solder joints there.

Very carefully I started removing the adapters. Even though HP made quite sturdy PCBs, I didn't want to risk any more damage, so I snipped the pins of the adapters and removed them one by one. I also removed the two 74ls373, they are the ones with the two jumpers next to them. You can see the solder blobs at their ends near to the EPROMs. That is where their pins were snipped and soldered from above, presumably to fit after the adapter boards were already put in.

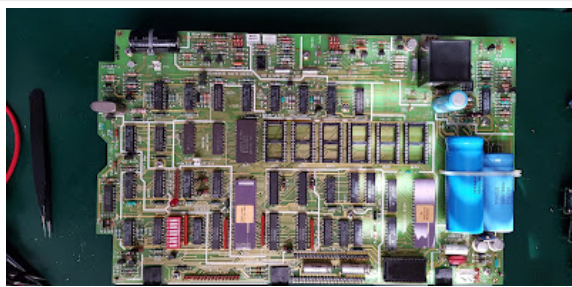
Once everything was removed, I was already able to see four broken traces under U209, the one in the socket. Those were fixed with scraping off the solder mask and soldering twin wires there.

Then I checked for continuity for every pad related to the ROMs and installed high quality sockets and replaced the 2 74ls373. All this took quite some time, but was well worth the effort as at the end I had a nice board.

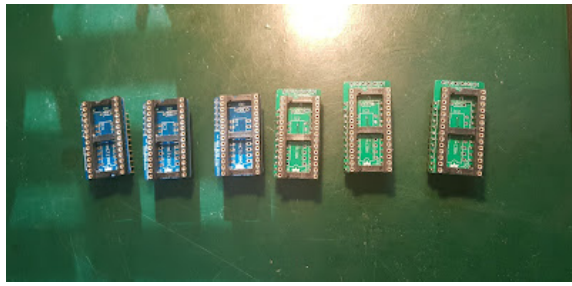
Next, I turned my attention to the adapter boards. My initial idea was to scrap the 6 EPROMs and just use one with a 74ls148 priority encoder figuring out the additional address lines from the 6 chip select signals. But to make it nice it needed some PCB, and work, and then I also realized I actually had 3 of the same (well, nearly same, they were blue, and a bit different layout) adapter boards from an earlier project, so I actually only had to clean up three of the old ones. So I went with tidying up those boards, as the previous owner even got those wrong, instead of using the

proper jumper places he used bodge wires to configure it. After some tedious work with the solder sucker and the iron, I got all six EPROMs ready for action.

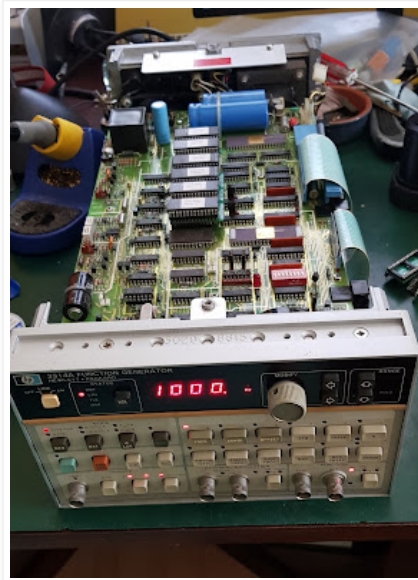
Plugged them in and did again a quick check that everything is in place and turned the instrument on. It started the countdown and then did the calibration sequence without problem. Honestly I wasn't expecting that, I was prepared to see a bunch of calibration errors at best.

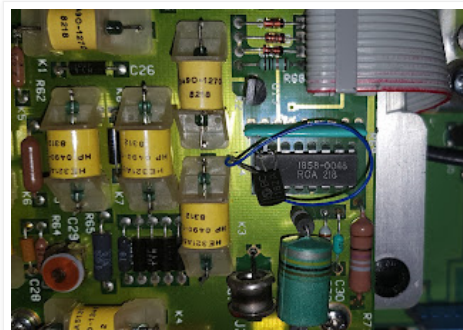
The relays are controlled by a latch which in turn controls a CA3082 transistor array. The latch seems to be good, but the voltages on some of the outputs of the array were strange. As a quick test I piggybacked some random NPN transistor on one of these outputs, and surprise surprise, the corresponding relay came to life.

So the CA3082 seems to be a fault. This is an obsolete part, not too easy to get. Of course I made a purchase on eBay for some cheap solution, I'm pretty much certain that it will be fake, but let's take some chances. As plan B I also designed a small PCB with surface mount transistors as a pin compatible replacement.
