HP3400A Images Date ▲ (<https://groups.io/g/HP-Agilent-Keysight-equipment/topic/93892915?p=Created%2C%2C%2C20%2C2%2C0%2C0>) around Photochopper demodulator (help)

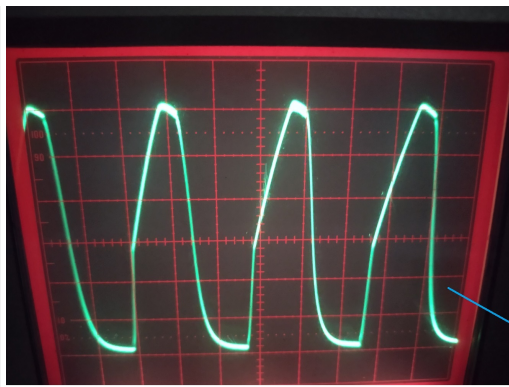
Waveform on my unit

This is the troubleshooting step where you apply 10mv thru 499KΩ and monitor waveforms and DC voltages.

Looks like V504 is not shorting to ground for half the cycle. This could be a failing photocell or the neon light getting dim with age (it is lit, correct?) there have been a number of discussions on what to replace aging neons with but I don't remember any details.

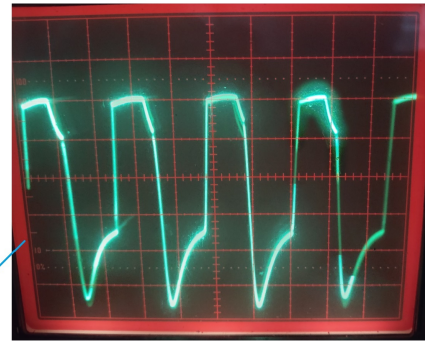
Waveform on my unit

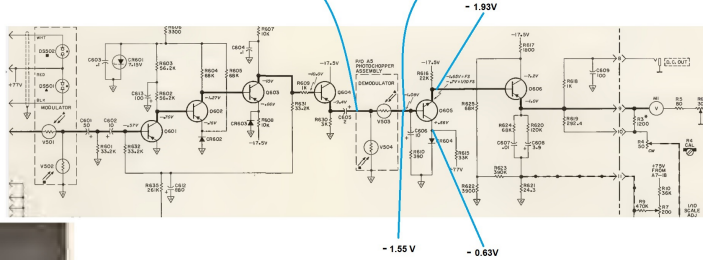
Waveform in Manual

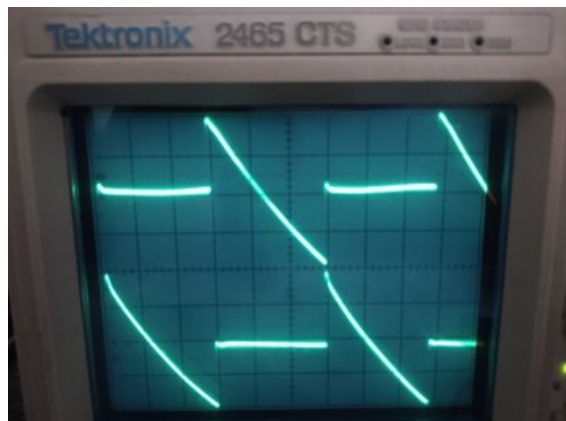
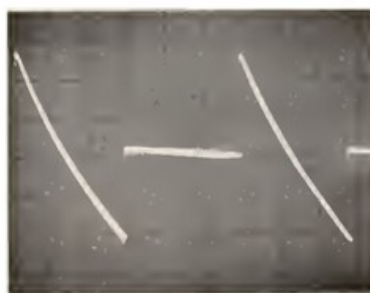
Here is the drive wave form to the neons, I think this is a pretty good waveform, when compared to the manual, making me think my neons are OK.

Waveform from Manual

There is a slight glitch at the top of the bottom waveform.

The glitch on the bottom trace is matched by a corresponding glitch on the top trace at the start of the flat portion - when the neon bub is lit. The neon is operating on the voltage difference between that shown on the scope and +77V, so the neon starts with a lower lit voltage which then increases a little. Probably not meaningful.

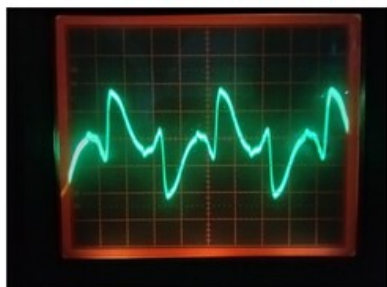
These are the Waveforms from my working HP3400A

Waveform at the junction of V501 and V502
With red wire removed and 10mv applied to pin 13 of A6 board. 2ms/Div and 20mv/Div

Waveform at the junction of V503 and 504
With red wire removed and 10mv applied to pin 13 of A6 board. 2ms/Div and 1V/Div

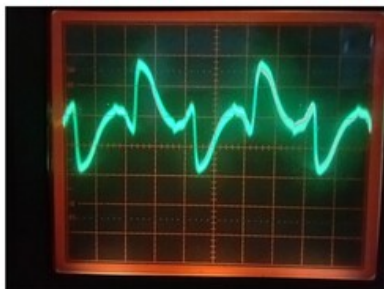
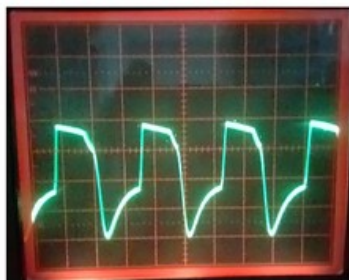
These are the waveforms from the HP3400A that will not pass the initial calibration for the DC OUT Calibration.

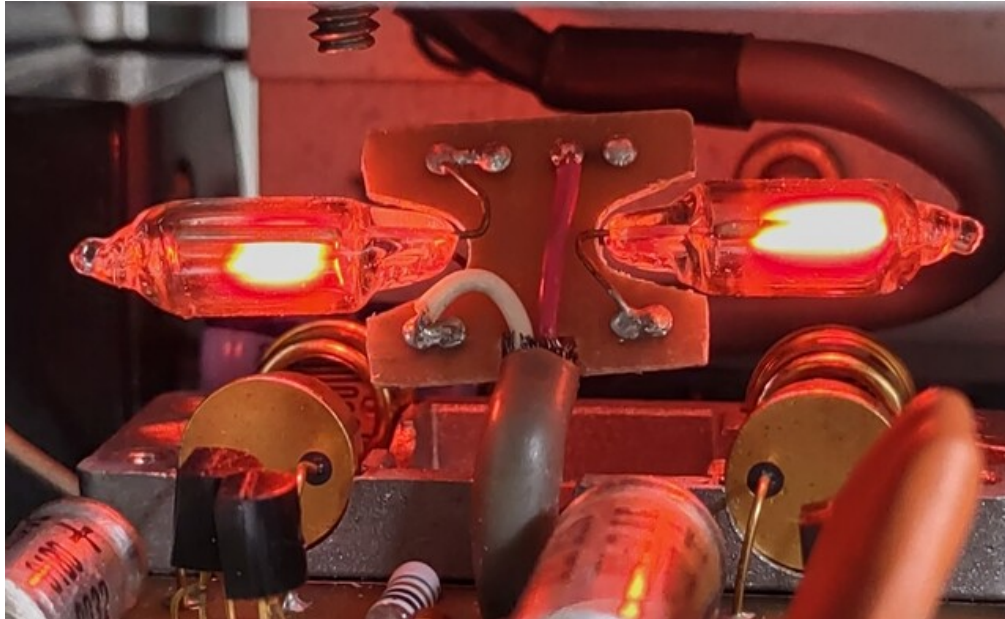
I was suspecting the LDR, but now after viewing the difference in intensity of the Neon bulbs, I'm not as sure. Here is a Dropbox link to a video showing the neon's alternating in brightness (camera modulated). <https://www.dropbox.com/s/ktrk8p3ikdt69yr/HP3400A%20Neon%20Bulb%20intensity%20video.mp4?dl=0> Any opinions about LDR vs Neon? I guess I could swap their relative positions to see if that changes the problem from demod side to modulation side.

Gas discharge tubes age and begin to strike at a higher voltage.
I would suspect that the Neon bulbs have aged and are striking at a higher voltage.
This would give the appearance of the LDR failing.
With new neon bulbs, you may fix the problem, until they age, but, that would probably be past the time that you would care to use the instrument.

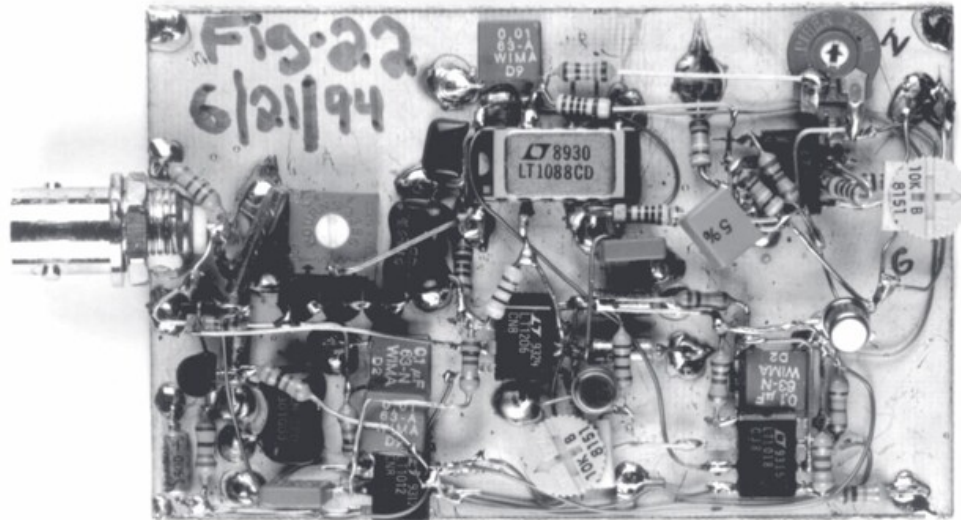
Figure A7. Figure 22's Circuit Puts Entire HP3400 Electronics on One Small Board. FET Buffer-LT1206 Amplifier Appear Left Center Behind BNC Shield. LT1088 IC (Upper Center) Replaces Thermal Converter. LT1013 (Upper Right) Based Circuitry Replaces Photo-Chopper Board. LT1018 and Components (Lower Right) Provide Overload Protection. Ain't Modern ICs Wonderful?

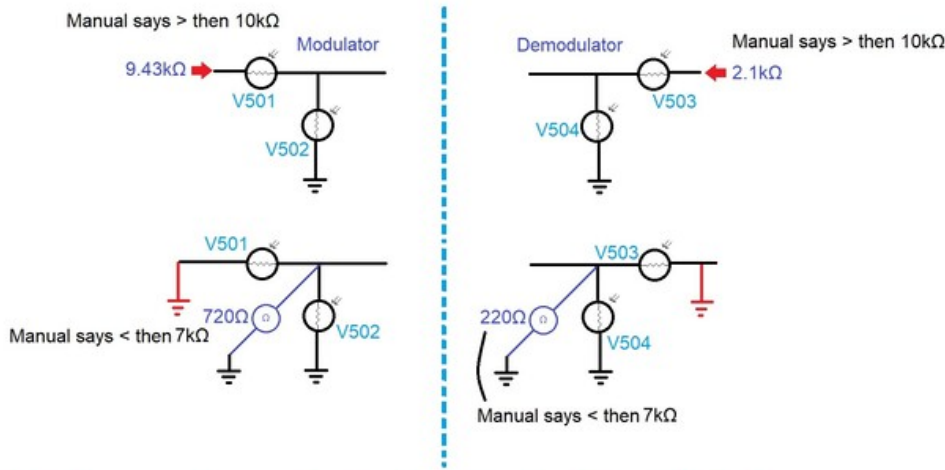
Just when you think you have it figured out and then you follow the manual!!
I took the resistance measurements following the procedure in the manual. Then I did some outside the procedure to get individual LDR measurements.
It looks to me like all of the LDRs are getting to the end of life. with V503 being the worst case.
Mikek

All measurements Made following the Procedure in Manual

V501 3KΩ
V502 1.7kΩ
V503 400Ω
V504 1.5kΩ
