E4418B-07A

S E R V I C E N O T E

Agilent E4418B EPM Power Meter

Premature RAM Backup Battery Failure

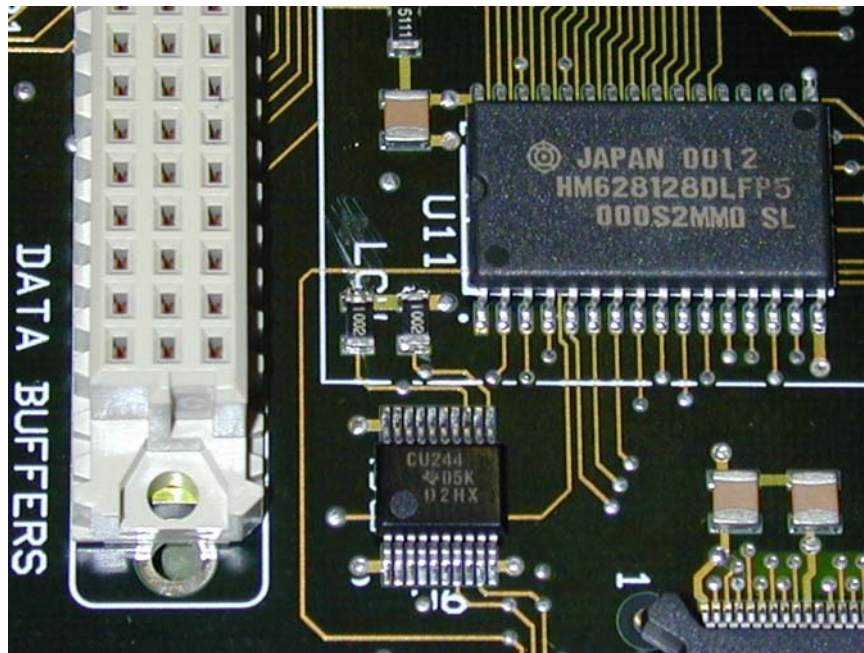
Figure 2. Location of Surface Mount Resistors

Two pull-up resistors were added as part of this design change. It has since been discovered that these pull-up resistors reduce the lifetime of the RAM lithium backup battery. The backup battery is needed to retain data in the memory when the unit is disconnected from the mains power supply. This will not affect measurement integrity of the unit, however the unit will lose all user data that was stored in it before the battery failure occurred. When the battery has failed it will display the following Power On Self Test error: RAM Battery Failed.

- Processor Assembly revisions prior to 'S' are not covered by this service note. RAM backup battery failures on these boards may be detailed in a previous service note, or they may simply be caused by natural aging of the unit. Check other service notes for this unit to verify this failure mode is not likely to be caused by any other documented problems. Do not carry out steps 4 to 14.
- Locate the two surface mount pull-up resistors (see Figure 2).
