**E4418B-18A**

**S E R V I C E N O T E**

**Agilent E4418B EPM Average Power Meter**

**Front Panel Display Problems Caused by Power Assembly Cable**

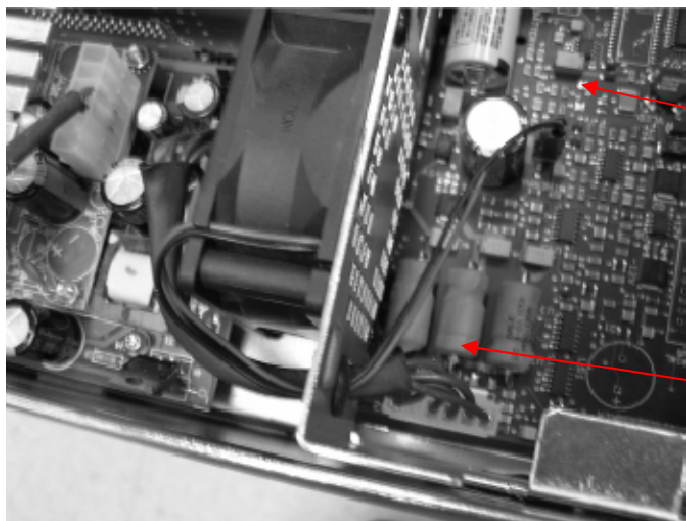
Put back fan connector

New cable with RED color

- 4) Replace with new PSU cable assembly E4418-61029. You can differentiate the cable assembly by the colors. The old cable is Black and new cable is RED.

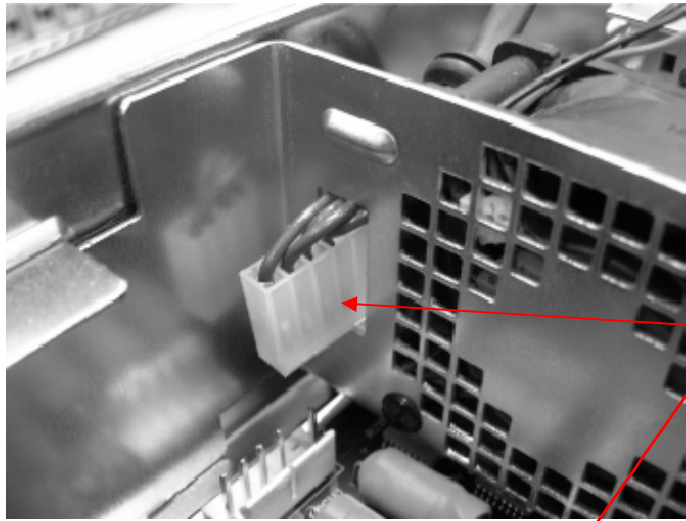
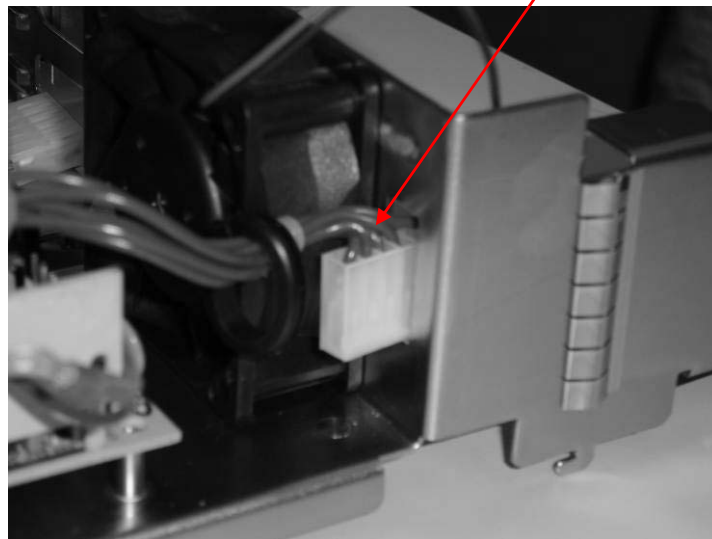
Insert the plastic casing horizontally

- 5) Here are some tips regarding the new cable. Since the plastic casing is slightly bigger in size, so you cannot directly pass through connector through hole. So you need to insert the cable horizontally. See illustration below.

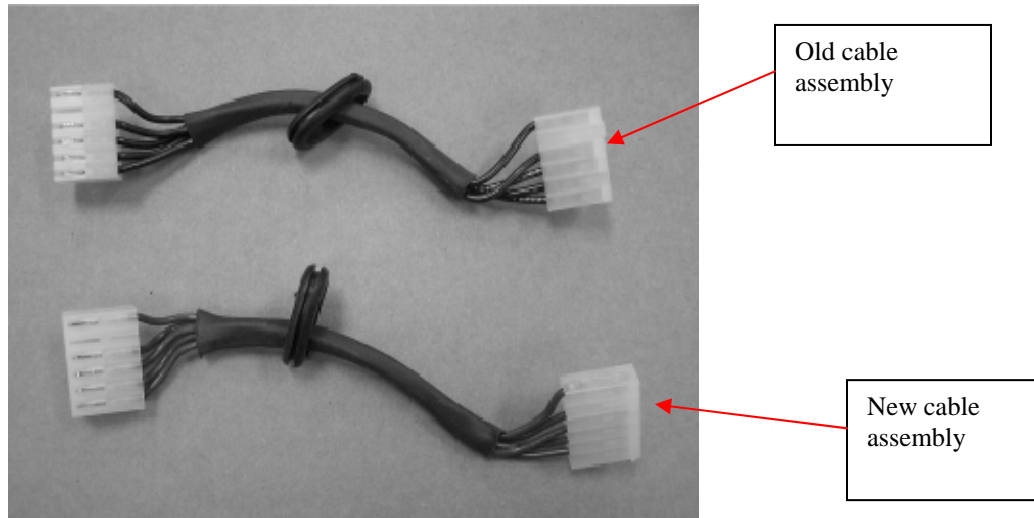
- 6) Photo below show different of old and new cable. The new cable is red in color whereas the old cable is black in color.

Note: If the power cable assembly is red in color, indicates that the cable already been changed. No action is needed.
