E4418B-20

S E R V I C E N O T E

Agilent E4418B EPM Power Meter

Hot plugging problem caused by analog switches (U11) under the measurement board assembly (E4418-60007)

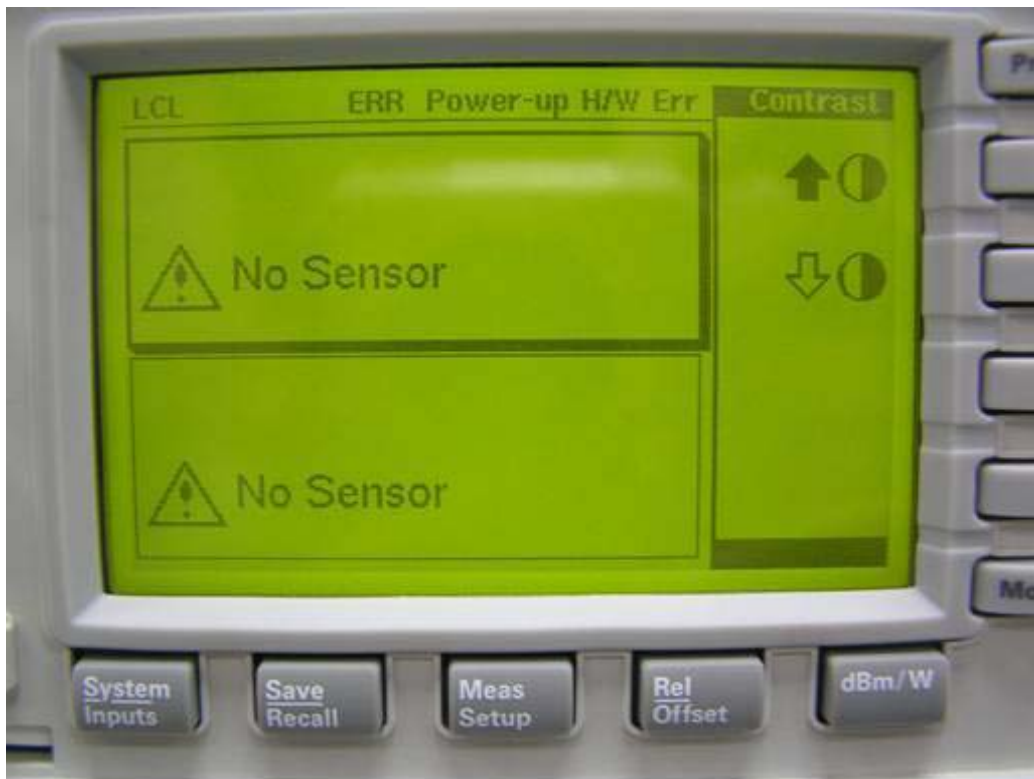
Figure 1: No sensor is detected while sensor is connected

It has been found that analog switch (U11) is causing the hot plugging problem. There are 3 different suppliers who are supplying this part: Analog Device, Vishay and Intersil suppliers. The analog switch supplied by Vishay was found to be contributing to the hot plugging problem. It was a batch related issue that happened in 2005. Current parts do not have this failure.

Replace the problematic measurement board with a good measurement board. After replacing the measurement board, repeat the steps mentioned above to verify that the problem is resolved. It should indicate that sensor is connected even after hot plugging.
