## WIZARD WORKSHOP ARTICLES

### CG 551AP SHIPPING

CG 551AP/CG 5001

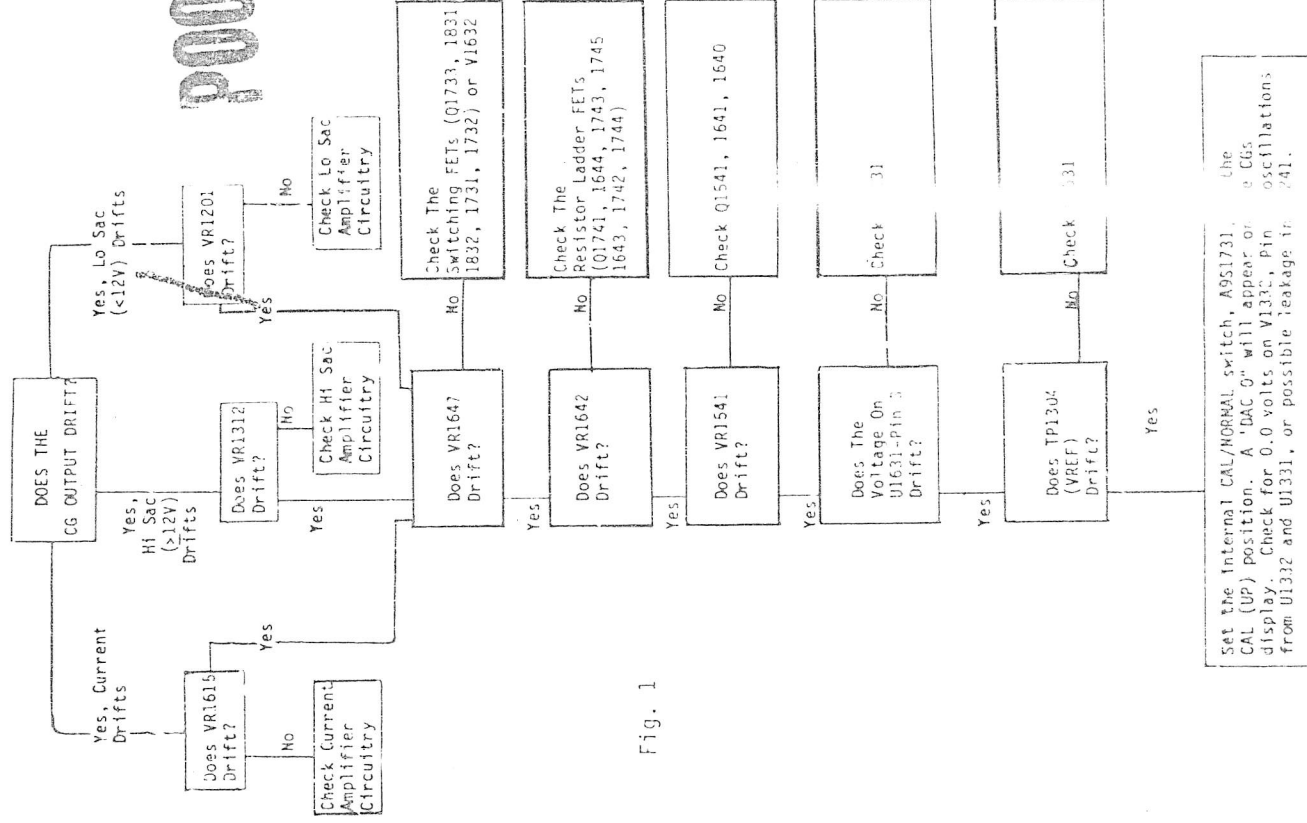
Fig. 1

TROUBLESHOOTING FLOWCHART FOR CG551AP DRIFT

In the event of voltage or current output drift problem with the CG551AP, this troubleshooting flowchart will be helpful in the isolation of the faulty components.

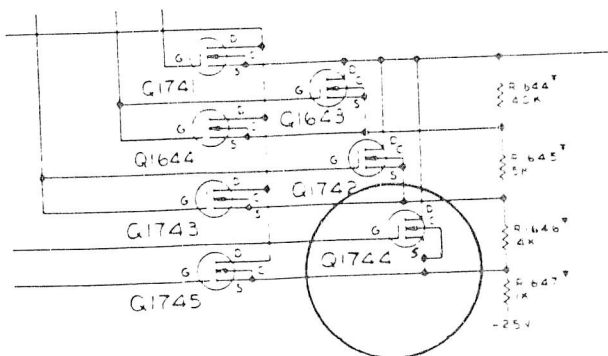
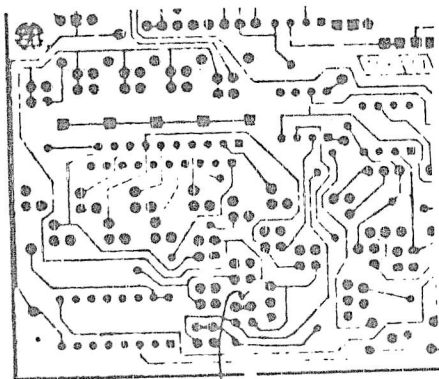
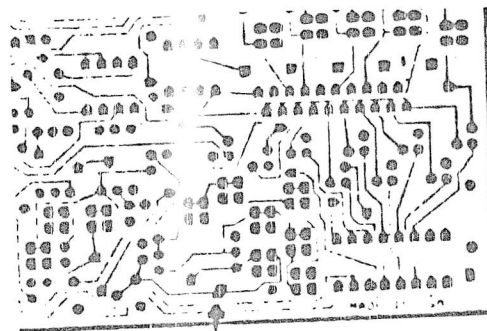
DIAGRAM 21 PRECISION DIVIDER-A6  
V-I CONVERTER-A6

An FET in location Q1744 which has had  
its source to substrate voltage exceeded  
will become leaky. When Q1744 has  
leakage, the CG may show Error Codes  
51,54,81,83,87, as well as 1V and 10V  
amplitudes reading out of tolerance.

CHANGE—the connection of the collector of Q1744 (location J8)  
as shown below:

On the component side of the board, cut  
the run at Q1744 which leads to C1641. A  
good place for cutting the run can be  
found under the lead of R1647 closest to  
the rear of the board. On the backside  
of the board, add a 26 AWG bare wire  
strap that connects the "S" lead to the  
"C" lead. This modification makes the  
configuration of Q1744 identical to the  
rest of the FETs in the V to I Converter.

ADD #26 BARE WIRE

CUT RUN

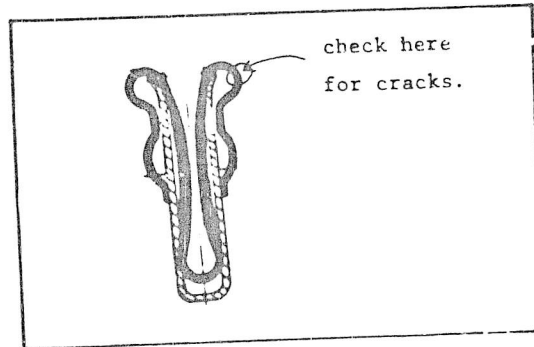
A reliability problem has been discovered with the Berg sockets used under the magnetic latch relays on the output board of the CG551AP/5001. Many of these sockets were installed incorrectly, causing intermittent operation of the relays. Some of the sockets have broken solder joints or lifted circuit board solder pads, and some of the sockets themselves are damaged.

The broken solder joints and lifted solder pads can be observed and repaired from the bottom of the board. The relays must be removed to check for damaged Berg sockets. Using the highest magnification available, a microscope if possible and a strong light, examine the sockets for fractures in the areas indicated on the drawing. All damaged sockets must be replaced.

When replacing these sockets, it is suggested that adhesive tape be applied over the gold relay contact pads to prevent solder from adhering to the contact areas. Use a thin, stiff wire, such as a straight pin, to insert the new Berg sockets into the holes. Do not apply force to the top of the socket, as this will damage it. After replacing all the damaged sockets, remove the adhesive tape and clean the contact areas with isopropyl alcohol.

All CG551AP/5001's that come in should be inspected for damaged Berg sockets. The factory is reworking all units in stock and has taken steps to prevent recurrence of this problem. Although these magnetic latch relays and sockets are used in other products, this problem has been observed only in the CG.

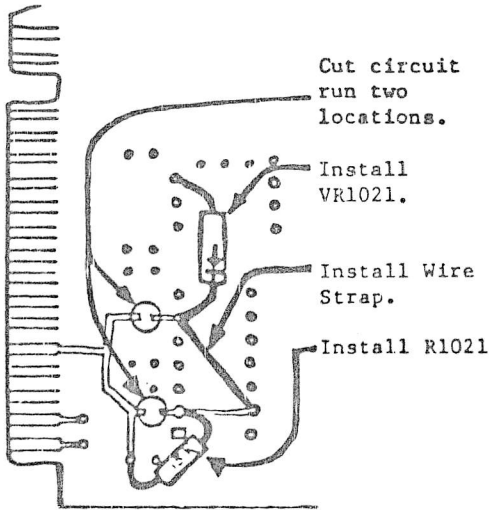
Figure 1.0  
Partial view, A9 CKT. Bd.  
(Back Side)

The modification (M60339) will suppress negative spikes caused by the 015-0311-00 Programmable Pulse Head. Typically, the only time these spikes occur is when the Pulse Head is installed after the CG is powered-up. These spikes, without this modification, will cause the CG to initiate self-test.

The modification consist of a clamp circuit at the input of A9U1021. It is comprised of adding A9R1021 (P/N 315-0153-00) and A9VR1021 (P/N 152-0175-00) on the backside of the A9 (CPU) circuit board (see figure 1.0). The schematic drawing changes are indicated in Figure 2.0.

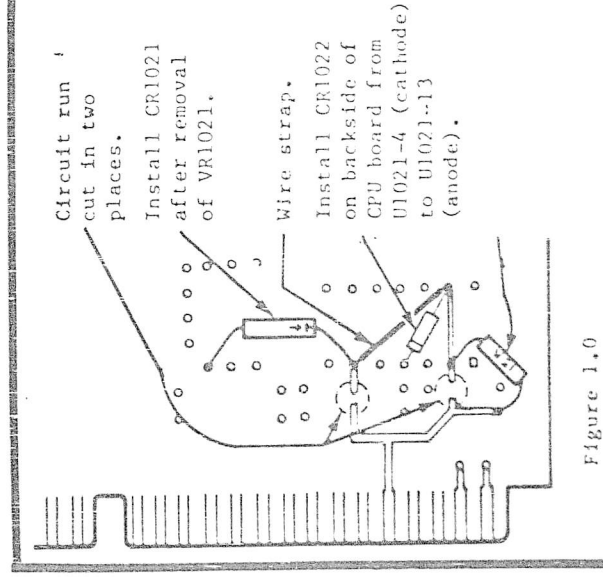
When this modification is installed, using Zener diode Tektronix P/N 152-0175-00, an operator discrepancy is noted. The discrepancy appears when the Pulse Head is not installed on the CG. The operator is able to program the Fast Edge Mode from the front panel without receiving an "Entry Error" message. Also, when the Pulse Head is attached to a powered-up CG it is not being sensed, therefore causing no CG relay action to occur. These are the only discrepancies that occur as a result of installing Zener diode VR1021.

To correct this, remove VR1021 and install CR1021 (Tektronix P/N 152-0141-02) in its place. Also install CR1022 (Tektronix P/N 152-0141-02) on the backside of CPU board from U1021-4 (cathode) to U1021-13 (anode). Figure 1.0 shows the parts orientation on the backside of the CPU board. Figure 2.0 indicates the schematic changes.
