DS3112

TEMPE T3 E3 Multiplexer

REVISION B2 ERRATA

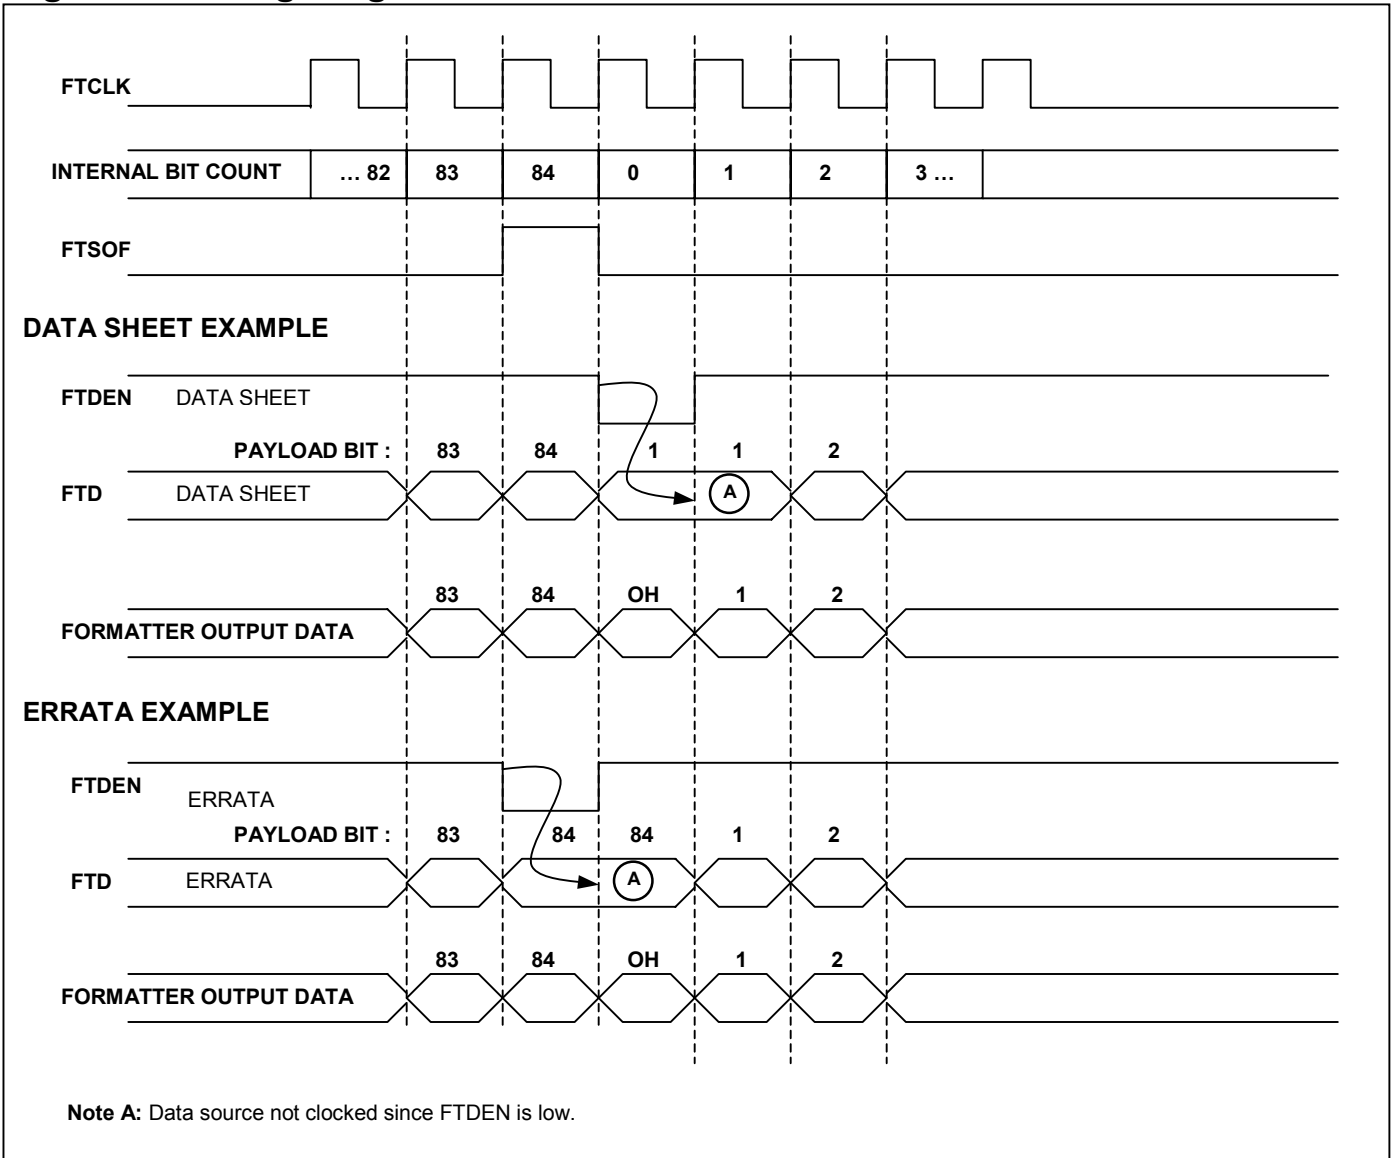
Figure 1. Timing Diagram

The FTDEN output pin (T3/E3—transmit formatter serial-data enable) pulses one clock cycle earlier than specified in Figure 2.4A of the DS3112 data sheet. This occurs in T3 mode only. FTDEN is early for both data-enable and gapped-clock modes of operation. This only affects unchannelized T3 operation; channelized T3 and E3 are not affected.

This erratum has no affect on the output data stream. Figure 1 shows that whether FTDEN pulses per the data sheet or one cycle early, the formatter output data is the same. The overhead bit is properly inserted between payload bit 84 and payload bit 1. The example in Figure 1 depicts the DS3112 where FTDEN is configured as a data enable. The gapped clock case is identical.

Use an external flip-flop to delay the FTDEN signal one clock cycle.
