Errata
AM263x Sitara MCU
Silicon Revision 1.0A

This document describes the known exceptions to the functional specifications (advisories). This document may also contain usage notes. Usage notes describe situations where the device's behavior may not match presumed or documented behavior. This may include behaviors that affect device performance or functional correctness.

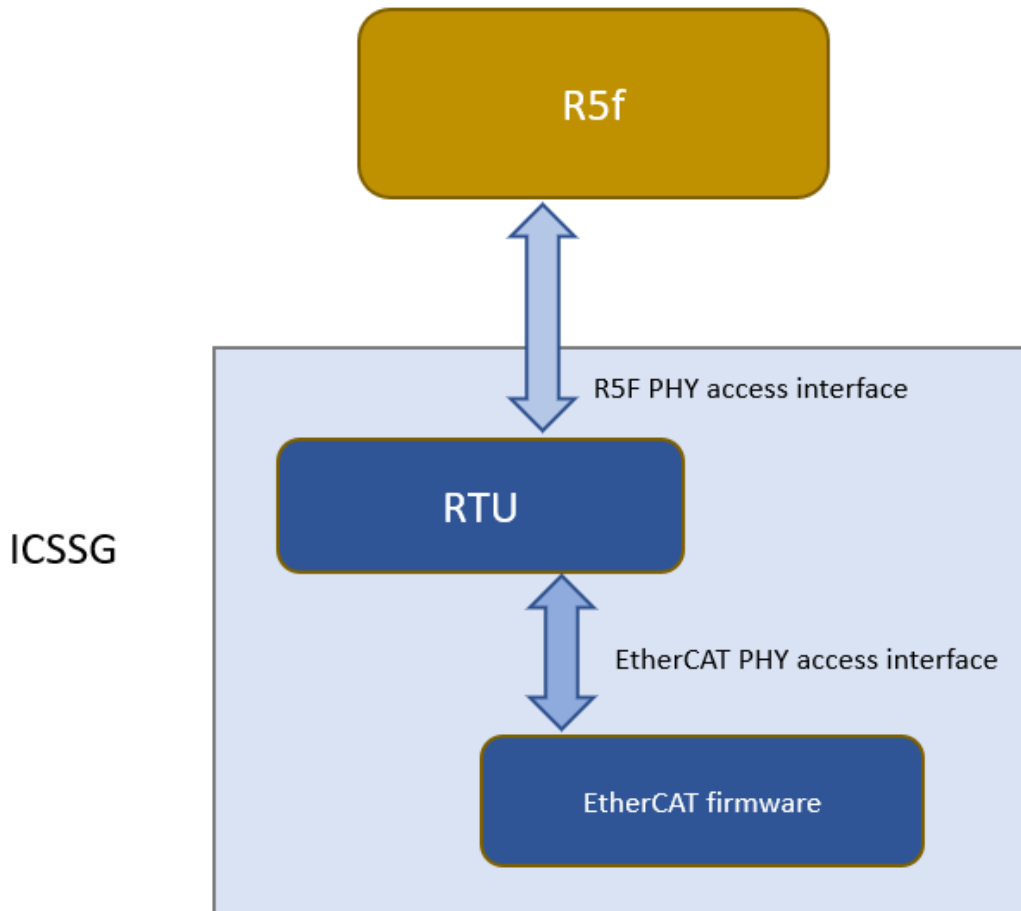
Figure 3-1. MDIO Emulation via Manual Mode using PRU Core

It is possible that the MDIO interface of all instances of CPSW and PRU-ICSS peripherals (if present) returns corrupt read data on MDIO reads (e.g. returning stale or previous data), or sends incorrect data on MDIO writes. It is also possible that the MDIO interface becomes unavailable until the next peripheral reset (either by LPSC reset or global device reset with reset isolation disabled in case of CPSW).

i2329 (continued) MDIO: MDIO interface corruption (CPSW and PRU-ICSS)

MDIO protocol can be emulated by reading and writing to the appropriate bits within the MDIO_MANUAL_IF_REG register of the MDIO peripheral to directly manipulate the MDIO clock and data pins. Refer to TRM for full details of manual mode register bits and their function.

In this case the device pin multiplexing should be configured to allow the IO to be controlled by the CPSW or PRU-ICSS peripherals (same as in normal intended operation), but the MDIO state machine must be disabled by ensuring MDIO_CONTROL_REG.ENABLE bit is 0 in the MDIO_CONTROL_REG and enable manual mode by setting MDIO_POLL_REG.MANUALMODE bit to 1.

For EtherCAT implementation on PRU-ICSS, the software workaround will be done in RTUx/ TX_PRUx Core. The core will have to be dedicated for workaround, which means this can't be used for other purpose. The implementation will support two user access channels for MDIO access. This provides option for R5f core and PRU core to have independent access channel. The APIs will be similar to the ones we will have in RTOS Workaround implementation.
