# Errata

## AM64x/AM243x Processor Silicon Revision 1.0, 2.0

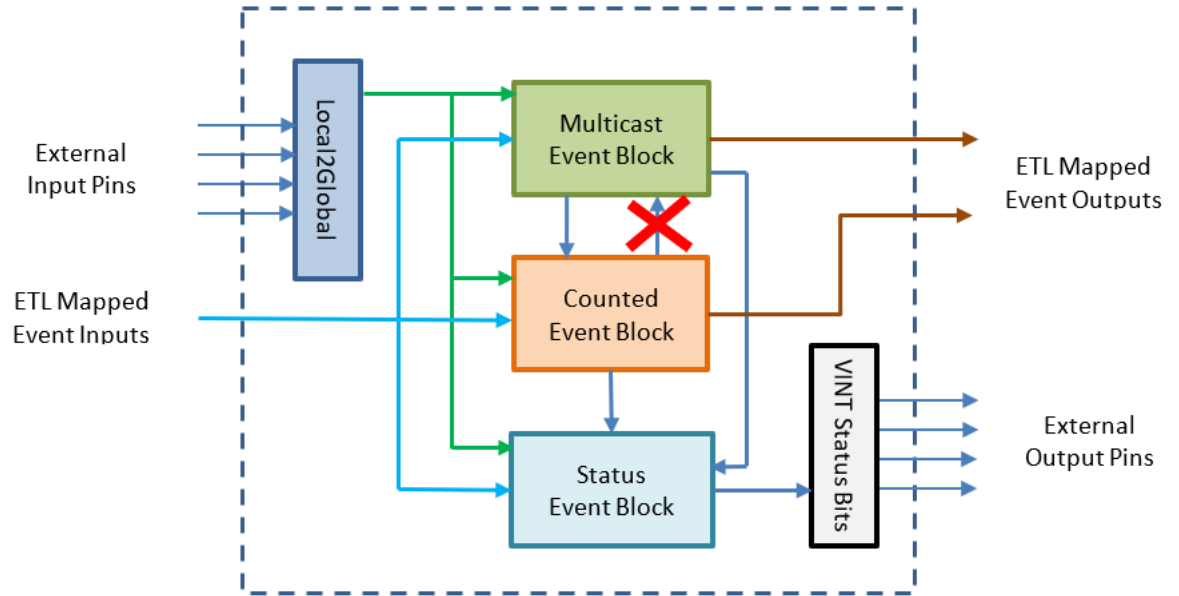
**Figure 2-1. Interrupt Aggregator Version 1.0**

An issue was found after design that could cause the IA to deadlock. The issue occurs when event “loops” occur between these three processing blocks. It is possible to create a situation where a processing block can not output an event because the path is blocked,

and since it can not output an event, it can not take any new input events. This inability to take input events prevents the output path from being able to unwind, and thus both paths remain blocked.

**Workaround(s):** Figure 2-1 shows the conceptual block diagram of IA 1.0. Potential loops are avoided by adopting the policy of not allowing the counted event block to send events to the multicast block. This method was chosen because it is more common to split an event first, and then count one while sending the other elsewhere. With this path blocked by convention, it is not possible for a single event to visit any block more than once and thus not possible for paths to become blocked so long as the outputs remain unblocked.

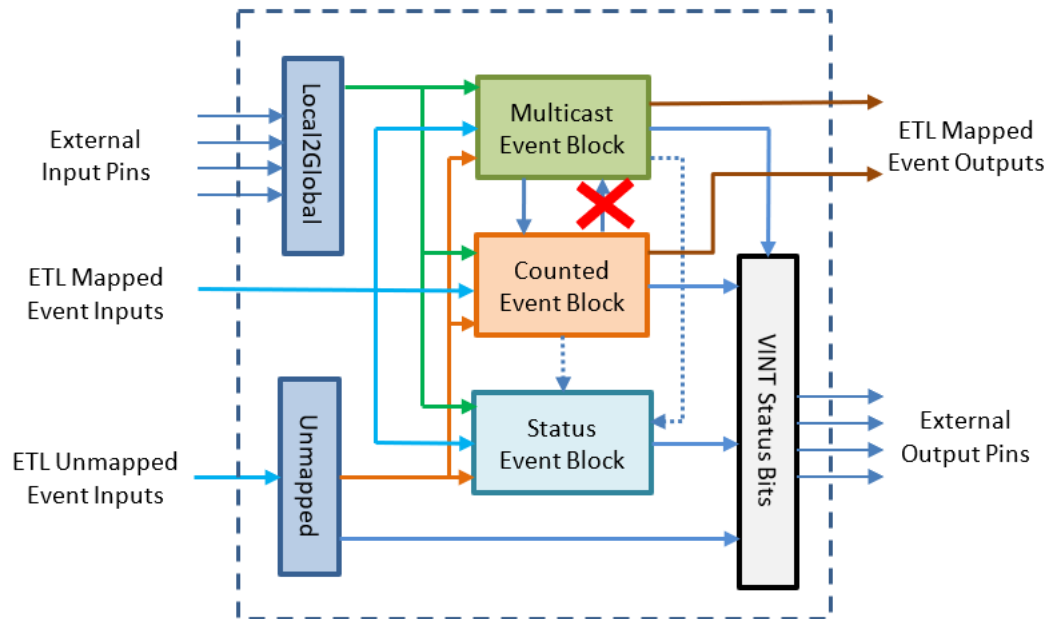
**Figure 2-2. Interrupt Aggregator Version 1.1**

IA version 1.1 introduced two additional changes to the architecture. First, there is a new processing block for “unmapped” events. These are events that are sent to a fixed destination (the IA) instead of being programmable at the source IP. Being fixed, they are called “unmapped”. Once in the IA, they are mapped to a traditional ETL event destination. The block that performs this mapping is called unmapped event block. The second change to the IA for 1.1 is that now, the multicast and counted event blocks (as well as the new unmapped event block) can directly set VINT status bits, and they do not need to forward output ETL events to the status event block.

Figure 2-2 shows the diagram of IA 1.1. Note that the same policy applies to avoid deadlock. In addition, the paths shown as dotted lines (sending ETL events from the multicast or counted blocks to the status event block) is now discouraged. These paths still function as before for backward compatibility, but are rendered obsolete as all blocks are now able to directly set status event bits.

By following the conventions outlined here, the system is safe from looping hazards that can create a deadlock scenario.
