Errata

DRA72x (SR 2.0, 1.0) and DRA71x (SR 2.1, 2.0) SoC for Automotive Infotainment

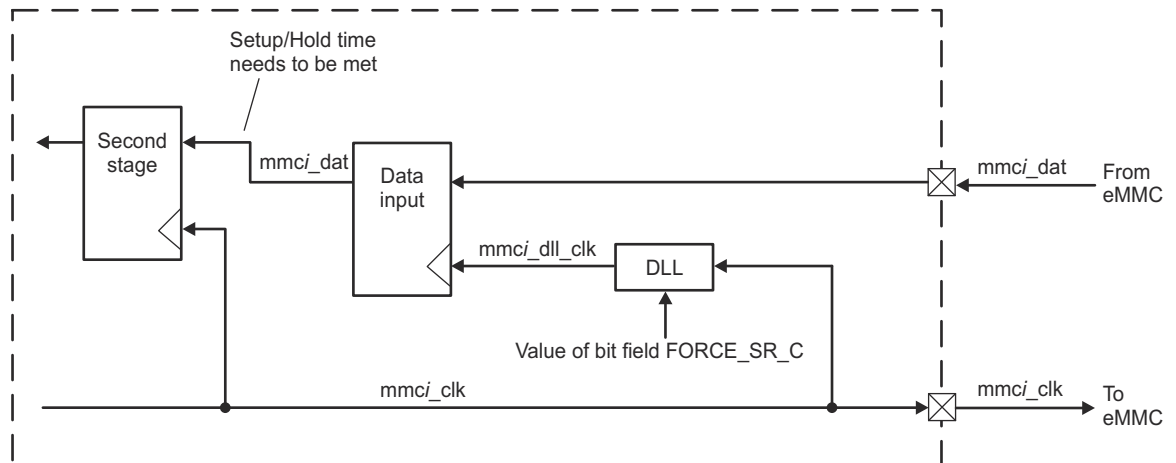
Figure 2-1. Simplified SoC 192-MHz Mode DLL Block Diagram

Internal to the MMC module, a second stage latch is used to recapture data captured by DLL delayed clock, `mmc_i_dll_clk`. The second stage latch captures with the original transmitting clock, `mmc_i_clk`.

`mmc_i_dll_clk` and `mmc_i_clk` both run at the same clock frequency. This results in a narrow range of tuning ratio elements, where the delayed `mmc_i_dll_clk` comes in phase with `mmc_i_clk`. If the clocks are in phase, the data captured by the first clock violates the setup and hold time requirements needed for the second stage latch, resulting in incorrectly read data. This is known as tuning re-timing errors.

A DLL tuning algorithm has been implemented that can avoid the tuning re-timing errors. More details on this can be found in App Note [SPRACA9](#). The following notes summarize the updated algorithm:

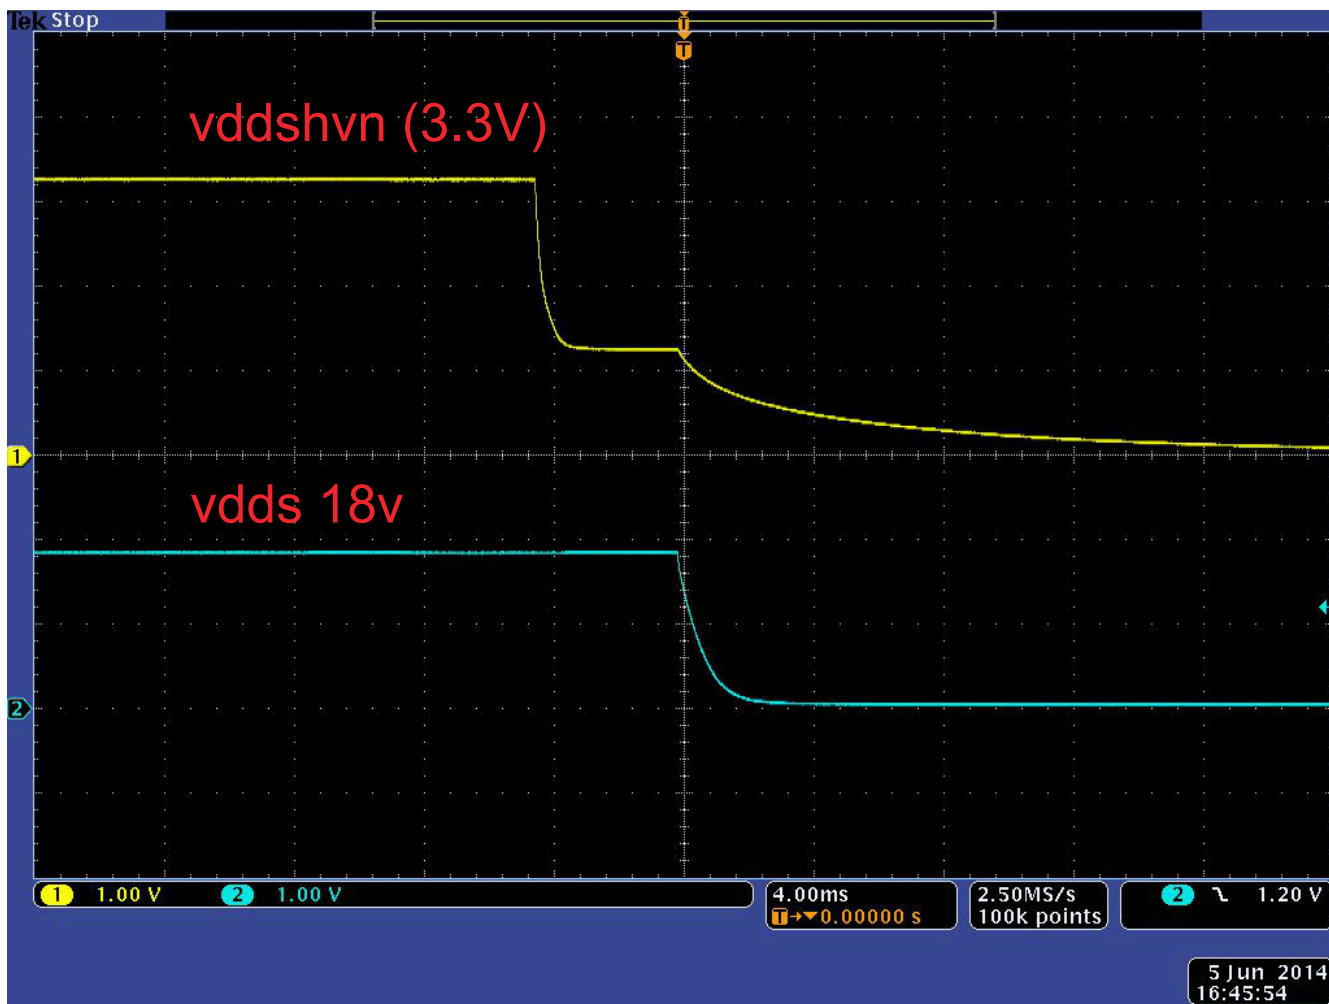
**Figure 4-1. PAB_RevA**

The Data Manual allows the vddshvn rail (in either 3.3V or 1.8V mode) to power down at the same time or before the vdds18v rail. When the vddshvn rail is powered down before the vdds18v rail, the vddshvn rail stays at Plateau Level (<1.5V) until the vdds18v rail is disabled, as shown in the waveform below.

A subset of the SOC's LVCMOS IOs (refer to DM for details) have a pull-up resistor that is active by default, including during reset and power-down. The SOC's IOs that have internal or external pull-ups will stay at Plateau Level (<1.5V) during the power-down. If other ICs on the board that are interfaced to the SOC's LVCMOS signals use a separate supply then it's possible that the other IC's signals can be pulled to the Plateau Level while its power supply is off.

The root cause of the plateau is related to the LVCMOS IO buffer Dual Voltage detection circuitry. The LVCMOS Dual Voltage IO includes voltage comparator circuitry to determine if the IO is in 3.3V mode or 1.8V mode. During powerdown of vddshvn domains, a current path in the internal bias transistors results in the vddshvn rail being held to an intermediate voltage level (<1.5 V). This path can consume at most 500 uA per IO - worst

In general, TI recommends using the same supply source for connected components. E.g., a single LDO should drive vddshvn and the related 3.3V external components.

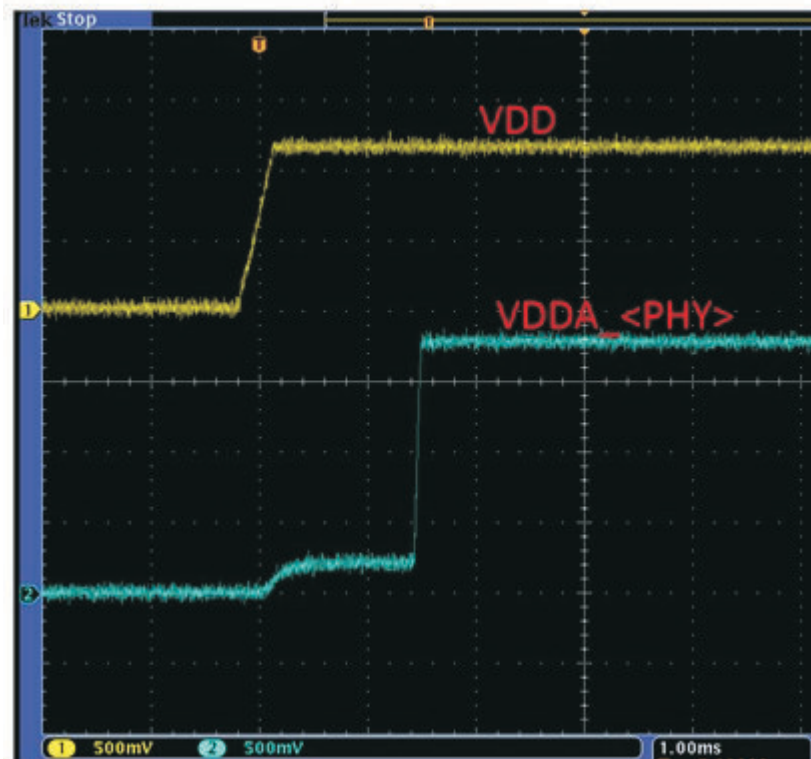
Figure 4-2. Leakage Voltage

The device-specific Data Manual requires Core AVS rail (VDD) to power up before the 1.8 V high speed analog PHY domain(s). When this sequence is followed, the high speed analog PHY domain will have a small step-up to a voltage plateau (< 0.5 V) that aligns to the beginning of the VDD ramp-up, and is maintained until the ramp-up of high speed analog PHY rail, as shown in [Figure 4-2](#). Note the leakage value will differ from system to system, but will be less than 500 mV. The leakage voltage in the provided capture is approximately 250 mV.

The root cause of the voltage plateau during power-up/down sequencing is related to the parasitic diodes in logic blocks which have multiple power sources. This leakage path is not a reliability concern for this device.

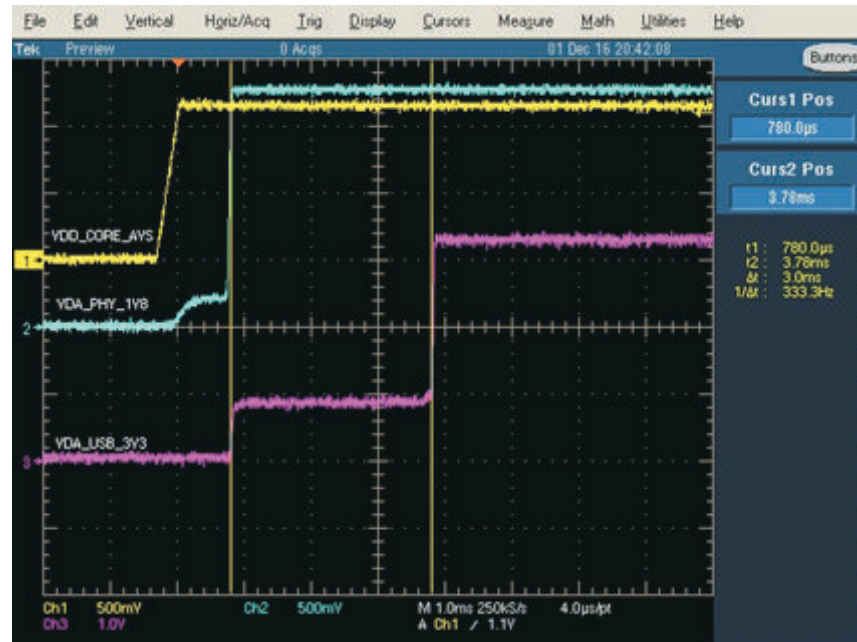
Figure 4-3. Original Power-Up Sequence

An unintended leakage current path between VDDA_PCIE (1.8 V) and VDDA33_USB1 (3.3 V) due to ESD protection diode connection across the signal to I/O supply pads exists. This path can allow current to flow from VDDA_PCIE to VDDA33V_USB1. The current flows whenever the voltage level on VDDA_PCIE exceeds VDDA33V_USB1 by more than a diode drop during certain power-up and power-down sequences.

This leakage current causes the un-energized VDDA33V_USB1 to rise to a ~1 V plateau (see [Figure 4-3](#)) due to the power resource's "off impedance" seen between the VDDA33V_USB1 power rail to ground. When the minimum "off impedance" is $\geq 100 \Omega$, the SoC leakage current is small and sustainable with no SoC reliability impacts.

Note: [Figure 4-3](#) shows in VDA_PHY_1V8 rail a plateau approximately 250 mV documented in i931, VDD to VDDA_"PHY" Current Path.

TI recommended Power Delivery Networks (PDNs) could have multiple different PMIC LDO power resources connected to the VDDA33V_USB1 rail. The LP8733/32 PMICs have a minimum OFF resistance equal to 150Ω so a PDN using these PMICs would not exceed safe leakage current level and could continue to use the original SoC power sequences. However, the TPS65917/919 PMICs have a minimum OFF resistance equal to 30Ω and would exceed the safe leakage current limit. As a result, any PDN using TPS65917/919 PMICs must implement the revised power sequencing as shown in DM version D or later. The specific sequence changes are:
