# J721E DRA829/TDA4VM Processors Silicon Revision 1.1/1.0

## ABSTRACT

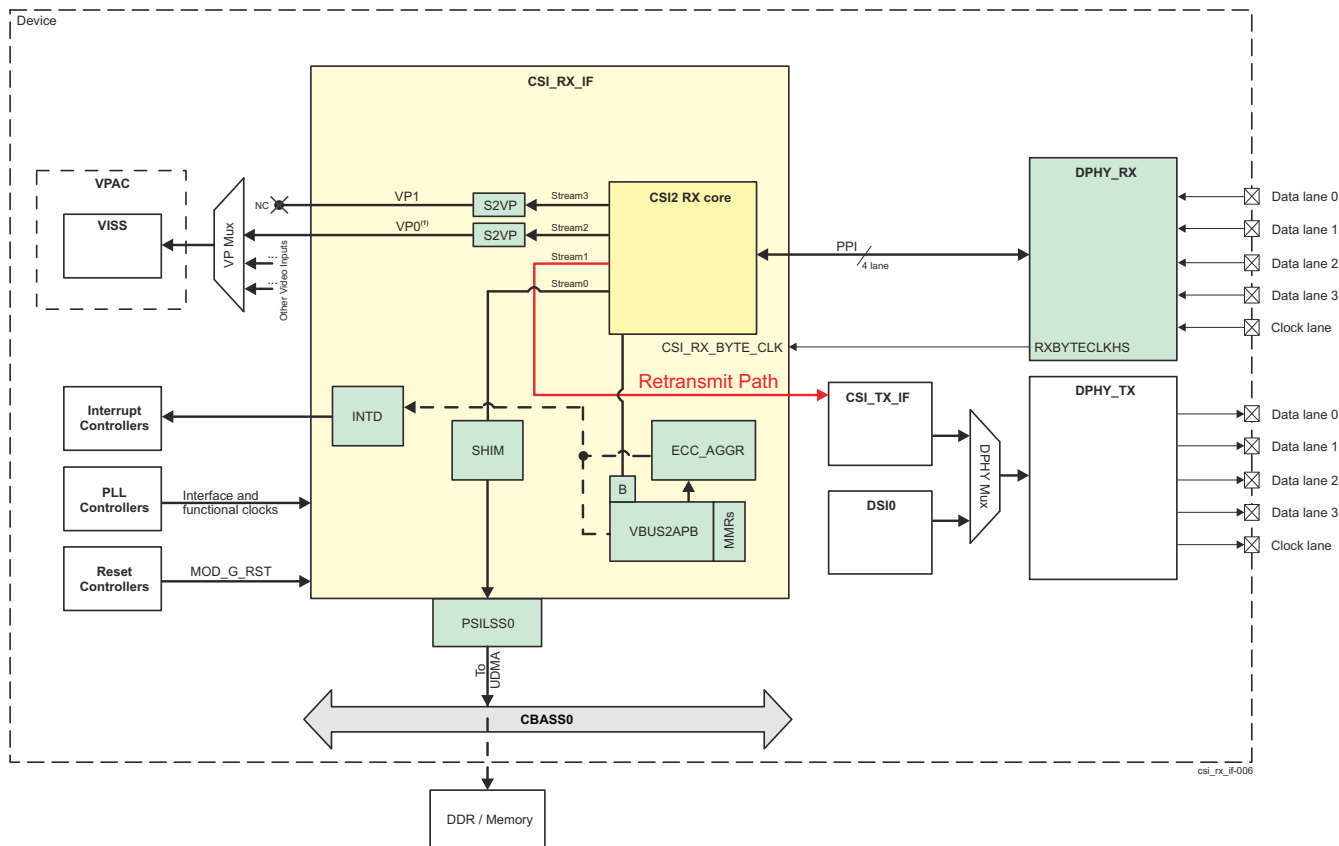
**Figure 3-1. CSI\_RX\_IF Block Diagram**

**Details:** CSI\_TX\_IF module does not recognize blanking in input data. Given all sensors are expected to have blanking, the re-transmit path between CSI\_RX\_IF module and CSI\_TX\_IF module cannot be used.

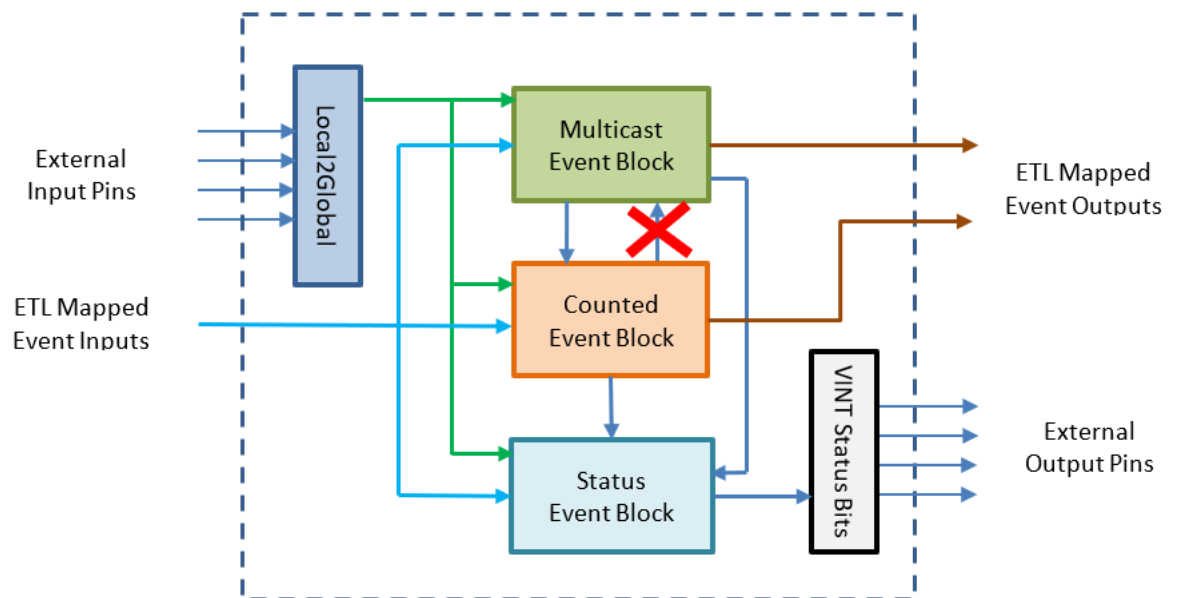
**Figure 3-5. Interrupt Aggregator Version 1.0**

An issue was found after design that could cause the IA to deadlock. The issue occurs when event “loops” occur between these three processing blocks. It is possible to create a situation where a processing block can not output an event because the path is blocked, and since it can not output an event, it can not take any new input events. This inability to take input events prevents the output path from being able to unwind, and thus both paths remain blocked.

**Workaround(s):** Figure 3-5 shows the conceptual block diagram of IA 1.0. Potential loops are avoided by adopting the policy of not allowing the counted event block to send events to the multicast block. This method was chosen because it is more common to split an event first, and then count one while sending the other elsewhere. With this path blocked by convention, it is not possible for a single event to visit any block more than once and thus not possible for paths to become blocked so long as the outputs remain unblocked.

By following the conventions outlined here, the system is safe from looping hazards that can create a deadlock scenario.
