## ABSTRACT

This document describes the known exceptions to the functional specifications (advisories).

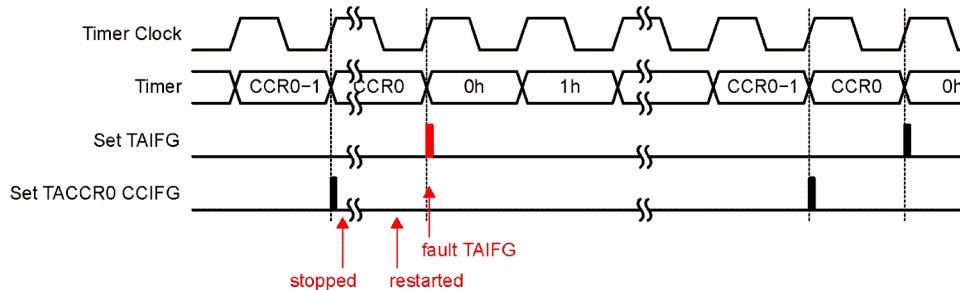
TAIFG Flag is erroneously set after Timer A restarts in Up Mode

In Up Mode, the TAIFG flag should only be set when the timer counts from TACCR0 to zero. However, if the Timer A is stopped at  $TAR = TACCR0$ , then cleared ( $TAR=0$ ) by setting the TACLRL bit, and finally restarted in Up Mode, the next rising edge of the TACLK will erroneously set the TAIFG flag.

**Workaround** None.
