Errata  
**MSP430F1481 Microcontroller**

This document describes the known exceptions to the functional specifications (advisories).

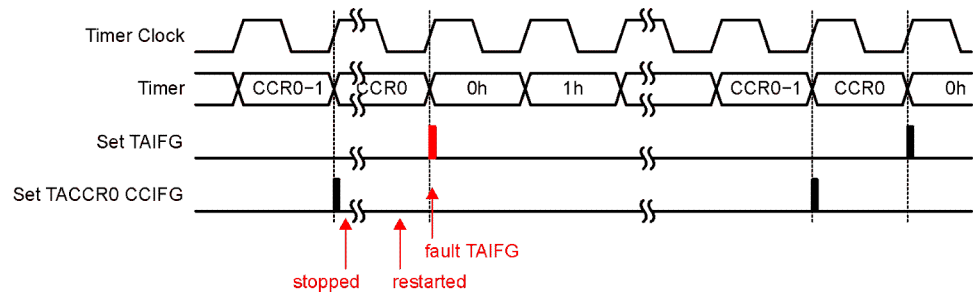
**TA21** *TA Module*

<b>Category</b>	Functional
<b>Function</b>	TAIFG Flag is erroneously set after Timer A restarts in Up Mode
<b>Description</b>	In Up Mode, the TAIFG flag should only be set when the timer counts from TACCR0 to zero. However, if the Timer A is stopped at TAR = TACCR0, then cleared (TAR=0) by setting the TACLr bit, and finally restarted in Up Mode, the next rising edge of the TACLK will erroneously set the TAIFG flag.

<b>Workaround</b>	None.
-------------------	-------

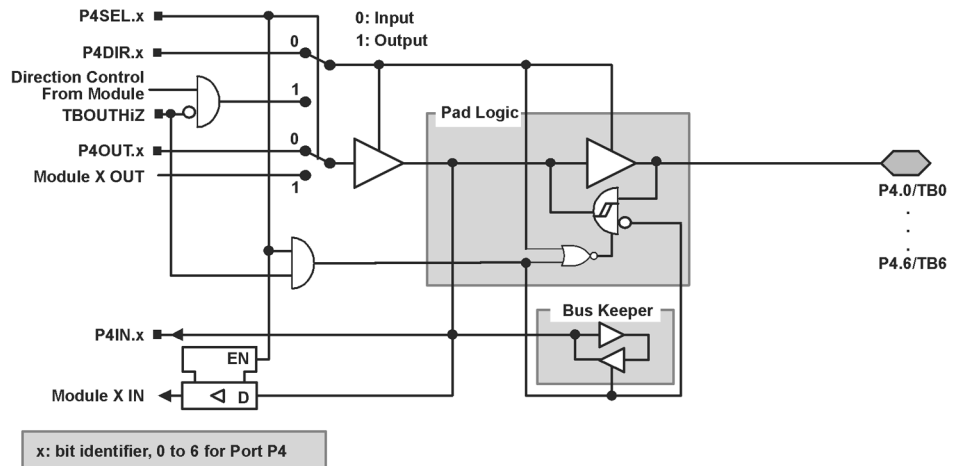
Port Realization With TB3 Bug

<b>Workaround</b>	Switch capture/compare mode to capture mode before the CCRx register increment. Switch back to compare mode afterward.
<b>TB3</b>	<b><i>TB Module</i></b>
<b>Category</b>	Functional
<b>Function</b>	Timer_B Port is switched to 3-state independent of selected function
<b>Description</b>	Incorrect 3-state function of Ports P4.0/TB0 through P4.6/TB6 (TBoutHiZ control). If TBoutHiZ is set to high, all ports P4.0/TB0 through P4.6/TB6 are set to 3-state, independent of the P4SEL.x control signals. This means a port P4.x is switched to 3-state with TBoutHiZ, even if it is not selected for Timer_B function. In addition, the ports P4.0/TB0 through P4.6/TB6 are switched to 3-state with TBoutHiZ, even if the port direction (direction control from module) is set to input. This is in accordance with the specification description but, nevertheless, is an unexpected behavior.
<b>Workaround</b>	No workaround.  Port function as specified

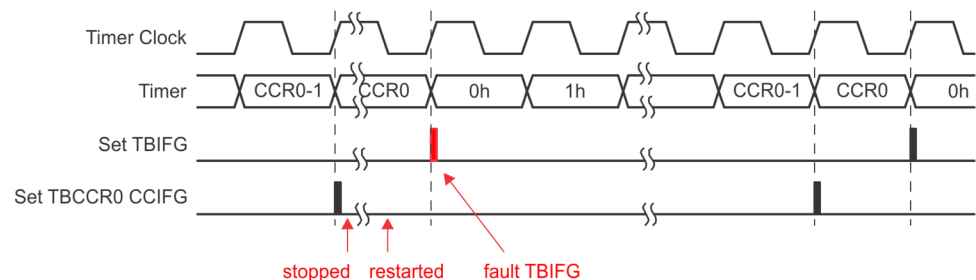
## TB24 *TB Module*

<b>Category</b>	Functional
<b>Function</b>	TBIFG Flag is erroneously set after Timer B restarts in Up Mode
<b>Description</b>	<p>In Up Mode, the TBIFG flag should only be set when the timer resets from TBCCR0 to zero. However, if the Timer B is stopped at TBR = TBCCR0, then cleared (TBR=0) by setting the TBCLR bit, and finally restarted in Up Mode, the next rising edge of the TBCLK will erroneously set the TBIFG flag.</p>

<b>Workaround</b>	None.
-------------------	-------
