ABSTRACT

This document describes the known exceptions to the functional specifications (advisories).

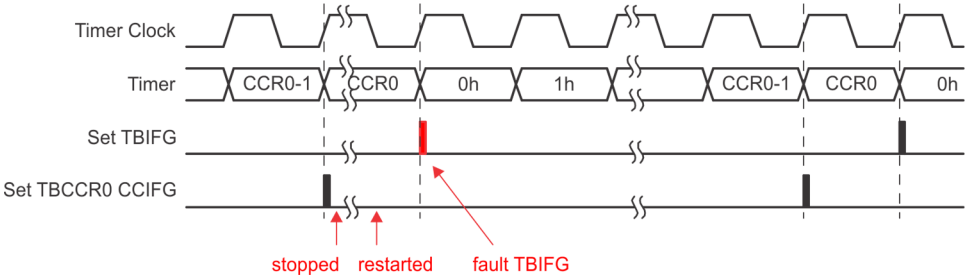
TB24	TB Module
Category	Functional
Function	TBIFG Flag is erroneously set after Timer B restarts in Up Mode
Description	In Up Mode, the TBIFG flag should only be set when the timer resets from TBCCR0 to zero. However, if the Timer B is stopped at TBR = TBCCR0, then cleared (TBR=0) by setting the TBCLR bit, and finally restarted in Up Mode, the next rising edge of the TBCLK will erroneously set the TBIFG flag.

Workaround	None.
