# **TMS320C6455/54**

## **Digital Signal Processor**

### **Silicon Revisions 3.1, 2.1, 2.0, 1.1**

## **Silicon Errata**

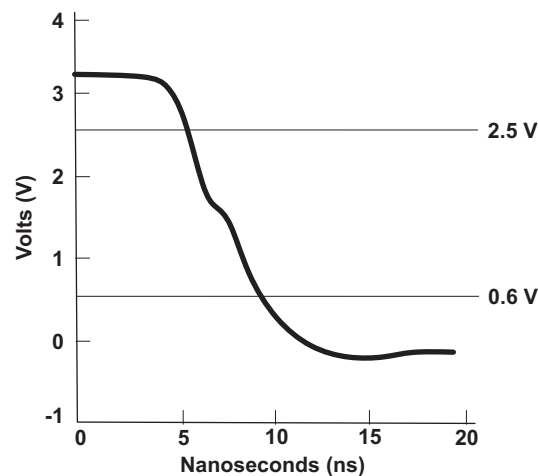
**Figure 3. Bad TCK Transition**

This phenomenon is observed when an erroneous clock edge is generated from the TCK signal inside the C64x+ DSP. This can be caused by several factors, acting independently or cumulatively:

A TCK edge that can cause this problem might look similar to the one shown in [Figure 3](#). A TCK edge that does not cause the problem will look similar to the one shown in [Figure 4](#). The key difference between the two figures is that [Figure 4](#) has a clean and sharp transition whereas [Figure 3](#) has a "knee" in the transition zone.

As the problem may be caused by one or more of the above factors, one or more of the steps outlined below may be necessary to fix it:

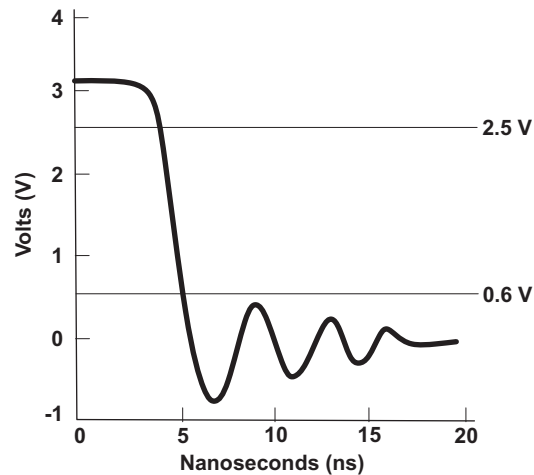
**Figure 4. Good TCK Transition**

As a result of the faster edge transition, there is increased ringing in [Figure 4](#). As long as the ringing does not cross logic input thresholds (0.6 V for falling edges, and 2.5 V for rising edges), this ringing is acceptable.

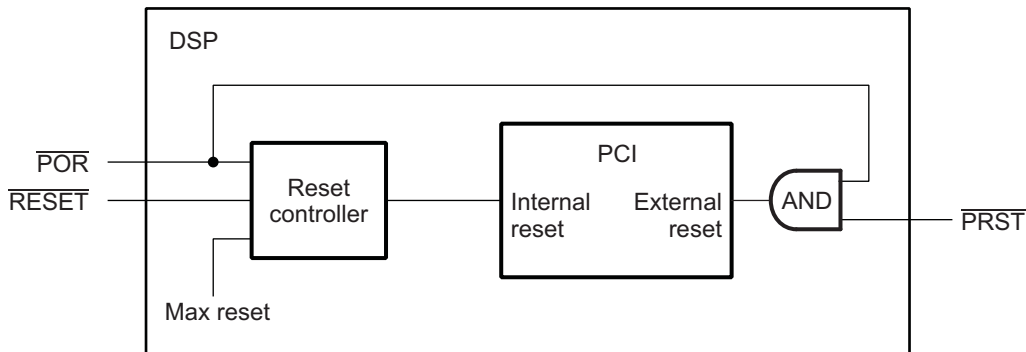
**Figure 5. Internal Reset Asserted By Reset Controller**

**Details:** The PCI module in the C6455/54 device has an internal and an external reset source. The internal reset is asserted by the reset controller during power-on, warm, and max reset, see [Figure 5](#). The internal reset is also asserted when the device state control registers are used to disable the PCI module. The external reset is asserted through the PCI reset pin,  $\overline{PRST}$ .

The PCI module can lock up or go into a bad state if its internal and external resets are asserted independently, meaning one is asserted and the other is not. Power-on and warm reset are controlled differently from system to system and, therefore, the effect of this issue is system specific.

**Workaround(s):** Systems should be designed such that a power-on or warm reset always generates the PCI reset and vice versa. Example circuits that ensure both the chip resets and the PCI reset are asserted together are shown in [Figure 6](#), [Figure 7](#), and [Figure 8](#). Note that asserting power-on reset also asserts PCI reset internally. Also, since a PCI reset will cause a chip reset, the configuration pins of the device will also be latched on a PCI reset. Therefore, these pins must be at valid levels to ensure the device is taken out of reset in the desired mode.

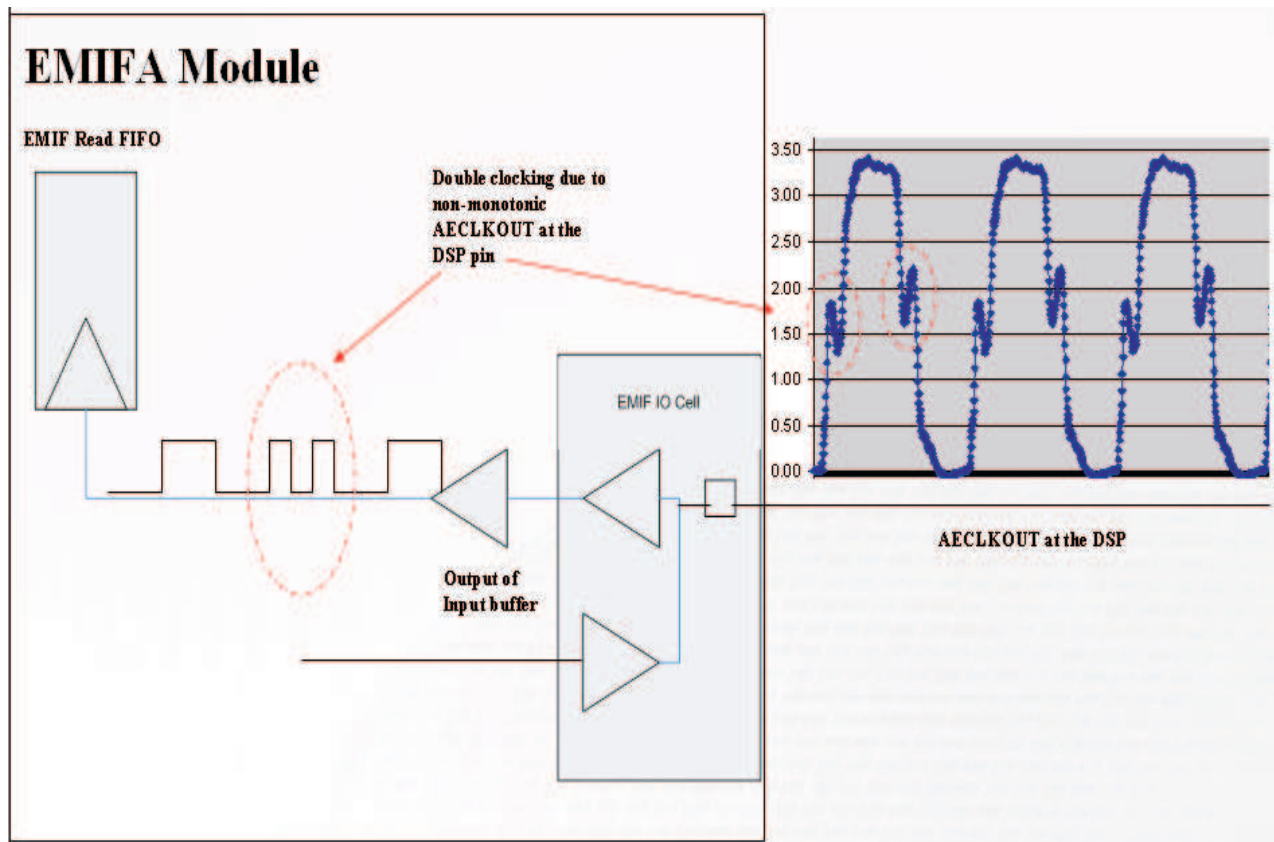
**Figure 10. AECLKOUT at the DSP**

If the above conditions are not within specification — as defined in the *TMS320C6455 Fixed-Point Digital Signal Processor* data manual (literature number [SPRS276](#)) and the *TMS320C6454 Fixed-Point Digital Signal Processor* data manual (literature number [SPRS311](#)) — then read data corruption can occur. If the signal quality is not achievable with the proper termination, then external buffering may be required. This ensures that the AECLKOUT is monotonic at the DSP and at the external device between  $V_{IL}/V_{IH}$ . In all cases, techniques for high-speed digital design should be applied to the EMIFA interface. Since the AECLKOUT is looped back for read data latch, it is very important to terminate the AECLKOUT at the DSP to ensure clock signal integrity. There is an inherent "shelf" near the switch point at the driver, which causes the transition to be non-monotonic at the DSP. The impact of this issue depends on where the AECLKOUT is non-monotonic at the DSP. The AECLKOUT topology must ensure that the AECLKOUT signal at the DSP and the load is monotonic between  $V_{IL}/V_{IH}$ .

**Workaround(s):** The workaround provides details on how to select the correct series termination values at the driver and loads to minimize reflections and over/undershoot. The workaround must also ensure that the AECLKOUT signal is always monotonic between  $V_{IL}/V_{IH}$  at the driver and the loads for weak and strong conditions.
