# ***TDA2x SoC for Advanced Driver Assistance Systems (ADAS) Silicon Revision 2.0, 1.1***

## *Errata*

This document describes the known exceptions to the functional specifications for the device.

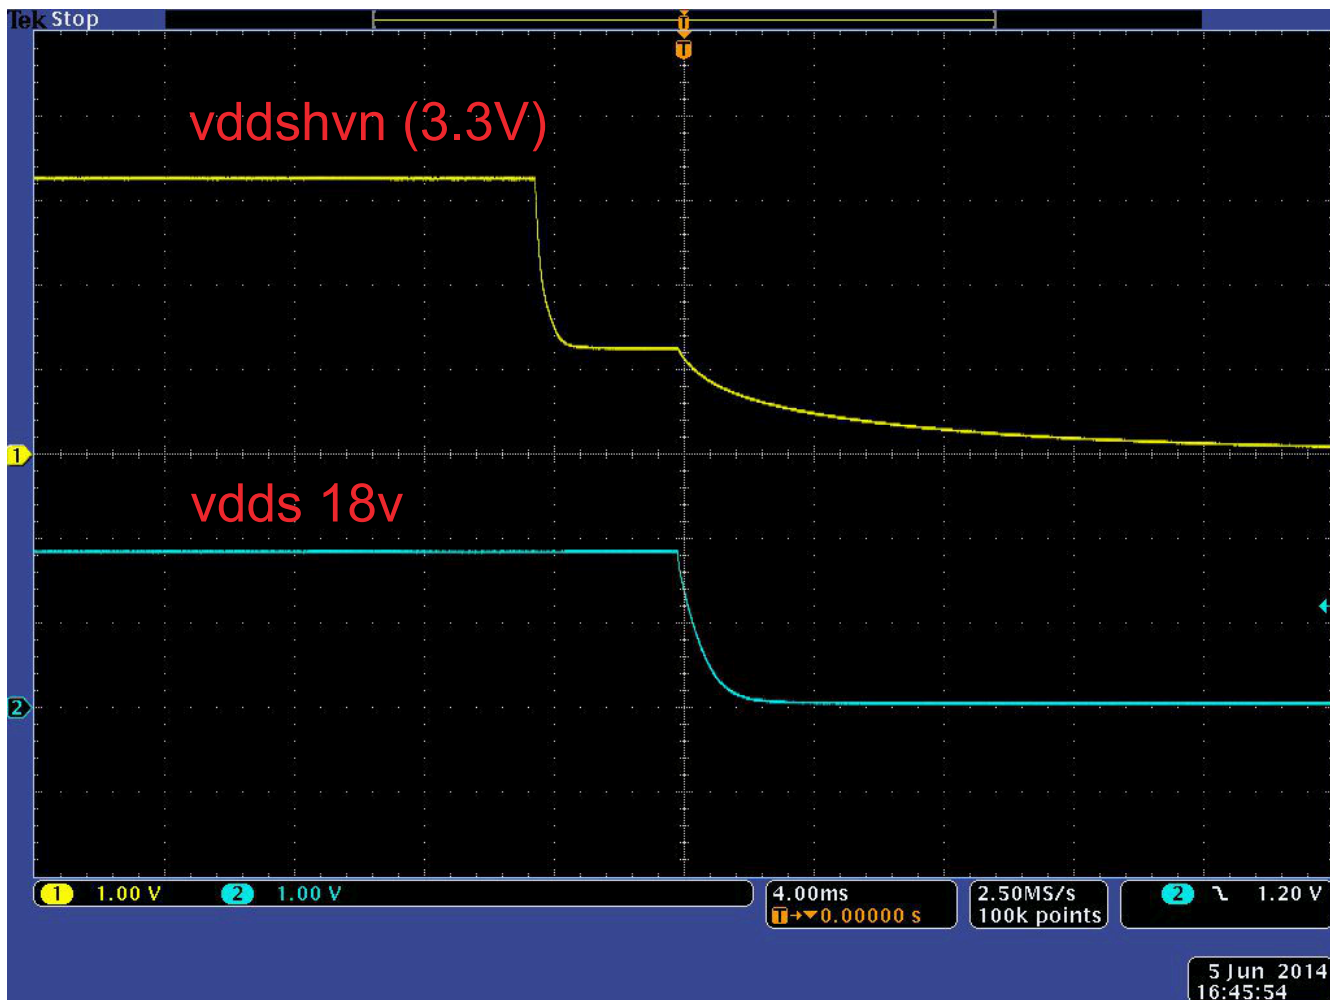
**Figure 4-1. PAB\_RevA**

The Data Manual allows the vddshvn rail (in either 3.3V or 1.8V mode) to power down at the same time or before the vdds18v rail. When the vddshvn rail is powered down before the vdds18v rail, the vddshvn rail stays at Plateau Level (<1.5V) until the vdds18v rail is disabled, as shown in the waveform below.

A subset of the SOC's LVCMOS IOs (refer to DM for details) have a pull-up resistor that is active by default, including during reset and power-down. The SOC's IOs that have internal or external pull-ups will stay at Plateau Level (<1.5V) during the power-down. If other ICs on the board that are interfaced to the SOC's LVCMOS signals use a separate supply then it's possible that the other IC's signals can be pulled to the Plateau Level while its power supply is off.

The root cause of the plateau is related to the LVCMOS IO buffer Dual Voltage detection circuitry. The LVCMOS Dual Voltage IO includes voltage comparator circuitry to determine if the IO is in 3.3V mode or 1.8V mode. During powerdown of vddshvn domains, a current path in the internal bias transistors results in the vddshvn rail being held to an

In general, TI recommends using the same supply source for connected components. E.g., a single LDO should drive vddshvn and the related 3.3V external components.

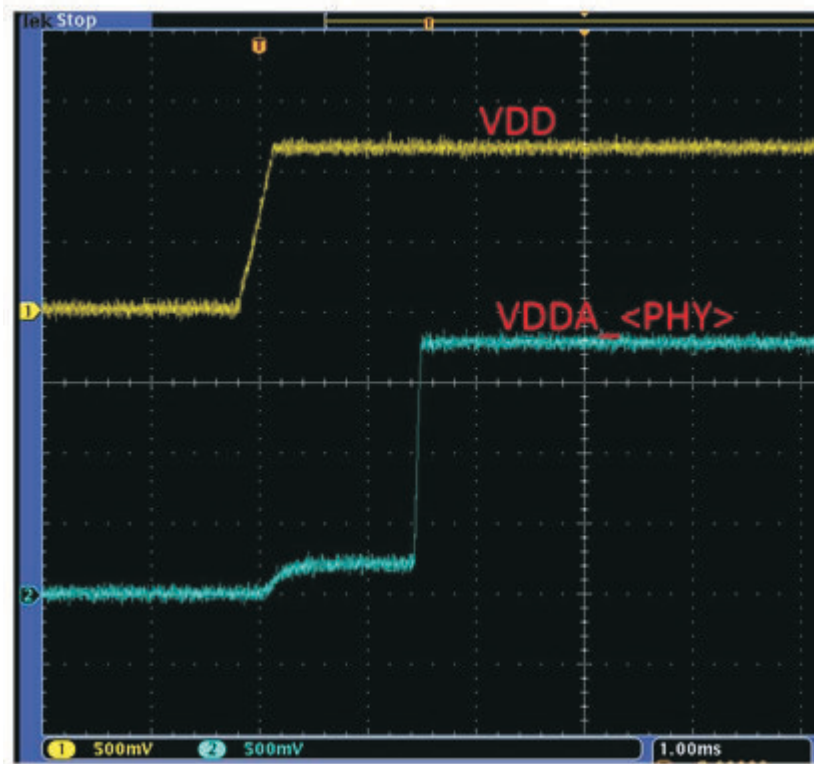
**Figure 4-2. Leakage Voltage**

**DESCRIPTION** A current path exists between VDD and the high speed analog PHY domain (VDDA\_HDMI, VDDA\_PCIE, VDDA\_SATA, VDDA\_USB2/3) during the supply power up and power down sequences.

The device-specific Data Manual requires Core AVS rail (VDD) to power up before the 1.8 V high speed analog PHY domain(s). When this sequence is followed, the high speed analog PHY domain will have a small step-up to a voltage plateau (< 0.5 V) that aligns to the beginning of the VDD ramp-up, and is maintained until the ramp-up of high speed analog PHY rail, as shown in [Figure 4-2](#). Note the leakage value will differ from system to system, but will be less than 500 mV. The leakage voltage in the provided capture is approximately 250 mV.

A similar condition exists during supply power down sequence. The high speed analog PHY domain(s) are required to be powered down prior to Core AVS rail (VDD), and may cause a small plateau to exist until Core AVS rail (VDD) is ramped down.

The root cause of the voltage plateau during power-up/down sequencing is related to the parasitic diodes in logic blocks which have multiple power sources. This leakage path is not a reliability concern for this device.
