# ***TDA2Px SoC for Advanced Driver Assistance Systems (ADAS) Silicon Revision 1.0***

## ***Errata***

This document describes the known exceptions to the functional specifications for the device.

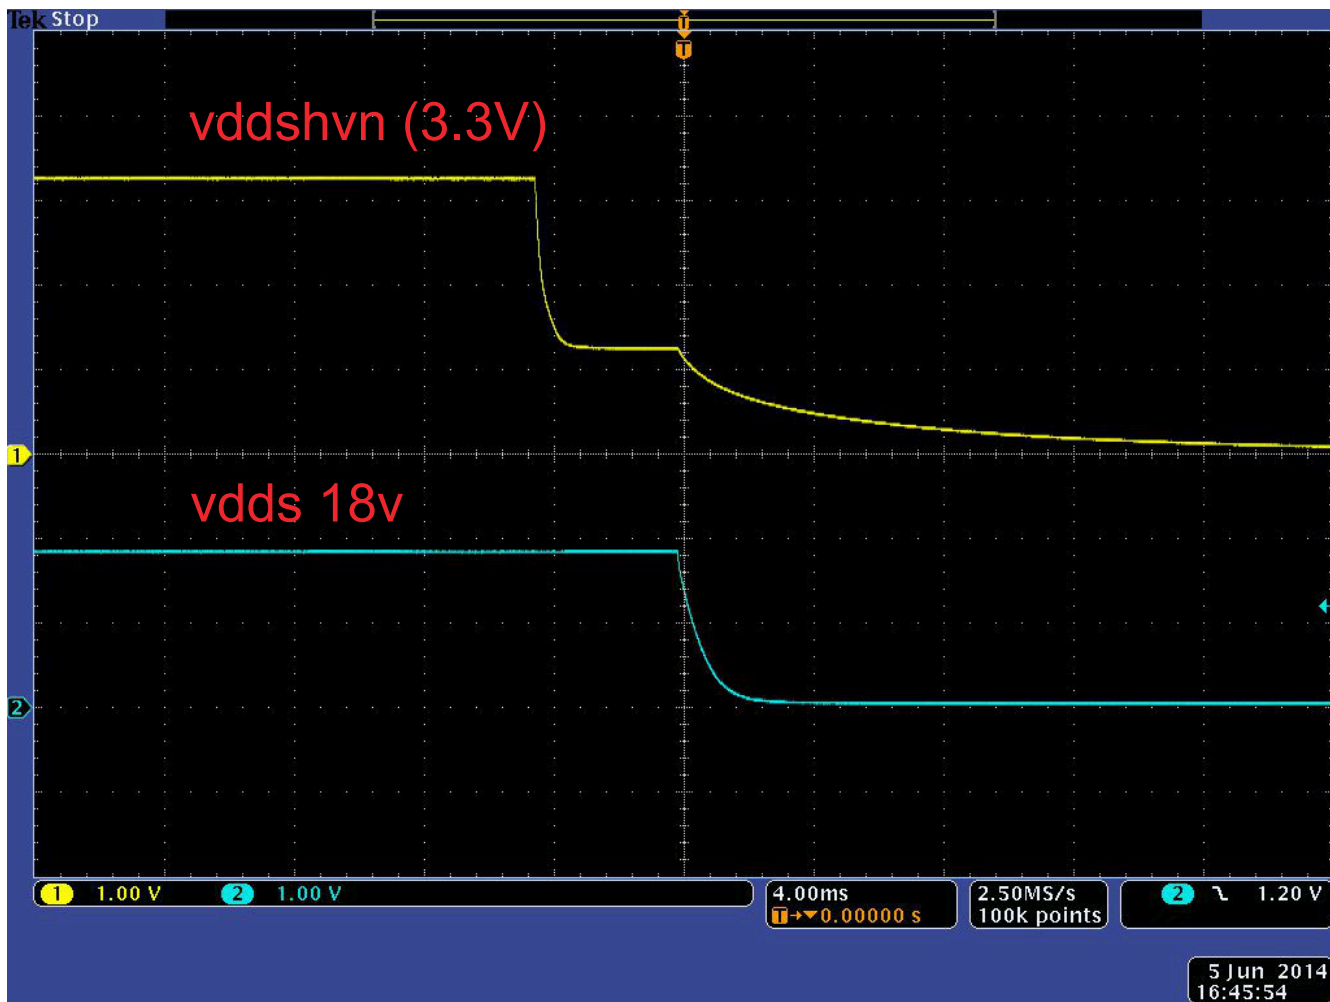
**Figure 4-1. PAB\_RevA**

The Data Manual allows the vddshvn rail (in either 3.3V or 1.8V mode) to power down at the same time or before the vdds18v rail. When the vddshvn rail is powered down before the vdds18v rail, the vddshvn rail stays at Plateau Level (<1.5V) until the vdds18v rail is disabled, as shown in the waveform below.

A subset of the SOC's LVCMOS IOs (refer to DM for details) have a pull-up resistor that is active by default, including during reset and power-down. The SOC's IOs that have internal or external pull-ups will stay at Plateau Level (<1.5V) during the power-down. If other ICs on the board that are interfaced to the SOC's LVCMOS signals use a separate supply then it's possible that the other IC's signals can be pulled to the Plateau Level while its power supply is off.

The root cause of the plateau is related to the LVCMOS IO buffer Dual Voltage detection circuitry. The LVCMOS Dual Voltage IO includes voltage comparator circuitry to determine if the IO is in 3.3V mode or 1.8V mode. During powerdown of vddshvn domains, a current path in the internal bias transistors results in the vddshvn rail being held to an

In general, TI recommends using the same supply source for connected components. E.g., a single LDO should drive vddshvn and the related 3.3V external components.
