TMS320C6674
Multicore Fixed and Floating-Point Digital
Signal Processor
Silicon Revision 1.0, 2.0

Silicon Errata

Literature Number: SPRZ341H
January 2011–Revised June 2015

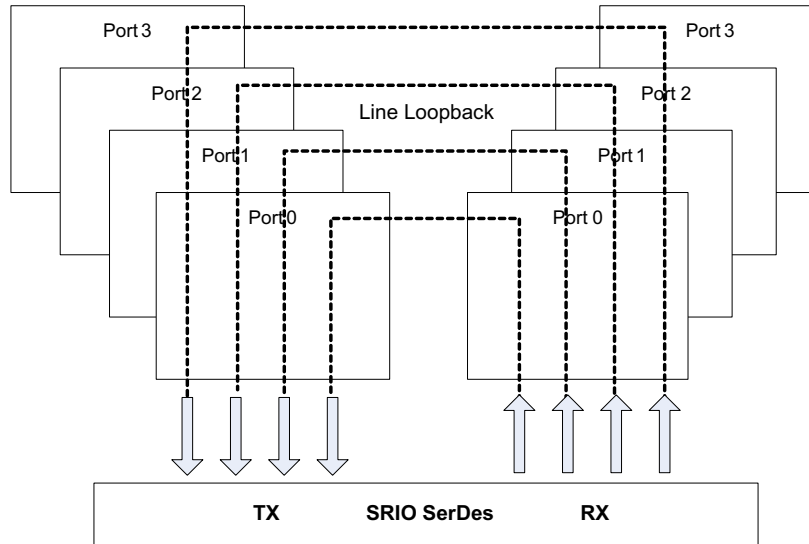
Figure 5. SRIO SerDes in Loopback Mode

Details: The SRIO physical layer is configured in line loopback mode on a per-port basis, by setting the LLB_EN bit in PLM_SP(n)_IMP_SPEC_CTL register. In line-loopback mode, the data from the SerDes receiver is looped back to the SerDes transmitter. [Figure 5](#) shows the line loopback from SerDes RX to SerDes TX:

The port does not provide any clock compensation when line loopback is enabled. The transmit clock must be externally synchronized with the receive clock. There is only a small FIFO that can compensate for PLL jitter or wander. Hence, correct operation of line loopback requires that the link partners use the same reference clock for the SRIO physical layer, in order to avoid overruns or underruns due to clock frequency mismatch between the link partners. As a result, line loopback mode is generally restricted to validation and qualification of board signal integrity in a lab environment.

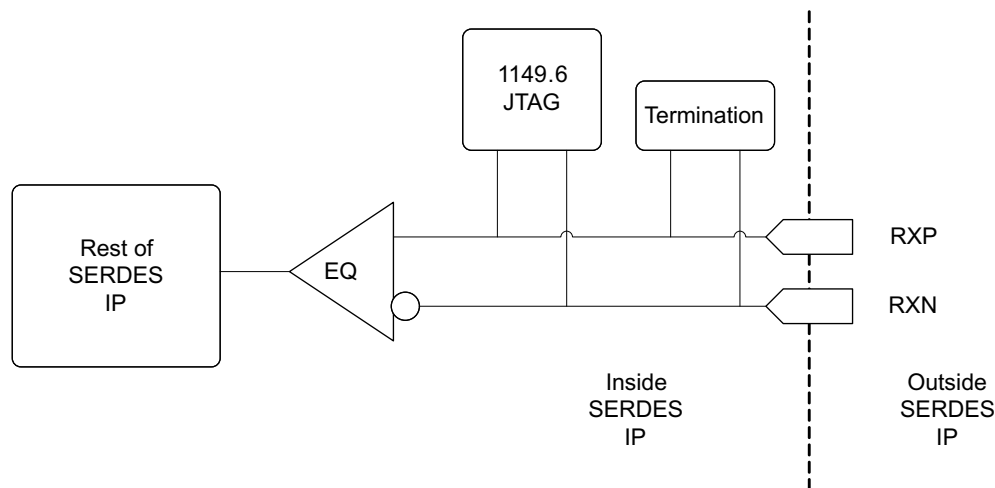
Figure 7. Simplified SerDes Receiver Block Diagram Depicting Relative Placement of Major Receiver Components

A problem has been identified in some cases where the AC-JTAG (IEEE 1149.6, edge-sensitive) input cells on Rincewind and Draco receivers do not reliably respond to input edge transitions from an associated transmitter. Because of this failure, the 1149.6 scan-chain users can receive faulty signal levels transitions or no transitions at all.

IEEE 1149.1, level-sensitive, input cells show no issue and normal operation of the SerDes receivers is also unaffected by this problem.

One potential workaround has been identified. The failure mode of the AC-JTAG comparator is most pronounced by single edge transitions at low frequency as this creates the highest likelihood of the comparator inputs being saturated and switching incorrectly. More frequent transitions can result in proper switching of the comparator output.

The basic procedure is to initiate multiple edge transitions and then read the state of the RX input cell in question. However, due to the nature of the failure, the exact number would have to be determined experimentally for a given device.

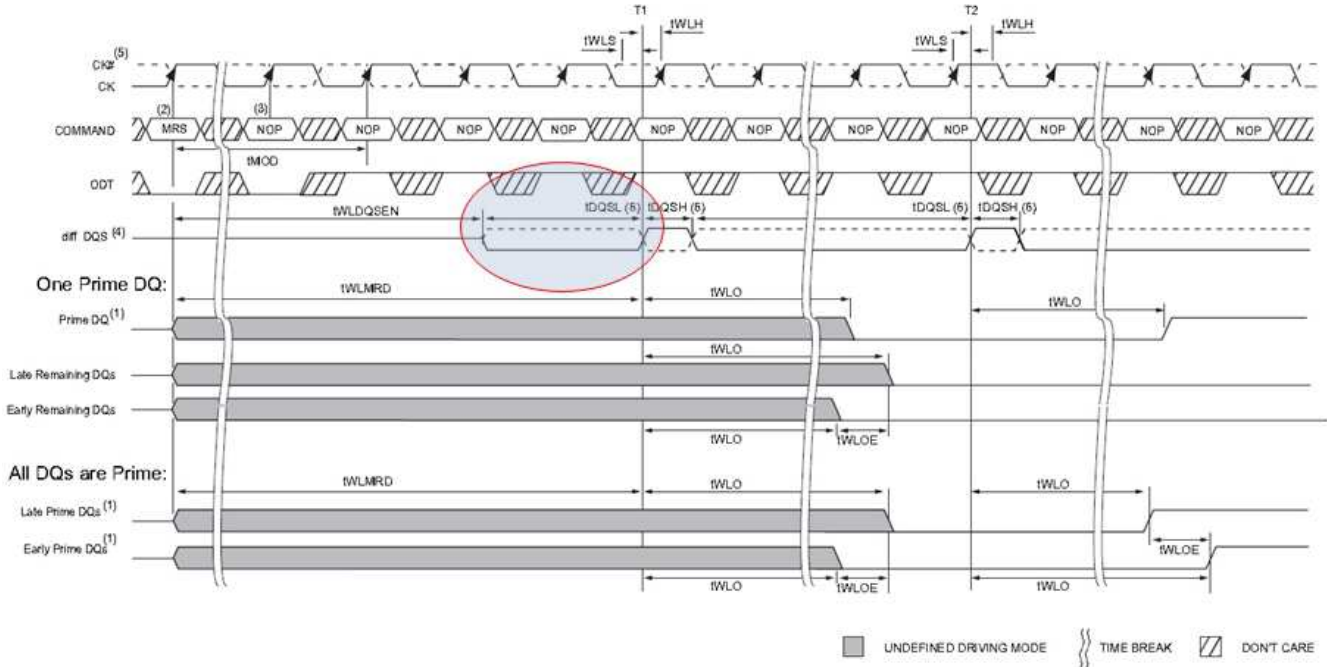
Figure 9. Timing Details of Writing Leveling Sequence

As shown in [Figure 9](#), the DDR3 JEDEC standard requires that the DQS strobe be sent with a preamble (DQS=0) for at least tDQSL during write leveling, prior to the first rising edge of the DQS strobe (DQS=1). It was observed in simulations that the first DQS strobe is sent immediately following the high impedance state of the DQS line and without a preamble. This Z->1 transition on the DQS line may allow incremental write leveling to fail. Note that this issue impacts only the incremental write leveling feature of the DDR3 Memory controller. No issue is expected with automatic write leveling.

At this time, incremental write leveling is not supported on this device and we recommend that the incremental write leveling intervals in RDWR_LVL_CTRL and RDWR_LVL_RMP_CTRL be programmed to 0 to disable this feature.

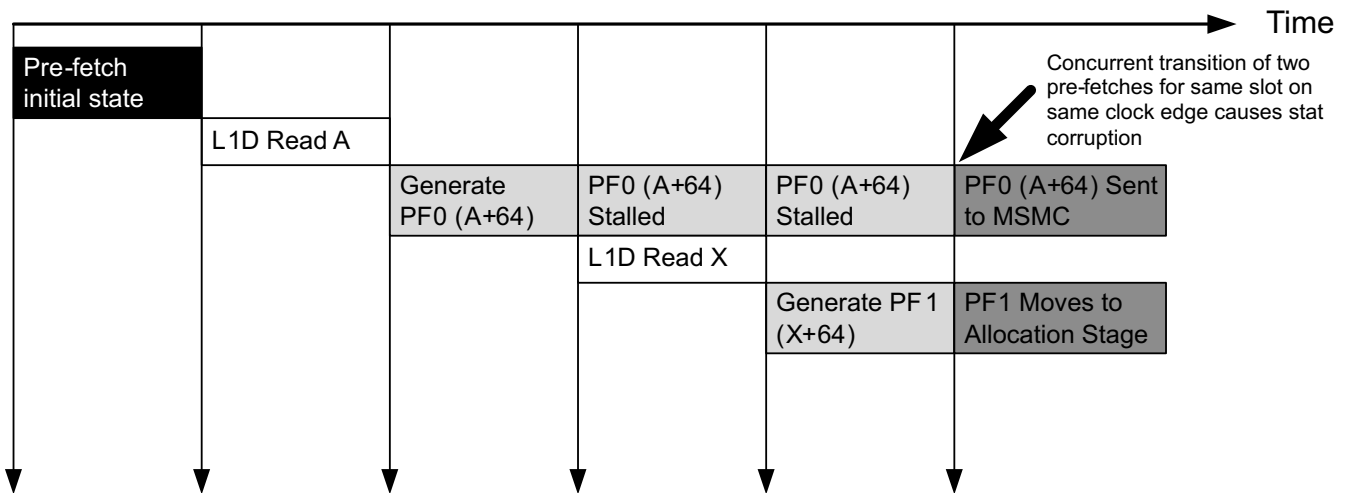
Figure 11. Sequence diagram

The fault lies in the 'sorting' hardware which can lead to the first pre-fetch not being marked stale under certain boundary conditions (see pathological sequence below). The subsequent fetch access when the pre-fetch access wasn't marked stale will access the stale data that has been cleared (but not yet marked as stale.) This results in the read exception and/or incorrect data being fetched. Thus, the issue occurs only when the re-fetch feature is triggered and only L1D accesses use the re-fetch feature.

7. PF0 transitions to the XMC output (to MSMC) on the exact same clock edge that PF1 is transitioning to the buffer allocation pipeline stage

8. Instead of PF0 being marked stale and thrown away when returned, both PF0 and PF1 are marked valid and outstanding.
9. This leads to two valid outstanding pre-fetches for the same data buffer slot which is an invalid state and can result in unexpected behavior for a subsequent pre-fetchable data access to address X+64.
