# TMS320F28002x Real-Time MCUs Silicon Errata

## Silicon Revisions A, 0

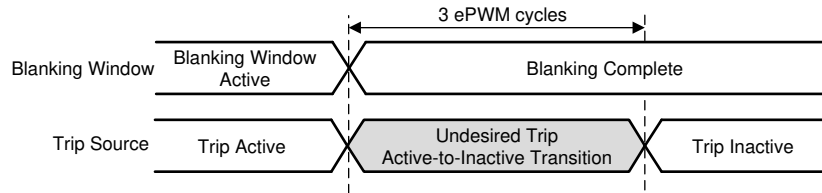
**Figure 3-1. Undesired Trip Event and Blanking Window Expiration**

**Details** The blanking window is typically used to mask any PWM trip events during transitions which would be false trips to the system. If an ePWM trip event remains active for less than three ePWM clocks after the end of the blanking window cycles, there can be an undesired glitch at the ePWM output.

Figure 3-1 illustrates the time period which could result in an undesired ePWM output.

**Workaround** Extend or reduce the blanking window to avoid any undesired trip action.
