# TMS320F28004x Real-Time MCUs Silicon Errata

## Silicon Revisions B, A, 0

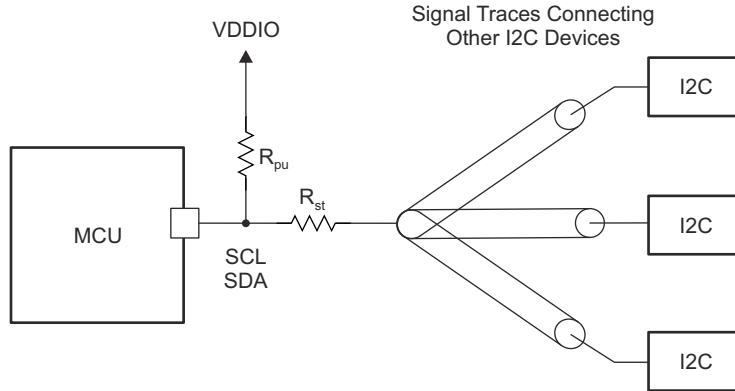
**Figure 3-4. Placement of Series Termination Resistor and Pullup Resistor**

The SDA and SCL outputs are implemented with push-pull 3-state output buffers rather than open-drain output buffers as required by I2C. While it is possible for the push-pull 3-state output buffers to behave as open-drain outputs, an internal timing skew issue causes the outputs to drive a logic-high for a duration of 0–5 ns before the outputs are disabled. The unexpected high-level pulse will only occur when the SCL or SDA outputs transition from a driven low state to a high-impedance state and there is sufficient internal timing skew on the respective I2C output.

This short high-level pulse injects energy in the I2C signals traces, which causes the I2C signals to sustain a period of ringing as a result of multiple transmission line reflections. This ringing should not cause an issue on the SDA signal because it only occurs at times when SDA is expected to be changing logic levels and the ringing will have time to damp before data is latched by the receiving device. The ringing may have enough amplitude to cross the SCL input buffer switching threshold several times during the first few nanoseconds of this ringing period, which may cause clock glitches. This ringing should not cause a problem if the amplitude is damped within the first 50 ns because I2C devices are required to filter their SCL inputs to remove clock glitches. Therefore, it is important to design the PCB signal traces to limit the duration of the ringing to less than 50 ns. One possible solution is to insert series termination resistors near the SCL and SDA terminals to attenuate transmission line reflections.

This issue may also cause the SDA output to be in contention with the slave SDA output for the duration of the unexpected high-level pulse when the slave begins its ACK cycle. This occurs because the slave may already be driving SDA low before the unexpected high-level pulse occurs. The glitch that occurs on SDA as a result of this short period of contention does not cause any I2C protocol issue but the peak current applies unwanted stress to both I2C devices and potentially increases power supply noise. Therefore, a series termination resistor located near the respective SDA terminal is required to limit the current during the short period of contention.

Insert series termination resistors on the SCL and SDA signals and locate them near the SCL and SDA terminals. The SCL and SDA pullup resistors should also be located near the SCL and SDA terminals. The placement of the series termination resistor and pullup resistor should be connected as shown in [Figure 3-4](#).
