## **TMS320F2837xS MCUs Silicon Revisions C, B**

This document describes the silicon updates to the functional specifications for the TMS320F2837xS microcontrollers (MCUs).

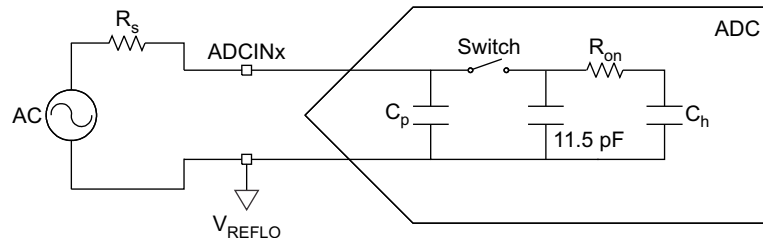
**Figure 3. Single-Ended Input Model**

The ADC input model should be used to select the sample-and-hold (S+H) duration for each ADC input. For the revisions affected, if the currently converting channel is an even-numbered channel and the previously converted channel was an odd-numbered channel (or vice versa), then the 12-bit input model will not accurately predict ADC input performance. Under these conditions, an additional capacitance should be added to the model. This capacitance has a value of 11.5 pF and should be placed between the S+H switch and  $R_{on}$  as shown in [Figure 3](#).
