UCD3138 Integrated Power Controller Family Errata

This document describes the known exceptions to functional specifications (advisories) for the UCD3138 integrated digital power controller family of devices.

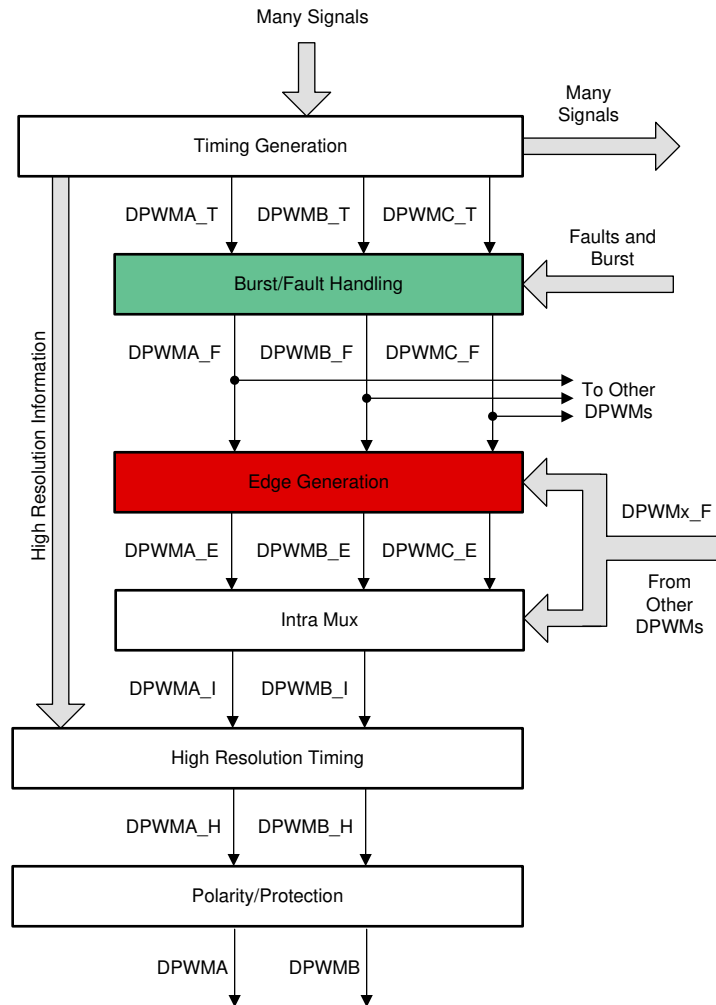
Figure 1. PWM Block Diagram

So after a fault, the power supply is safely shut off. Fault logic is before Edge Generation logic, as [Figure 1](#) shows.

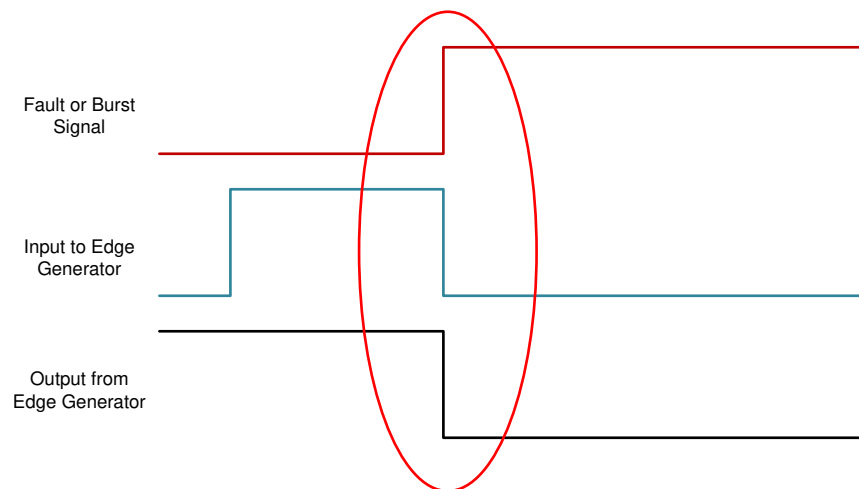
Figure 2. Fault or Burst Turns DPWM OFF

Some PSFB signals go low on a falling edge input. Fault will make all Edge Generation inputs go low. If the relevant input is high, the output will go low, so fault is handled as expected – [Figure 2](#).

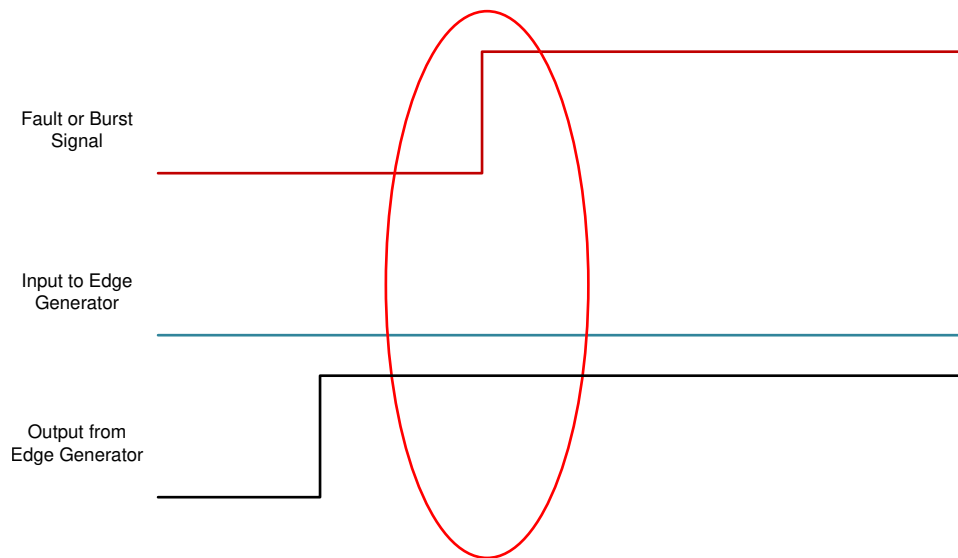
Figure 3. Fault or Burst Does not Turn DPWM OFF

With Fault or Burst mode, sometimes 1 out of 4 DPWM pins may not shut off. The bridge leg with a fixed pulse will always shut off, but one of the moving leg switches may not turn off.

If the relevant input is low, there is no falling edge to make the output go low, so it will stay high. – [Figure 3](#)

Use Firmware Interrupt to shut other DPWM pin off.

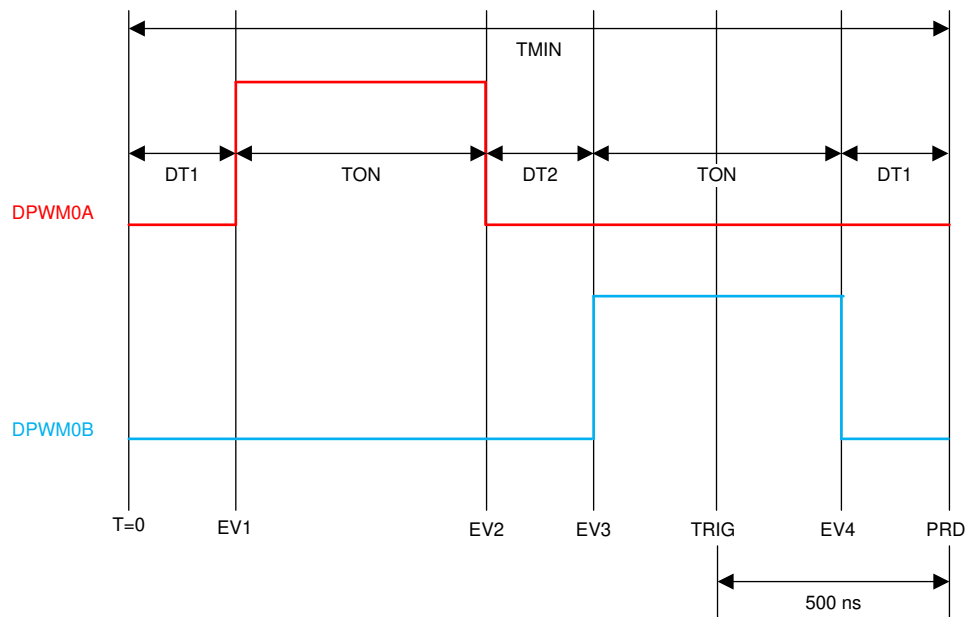
Figure 5. DPWM Representation

DPWM pulse extension in the LLC converter can occur under the following conditions, (1) the sample trigger is within 500 ns of the end of the frame, and (2) there is a large change in Y_N such that the converter transitions from multi-mode to resonant mode operation.

Place the sample trigger (TRIG) near the beginning of the period or no later than 500 ns from the end of the shortest period that must be supported.
