ADSP-218x EZ-ICE Tips and Tricks

Last Modified: 4/30/98

Introduction:

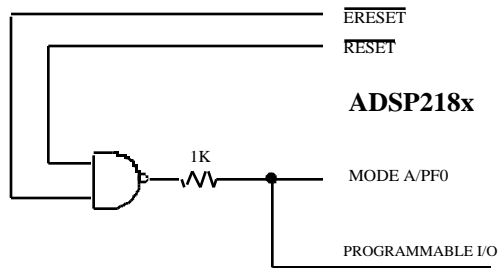
Figure 1: Active Mode Pin Configuration Example

Some customers may experience problems using the emulator with 100-pin 218x variants. First, make sure that the mode pins of the DSP are pulled high/low with a 1K or 2K resistor. Weaker resistor values may cause the processor to come up in an unknown state during emulation, due to reverse leakage current issues.

Issuing the chip reset command during emulation causes the DSP to perform a full chip reset, including a reset of its memory mode. Therefore, it is vital that the mode pins are set correctly **prior** to issuing a chip reset command from the emulator user interface.

If you are using a passive method of maintaining mode information (by tying the mode pins to a specific logic level) then it does not matter that the mode information is latched by an emulator reset. However, if you are using the /RESET pin as a method of setting the value of the mode pins, then you have to take into consideration the effects of an emulator reset.

One method of ensuring that the values located on the mode pins are those desired is to construct a circuit like the one shown in figure 1. The circuit in this figure forces the value located on the Mode A pin to logic low; regardless if it latched via the /RESET or the /ERESET pin. (Please refer to the appropriate DSP processor data sheet for the mode pin assignments for the specific processor in your design.)
