The Metrological and Financial Implications of a Clogged Fan-Filter!

BENCH BRIEFS
1st Quarter 1995

Service information from
Hewlett-Packard Company

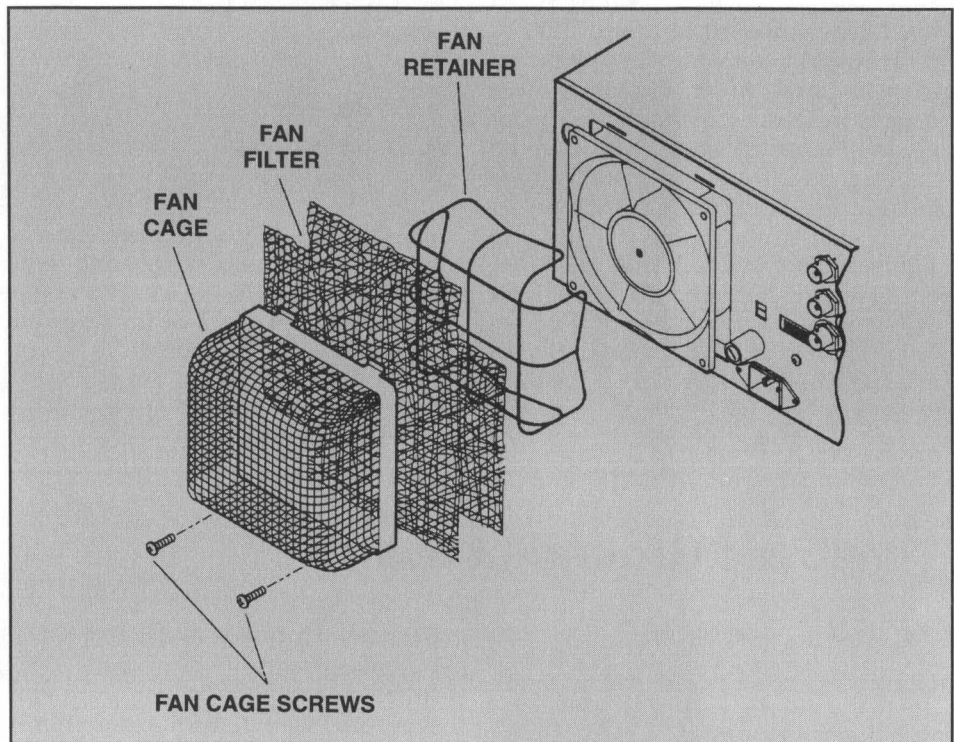
Over a period of months, the air filter for an instrument in your ATE system gradually becomes clogged. The internal operating temperature gradually rises and some metrological parameters gradually drift. At some point, due to circuit temperature coefficients, the instrument goes out of specification. Unaware of this problem, you continue to use the instrument!

burning. Almost simultaneously, the instrument goes into hard failure. Now for the first time, you become suspicious, to say the least. You search, inspect and ponder and it doesn't take long for you to spot the clogged air filter.

all you need to do is follow a simple preventive maintenance program to inspect and clean the air filters at regular intervals.

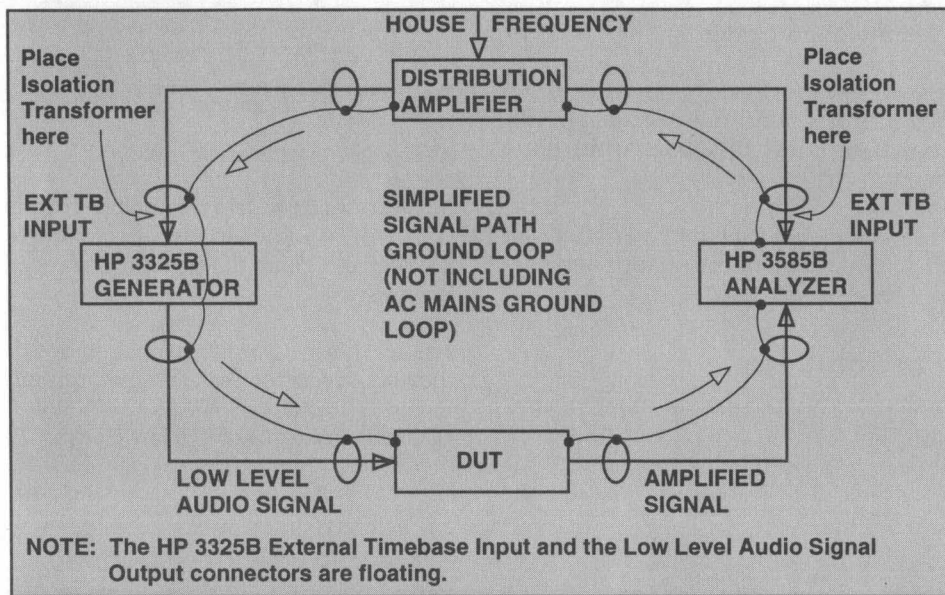
dio gain of a device-under-test (DUT). I locked the 3325B and 3585B timebases to the "house frequency standard" via a distribution amplifier. I then connected a very low-level audio signal from the 3325B to the DUT's input port. The DUT amplifies the small signal (80 dB gain), which I attempted to measure by connecting the DUT's output port to the 3585B 1M ohm input port. However, I discovered the DUT was self-oscillating (which it isn't supposed to do). When I disconnected the 3325B external timebase connection, I broke the ground-loop and the problem "went away."

Figure 1. Block diagram showing simplified ground-loop problem

Break the timebase ground-loop by inserting isolation transformers between the frequency distribution amplifier and the external timebase input of each instrument. (Place each isolation transformer as near the external timebase input as possible.)
