## Failure Modes of Digital ICs

# Safety-Related Service Notes

#### BENCH BRIEFS 1st Quarter 1996

Volume 36 No. 1

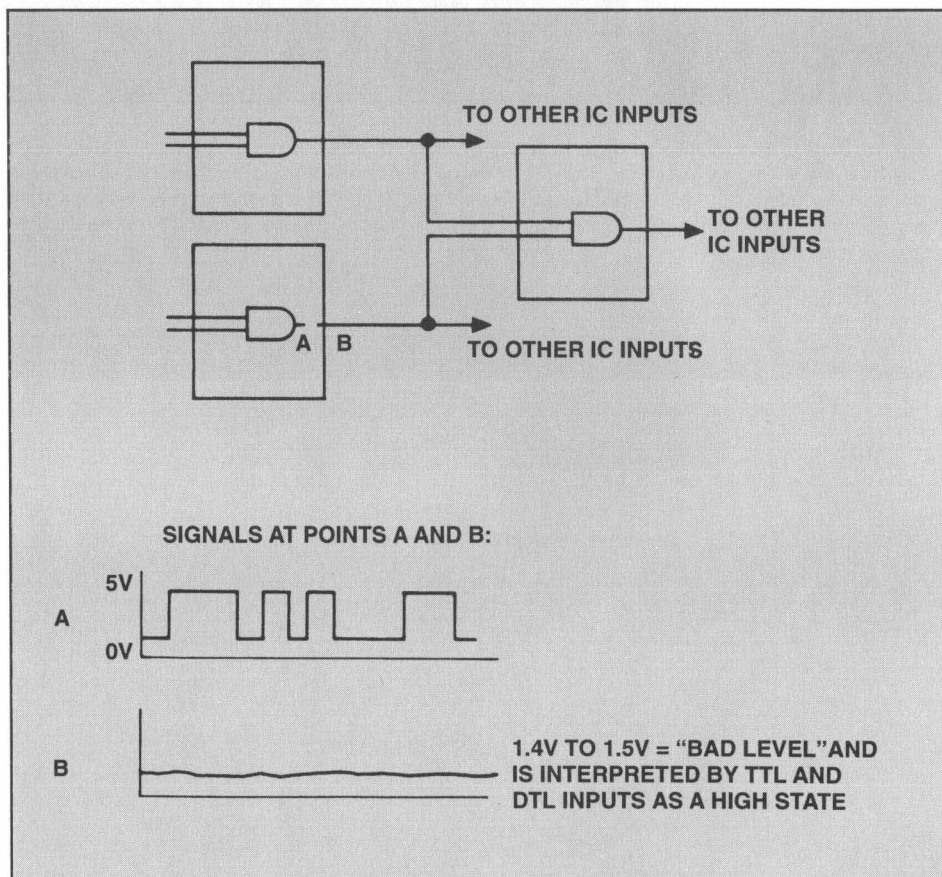
In the case of an open output bond (Figure 1), the inputs driven by that output are left to float. In TTL and DTL circuits a floating input rises to approximately 1.4 to 1.5 volts and usually has the effect on circuit operation as a high logic level. Thus an open output bond will

cause all inputs driven by that output to float to a bad level since 1.5 volts is less than the high threshold level of 2.0 volts and greater than the low threshold level of .4 volt. In TTL and DTL, a floating input is interpreted as a high level. Thus the effect will be that these inputs will respond to this bad level as though it were a static high signal.

Figure 1. The Effect of an Open Output Bond Upon Circuit Operation. An open output bond allows all inputs driven by that output to float to a "bad level." This level is usually interpreted as a logic high state by the inputs. Thus the inputs driven by an open output bond will respond as though a static logic high signal was applied.

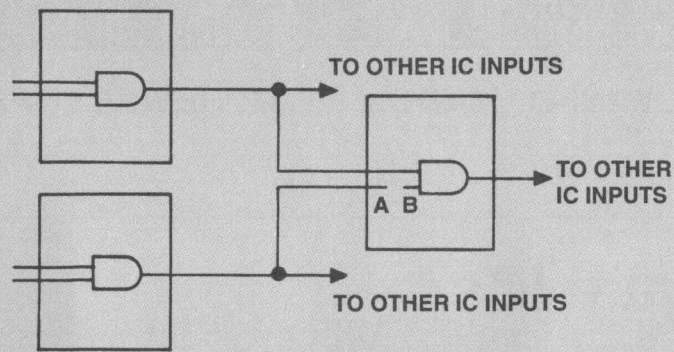
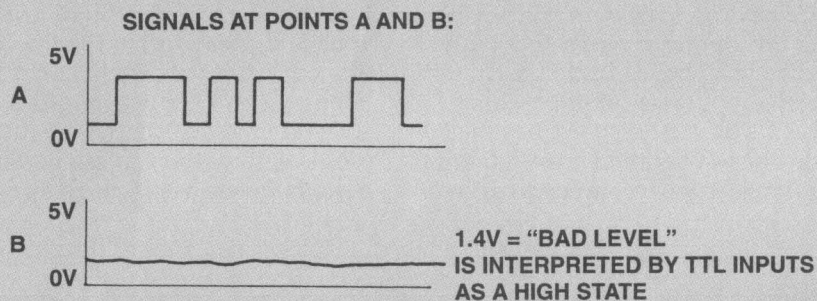
Figure 2. The Effect of an Open Input Bond Upon Circuit Operation. An open bond on an input has the effect of blocking the input signal from reaching the chip and allows the input of the chip to float to a "bad level." Thus even though the signal can be viewed at an external point such as Point A, the input of the chip responds to the "bad level" as though it were a static high level.

In the case of an open input bond (Figure 2), we find that the open circuit blocks the signal from entering the IC chip. The input on the chip is thus allowed to float and will respond as though it were a static high signal. It is important to realize that since the open occurs inside the IC, the digital signal driving this input will be unaffected by the open and will appear normal when looking at input pin A (Figure 2). The effect will be to block this signal inside the IC and the resulting IC operation will be as though the input were a static high.

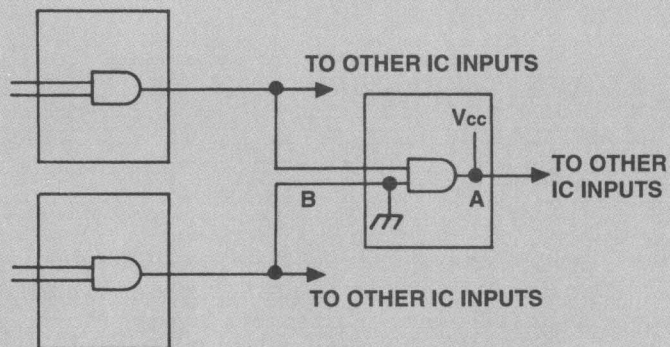
Figure 3. The Effect of a Short Between an Input or Output and Vcc or Gnd. All signal lines connected to Point A are held in the high state. All signal lines connected to Point B are held in the low state.

A short between an input or output and Vcc or ground has the effect of holding all signal lines connected to that input or output either high (in the case of a short to Vcc) or low (if shorted to ground) (Figure 3). In many cases, this will cause expected signal activity at points beyond the short to disappear and thus this type of failure is catastrophic in terms of circuit operation.

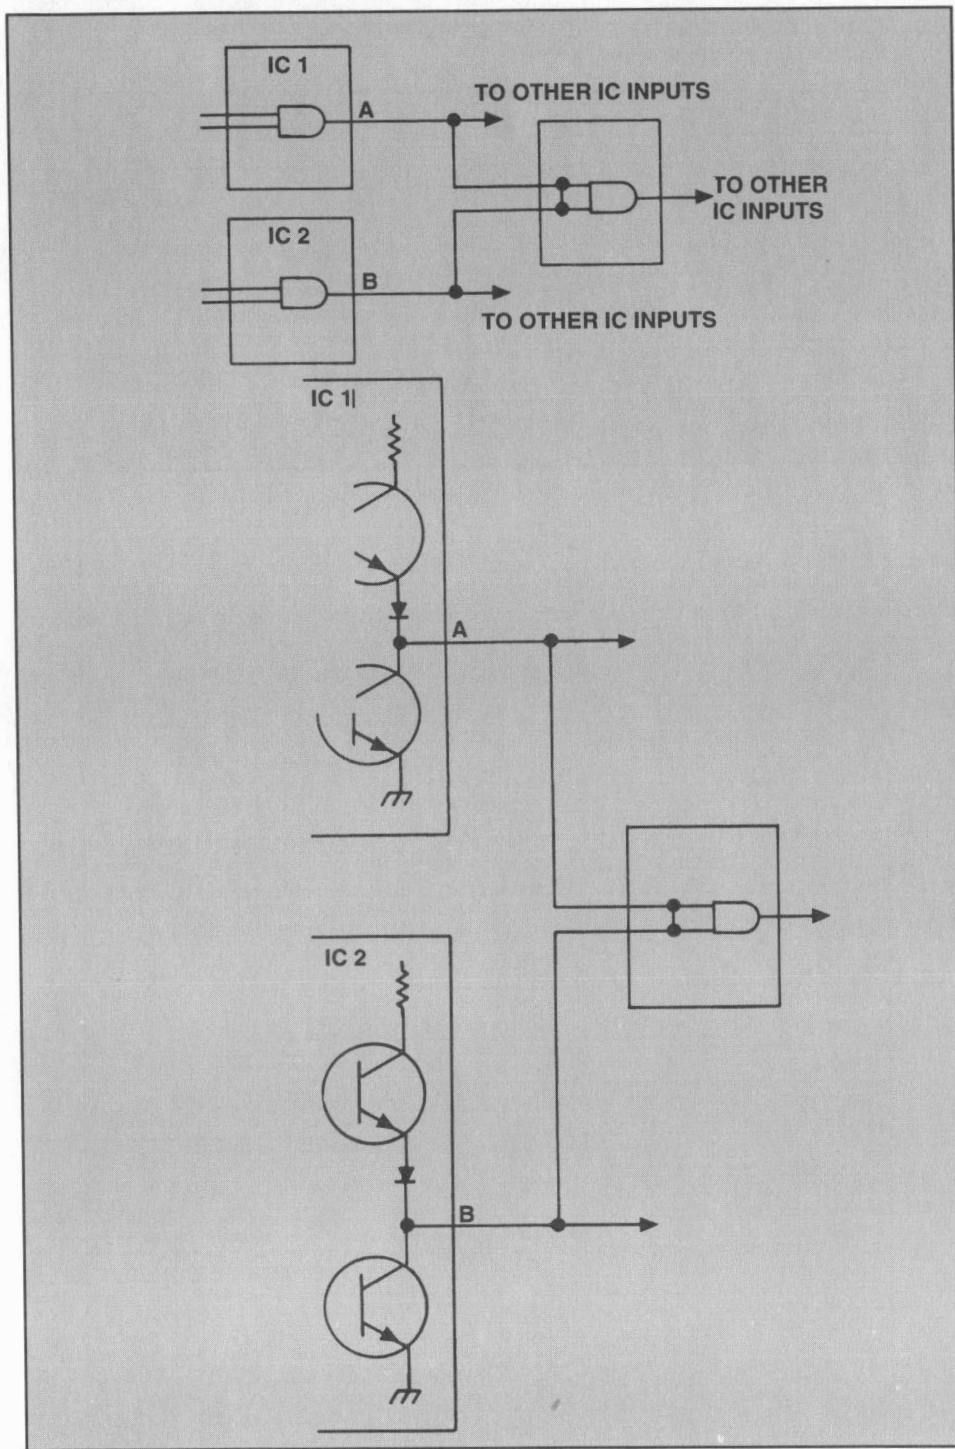
A short between two pins is not as straightforward to analyze as the short to Vcc or ground. When two pins are shorted the outputs driving those pins oppose each other when one attempts to pull the pins high while the other attempts to pull them low (Figure 4). In this situation the output attempting to go high will supply current through the upper saturated transistor of its totem pole output stage while the output attempting to go low will sink this current through the saturated lower transistor of its totem pole output stage. The net effect is that the short will be pulled to a low state by the saturated transistor to ground. Whenever both outputs attempt to go high simultaneously or to go low simultaneously, the shorted pins will respond properly. But whenever one output attempts to go low the short will be constrained to be low.

**Figure 4. Short Between Two Pins.** The error effect of a short between two pins occurs when the outputs driving those pins attempt to pull the short to opposite states. In this case, the output attempting to pull the node high will be supplying current while the output attempting to pull the node low is a saturated transistor to ground and will be sinking the current. The saturated transistor to ground will thus pull the node to a low state.

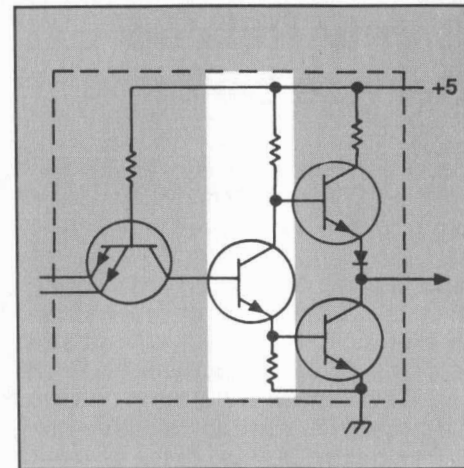
The fourth failure internal to an IC is a failure of the internal steering circuitry of the IC (Figure 5). This has the effect

of permanently turning on either the upper transistor of the output totem pole thus locking the output in the high state or turning on the lower transistor of the totem pole thus locking the output in the low state. Thus this failure

blocks the signal flow and has a catastrophic effect upon circuit operation.

**Figure 5. The Effect of a Failure of the Internal Circuitry of the IC Upon Circuit Operation.** A failure of the steering circuitry of an IC will either cause the output to be in a static high state or a static low state.

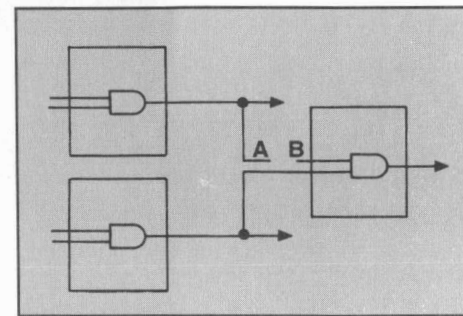
**Figure 6. The Effect of an Open in the Circuit External to an IC.** All inputs attached to the node at Point A will be driven properly. All inputs to the right of the open (Point B) will be left to float to a "bad level" and will therefore look like a static high state.

guishable from a short internal to the IC. Both will cause the signal lines connected to the node to either always high (for shorts to Vcc) or always low (for shorts to ground). When this type of failure is encountered only a very close physical examination of the circuit will reveal if the failure is external to the IC. An open signal path in the circuit has a similar effect as an open output bond driving the node (Figure 6). All inputs to the right of the open will be allowed to float to a bad level and will thus appear as a static high level in circuit operation. Those inputs to the left of the open will be unaffected by the open and will thus respond as expected. □
