MSP430F5529 Device Erratasheet

1 Revision History

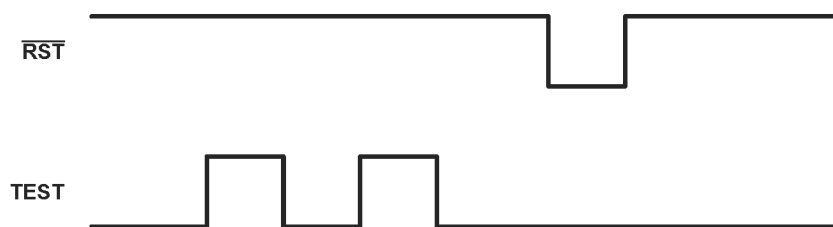
or

- Toggle the TEST pin twice when nRST is high and then pull nRST low.

Note: This sequence is not subject to timing constraints and the appropriate level transitions are sufficient to trigger an exit from BSL mode.

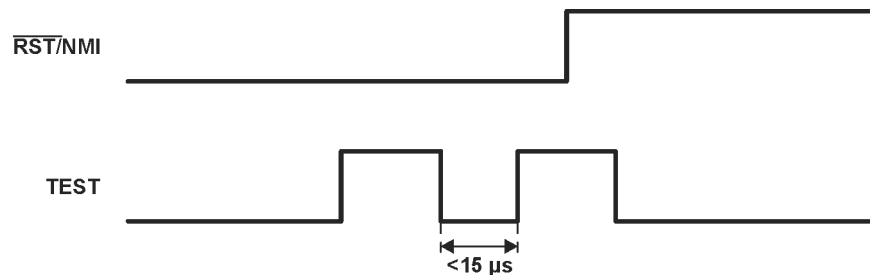
The BSL entry sequence requires that the low phase of the TEST/SBWTCK pin does not exceed 15us. This timing requirement is faster than most PC serial ports can provide, as shown in the following picture. If this requirement is not met, the entry sequence fails and the SYSBSLIND is not set.

Note: The erroneous behavior is only applicable if the default TI USB BSL is replaced by the TI UART BSL.

An external hardware solution is recommended to provide the appropriate BSL entry sequence. See [http://processors.wiki.ti.com/index.php/BSL_\(MSP430\)](http://processors.wiki.ti.com/index.php/BSL_(MSP430)) for recommendations on available BSL hardware.
