#### PS5010 MAINTENANCE INFORMATION

## PS5010 A14 FLOATING SUPPLY BOARD RELIABILITY IMPROVED

#### PS5010 CAPACITORS SHORT

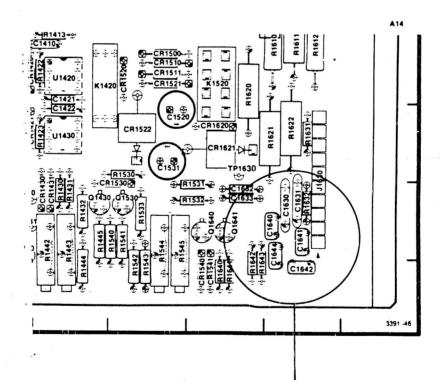
These capacitors were added in parallel with the Power Module 25V AC windings prior to the fuse for best filtering and least amount of ripple on the output. If one of these capacitors shorts, the Power Module will supply 500ma of current until the capacitor or the internal board run

burns open. The failure rate for these capacitors has been much higher than expected (five instruments to date have experienced burned Al4 boards).

Remove C1640, C1641, C1642, C1644 PARTIAL A14 FLOATING SUPPLY BENEFIT OF THE BOOK OF THE PROPERTY OF

The solution for this problem will be to remove the four capacitors and exception the CE O2 test of MIL 4olA. The specification will now state that CE O2 is exceeded by 15dB below 80KHz. This should not affect instrument performance.

These capacitors should be removed in all PS5010's below B030000 that come into the Service Center for repair or calibration. See the diagram below for details.
