Errata

AM62x Processor Silicon Revision 1.0

ABSTRACT

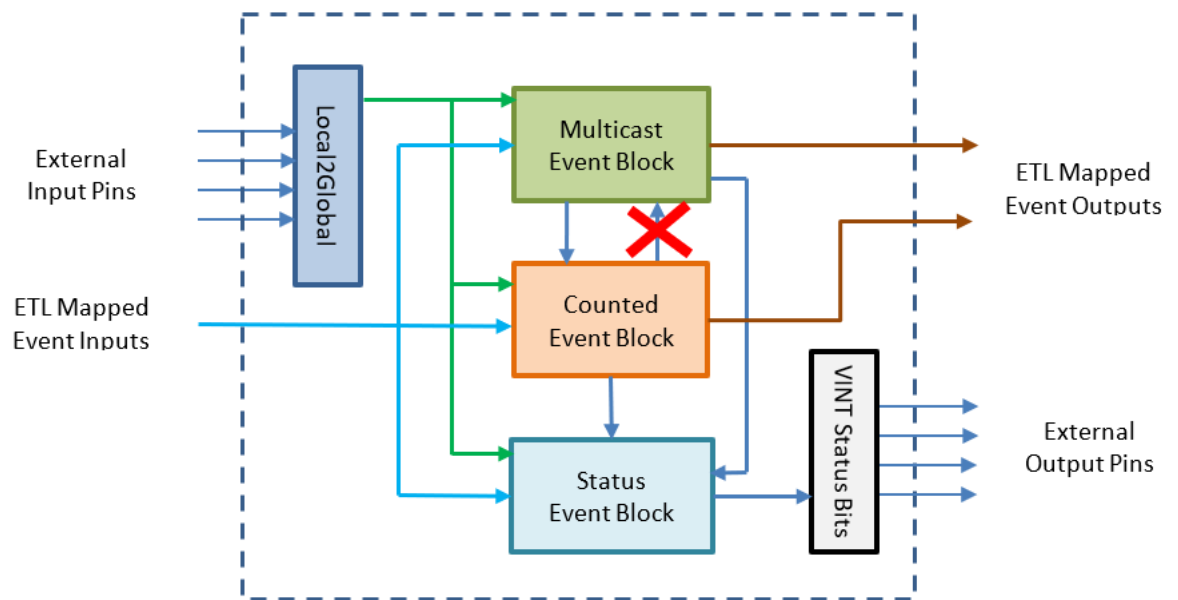
Figure 2-3. Interrupt Aggregator Version 1.0

An issue was found after design that could cause the IA to deadlock. The issue occurs when event “loops” occur between these three processing blocks. It is possible to create a situation where a processing block can not output an event because the path is blocked, and since it can not output an event, it can not take any new input events. This inability to take input events prevents the output path from being able to unwind, and thus both paths remain blocked.

Figure 2-3 shows the conceptual block diagram of IA 1.0. Potential loops are avoided by adopting the policy of not allowing the counted event block to send events to the multicast block. This method was chosen because it is more common to split an event first, and then count one while sending the other elsewhere. With this path blocked by convention, it is not possible for a single event to visit any block more than once and thus not possible for paths to become blocked so long as the outputs remain unblocked.

By following the conventions outlined here, the system is safe from looping hazards that can create a deadlock scenario.
