# J7200 DRA821 Processor Silicon Revision 1.0, 2.0

## ABSTRACT

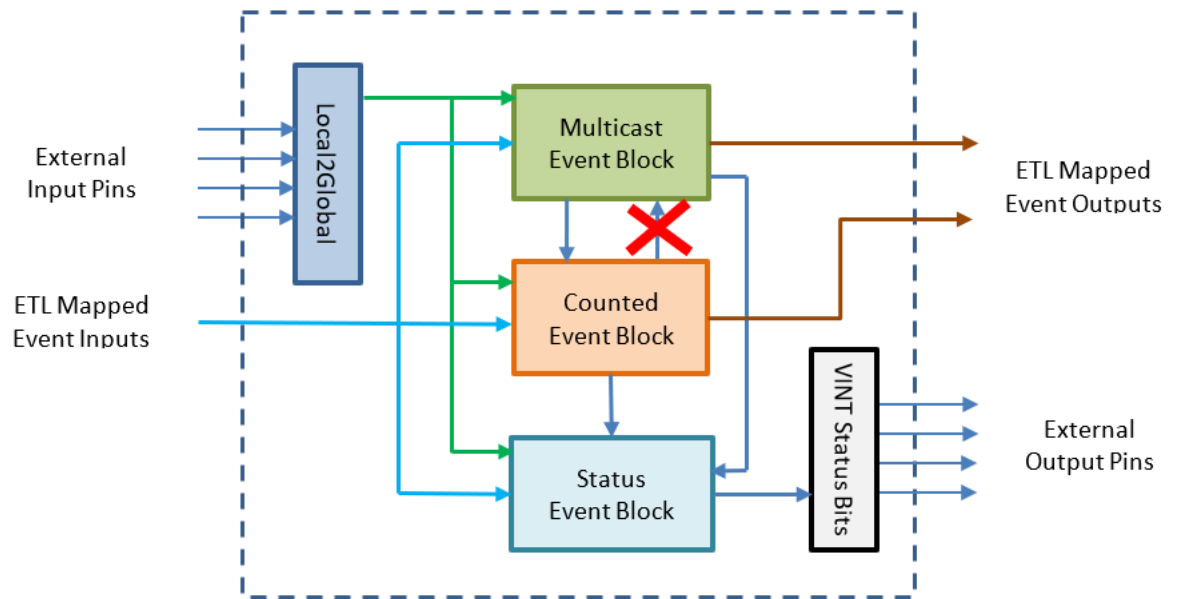
**Figure 3-1. Interrupt Aggregator Version 1.0**

An issue was found after design that could cause the IA to deadlock. The issue occurs when event “loops” occur between these three processing blocks. It is possible to create a situation where a processing block can not output an event because the path is blocked, and since it can not output an event, it can not take any new input events. This inability to take input events prevents the output path from being able to unwind, and thus both paths remain blocked.

it is not possible for a single event to visit any block more than once and thus not possible for paths to become blocked so long as the outputs remain unblocked.

By following the conventions outlined here, the system is safe from looping hazards that can create a deadlock scenario.
