Intro

This time we will take a look on Model 4912, which is a member of the 4910 family series of voltage references from Datron/Wavetek. They are of a similar size and weight to the Fluke 732A and were in direct competition.

There is no manual currently available for the 4912 so the 4910/4911 manual was used for troubleshooting. This specific Datron 4912 was acquired from a member of the volt-nuts group as being defective, but in good physical shape. The condition in which it was received showed that there was an issue with the batteries/charger and the output was low at approximately 0.5 VDC.

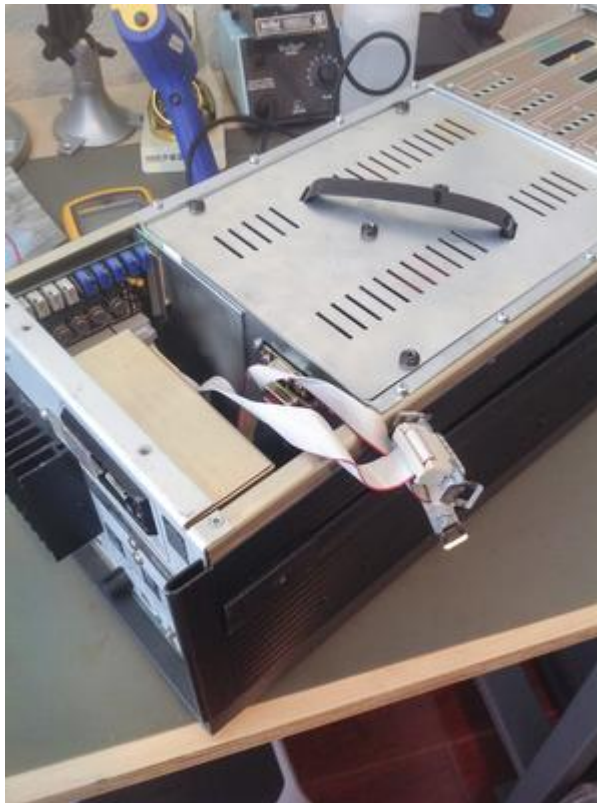
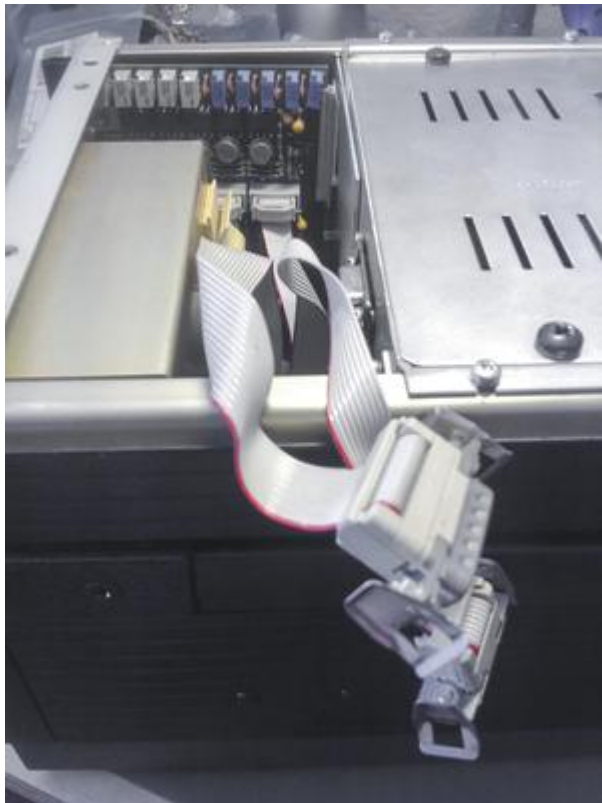
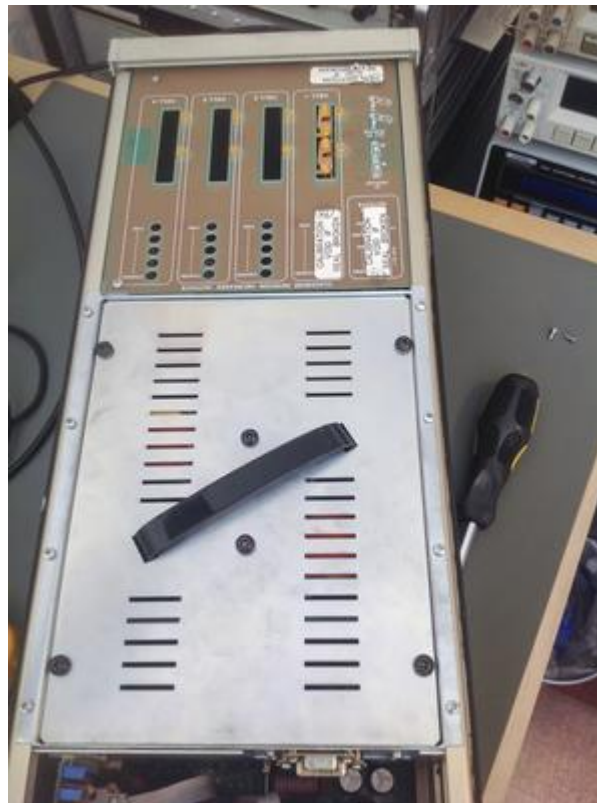
Teardown

The unit was opened and inspected for obvious issues. Apart from a cable from the battery assembly being disconnected, there was nothing that appeared wrong visually. Time for disassemble and tests.

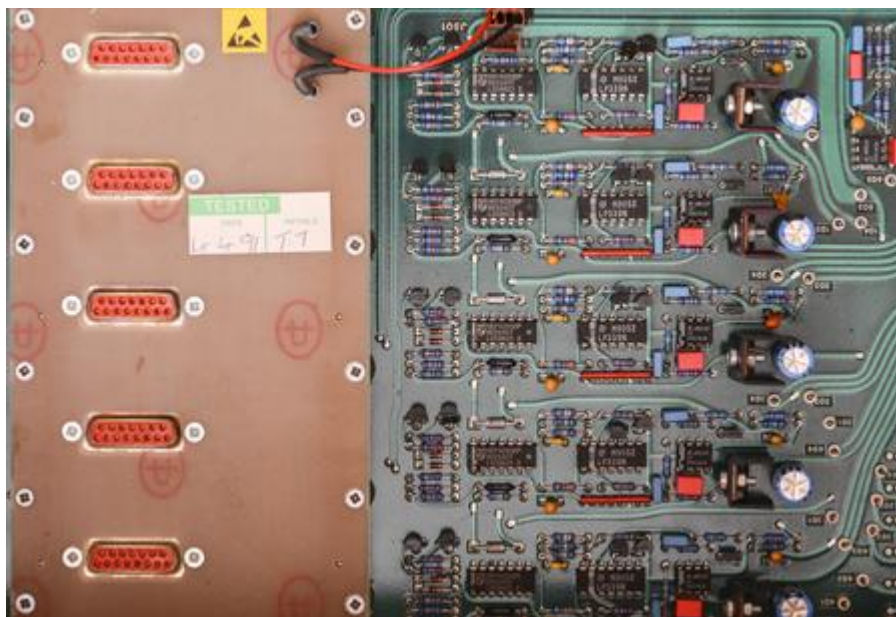
The main board includes separate circuits for each of the five supplies from the power supply assembly. This too made it easy to test. There is also a circuit to handle an external DC supply with its own regulator. A transit mode switch is also located on the board. The switch is used to select a low power mode for shipping of the reference. The switch protrudes from the rear cover. There are also connectors for up to four cell PCBs. It appears that Datron used the same backplane design for all three models. In the 4912 there are three slots that are not populated.

Comparing the voltages on each of the five circuits, it was found that the 12V was missing from two of three unused supplies. They have probably been defective for a long time but they had no effect on the operation of the single cell. The two supplies still needed to be repaired. The inputs were tested and found to be low. Measuring the resistance across the input path found that the two inputs were shorted to their respective grounds. There is a $1\mu\text{F}/35\text{V}$ tantalum on the inputs. They were removed and confirmed to be shorted. A temporary replacement was installed and the supplies were retested as having good outputs.

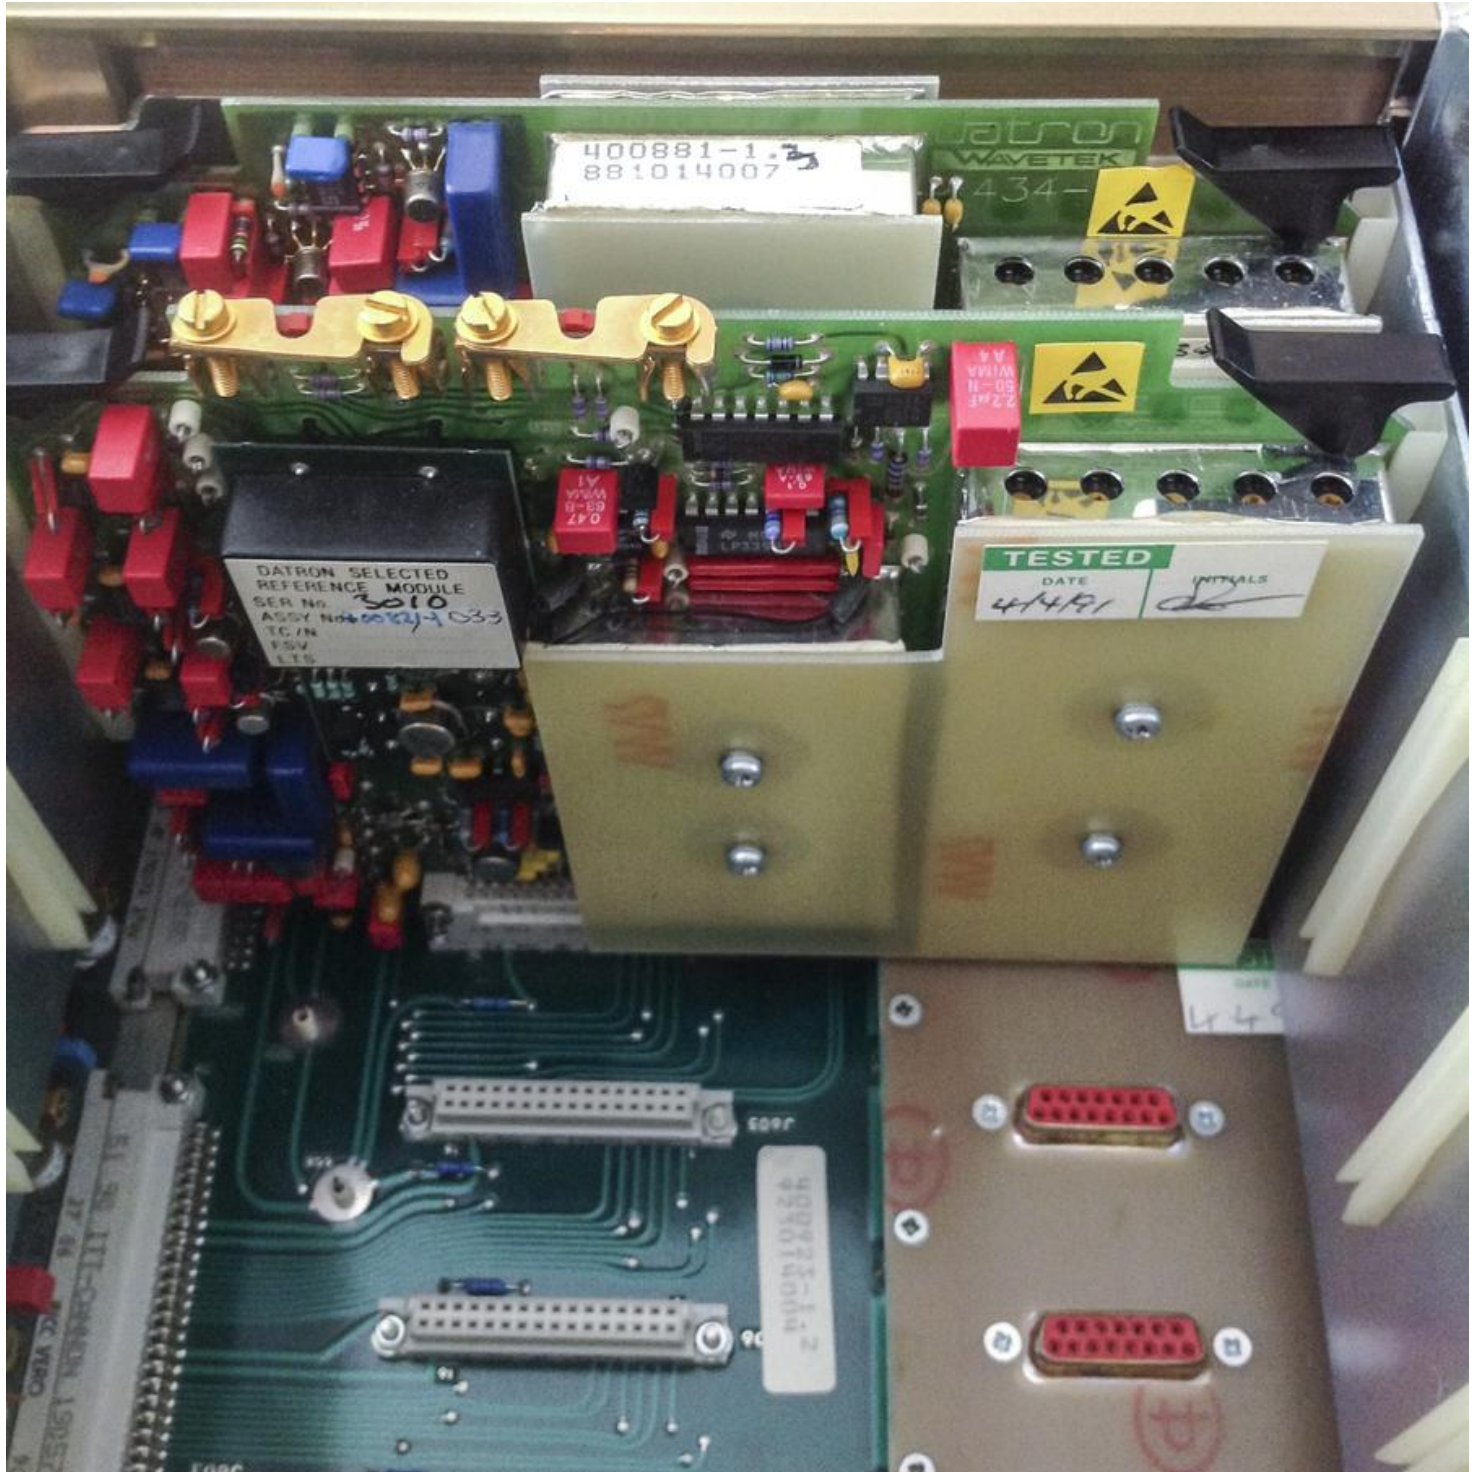
The cell pcb contains the LTZ1000 daughterboard assembly and also the PWM divider circuits. The divider is broken into a most significant switch and a least significant switch of 16-bits and 8-bits.

The output of the LTZ board measured at $\sim 7.23\text{V}$ between TP105 and TP108. This meant the problem was most likely in the output divider or op-amps. The HI and LO side of the output splits into both the direct output and averaged output. The continuity between the LTZ board LO out and the front panel LO was confirmed as good. The two jumpers connecting the averaged outputs were disconnected for testing purposes.

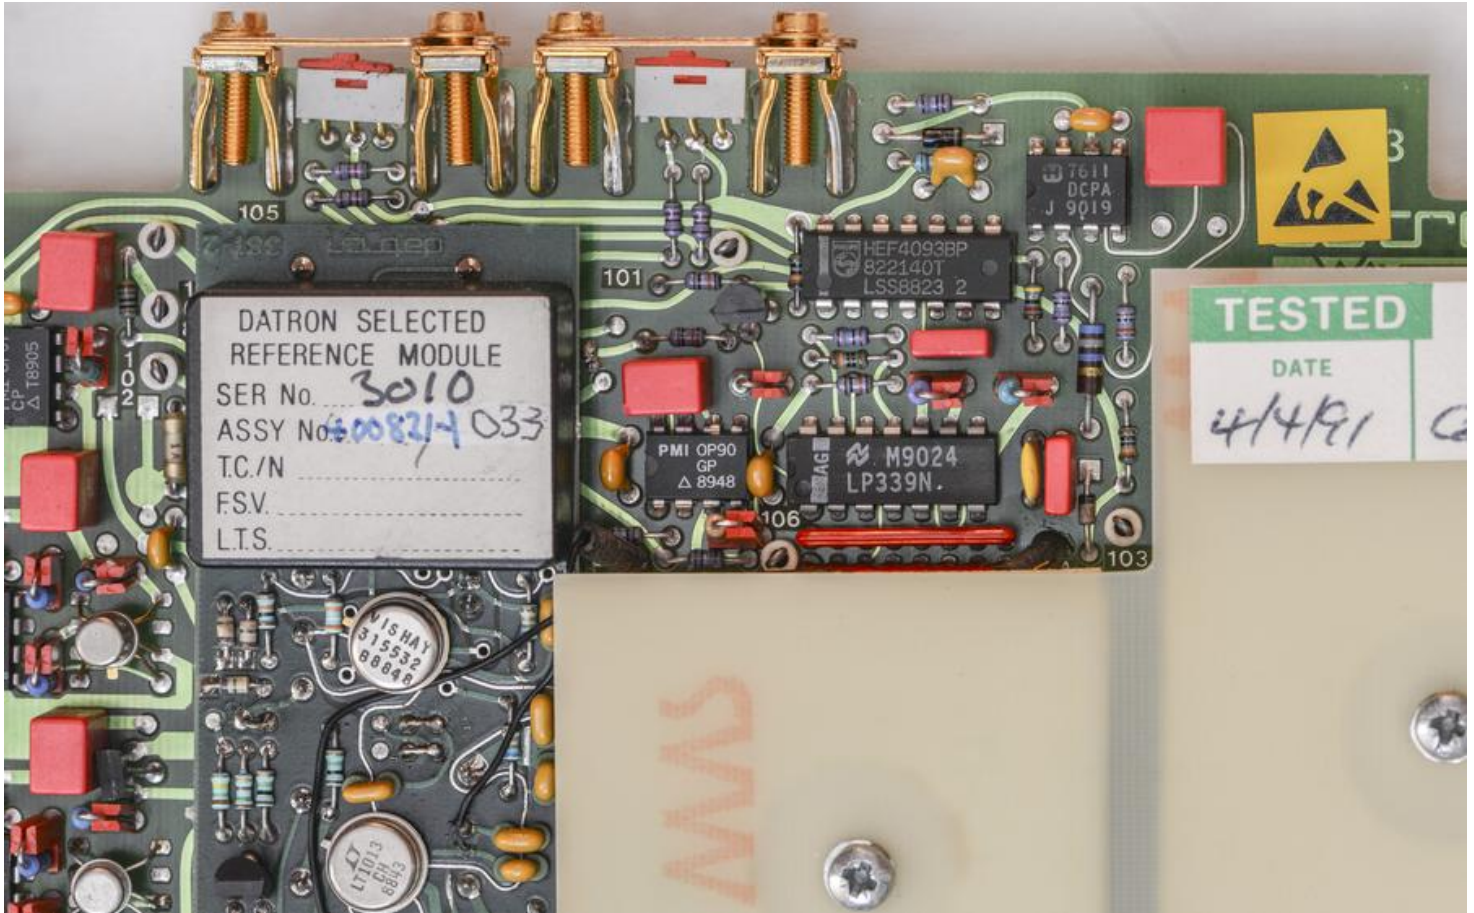
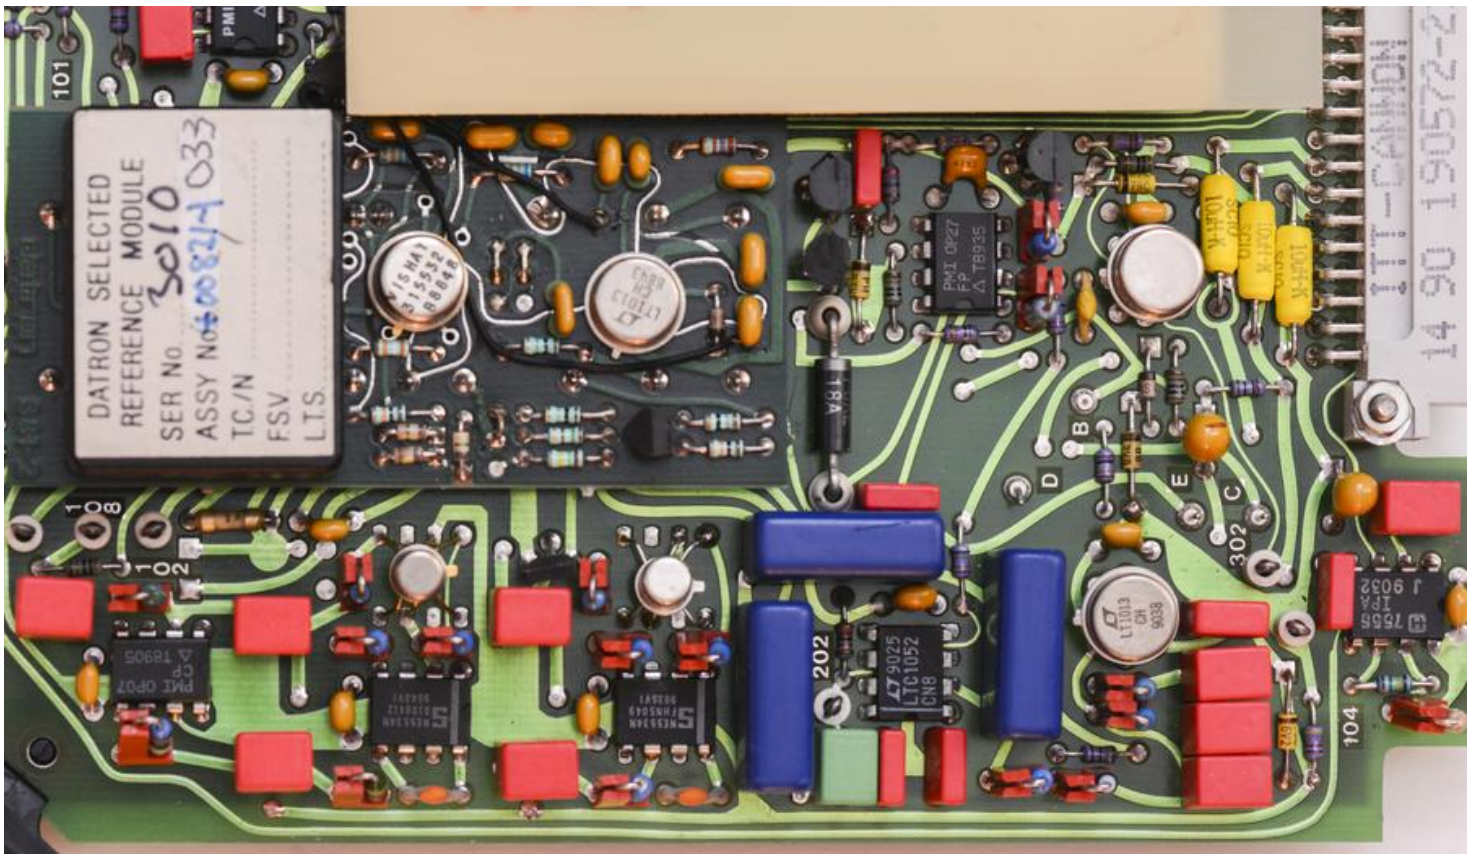
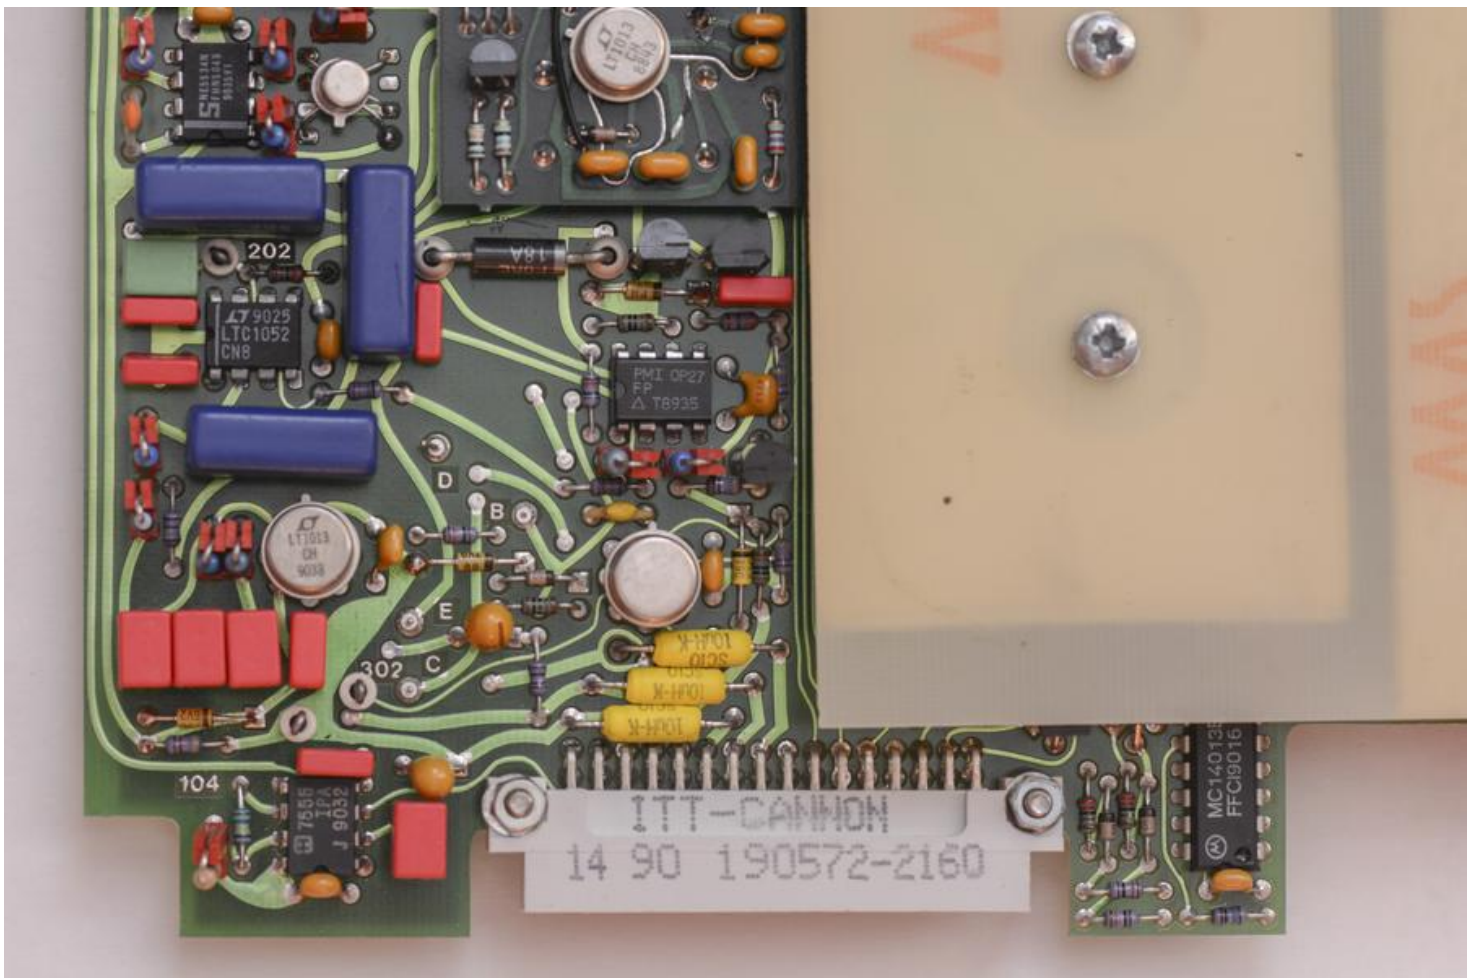
The LTZ board HI side output goes through two separate op-amps. It was difficult to confirm whether U109 was working as its output was low (0.5V). U111's output was ~11.5V but the output at the front panel was missing. The resistance between the HI and LO outputs at the front panel measured 7 ohms. It was suspected that more bad capacitors would be found.

All capacitors on the board were measured in circuit but only a couple were across the HI/LO outputs. They were removed and measured. Neither were found to be shorted. Probing around the board searching for shorts proved nothing. The 10V path goes into both dividers. The signal name is 10V(B) according to the schematics. All components in the two dividers were checked but the only issues found were two JFETs (Q204,Q206) had a low resistance across their terminals. They were removed from the pcb one at a time and tested on the DCA75. No readings appeared to be bad. Measuring resistance at the outputs showed that it was now ~ 130 ohms. The 10V output was then measured with the two transistors removed and it read 9.4V.

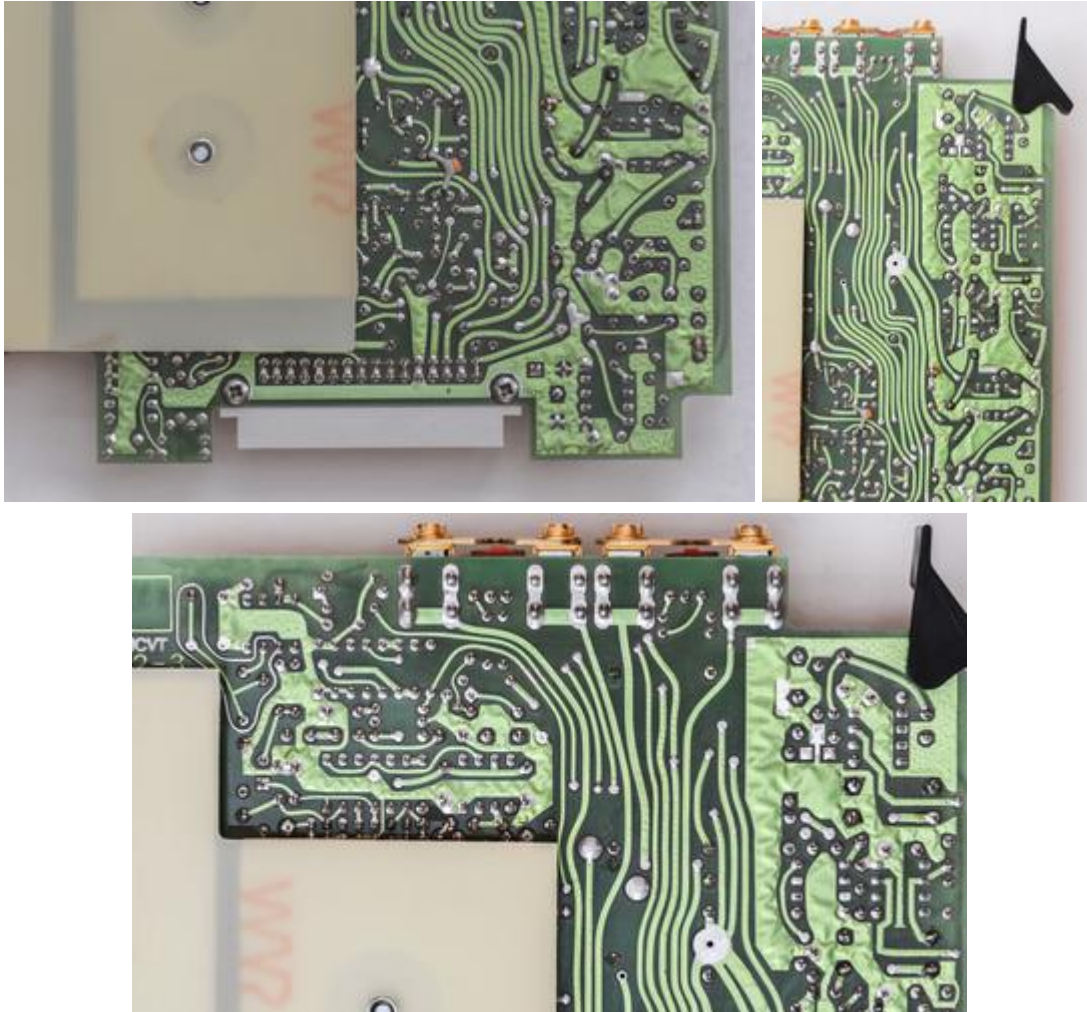
Q203,Q205, and Q208 were removed and tested with the DCA75. They also tested as good. It was decided that the transistors in this part of the board would be ordered. Q204 and Q206 have been marked by Datron so most likely they are binned parts. They could also be matched to each other. This will have to be tested if either one is determined to be defective.
