Topic: Broken Metcal RFG-30 soldering base unit fixed (Read 23033 times)

**Broken Metcal RFG-30 soldering base unit fixed**

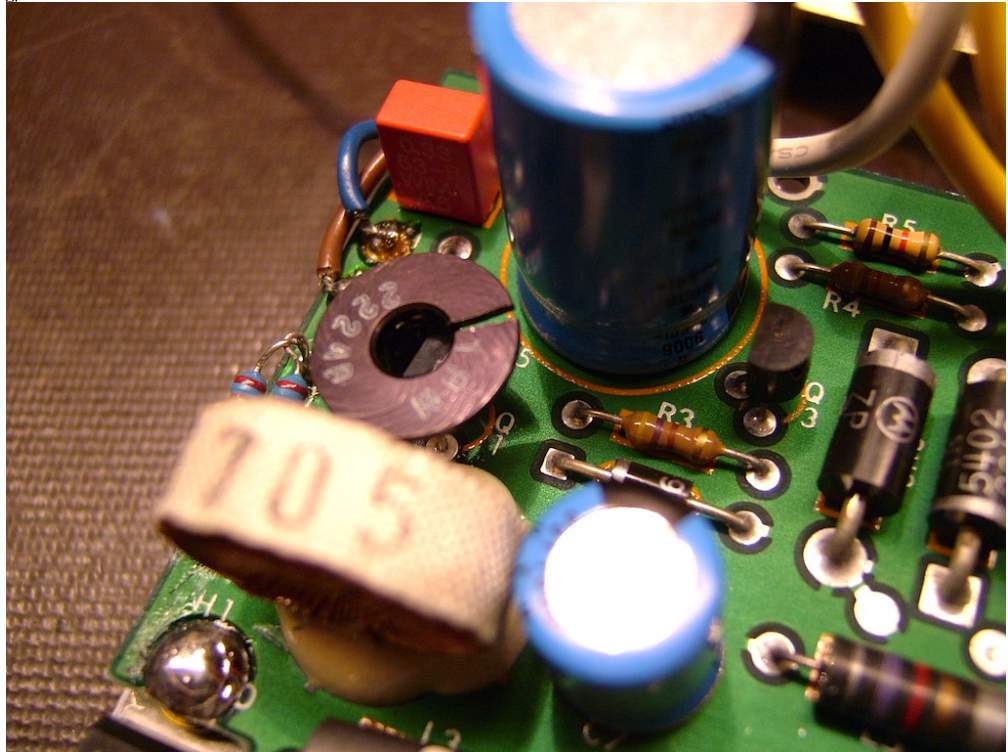
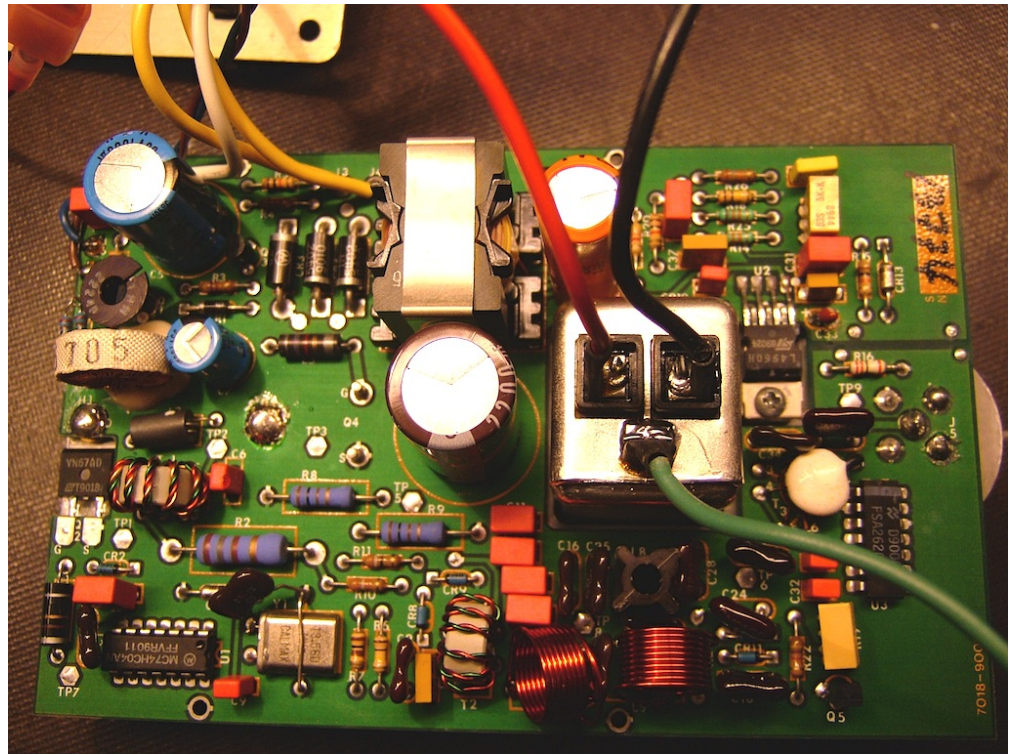
The heatsink story is a nasty one, there are 2 power FETs and regulator IC mounted on it, using a collection of nuts and bolts, some isolated from the heatsink, some not. For more fun the mains inlet mounts into it, as does the F-connector for the hand piece. See the picture for details. Design for serviceability: NOT!

The short proved to have blown a transistor, which manifested itself in a 100 Ohm resistor getting hot enough to 'smell'. What got me confused initially was that I still had 13.5MHz HF on the output connector. I first replaced the resistor, later I got the correct transistor type and now things are OK. The transistor is apparently part of some feedback circuit (?) that throttles the HF amplitude. The transistor in question is Q1, with a little heatsink, as shown in the detail picture.

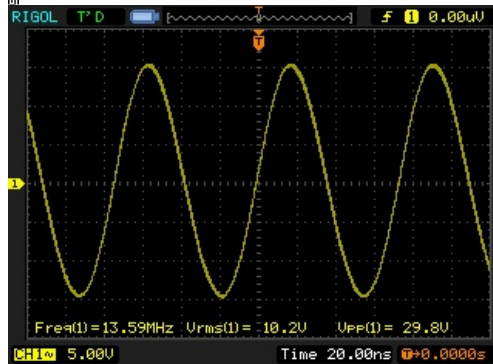
metcal_defective.jpg (38.89 kB, 320x234 - viewed 1647 times.)

Included are 3 scope screenshots, the first one showing the HF while the generator was broken. The 2nd one shows the HF amplitude during warm up. The 3rd one shows the HF amplitude with the iron idling at it's Curie temperature.

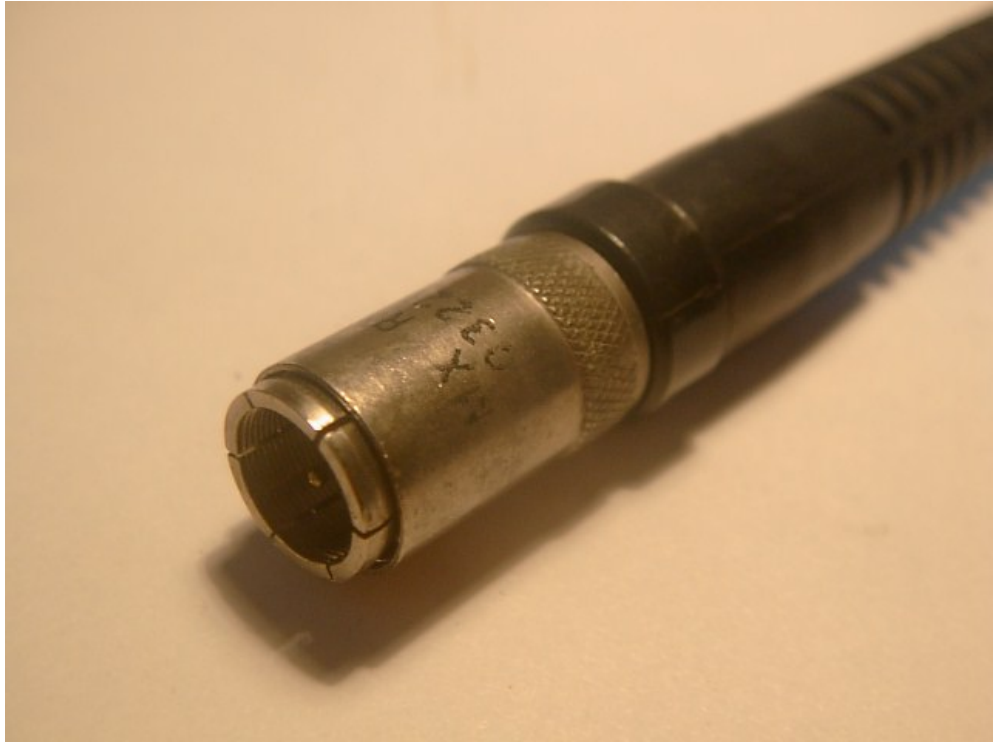
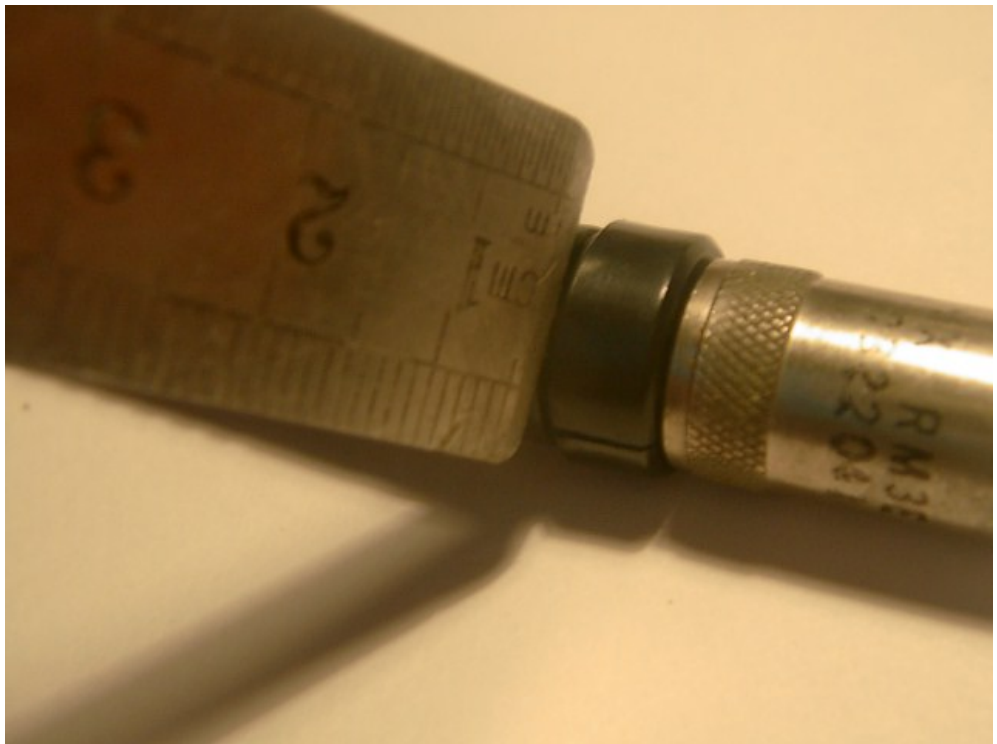
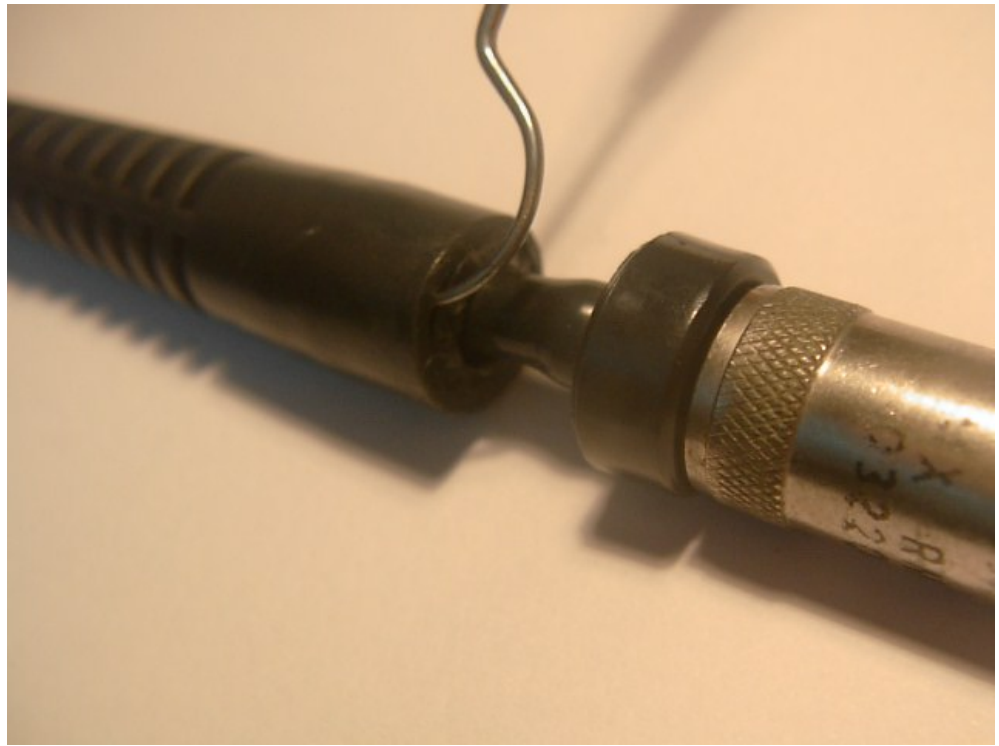
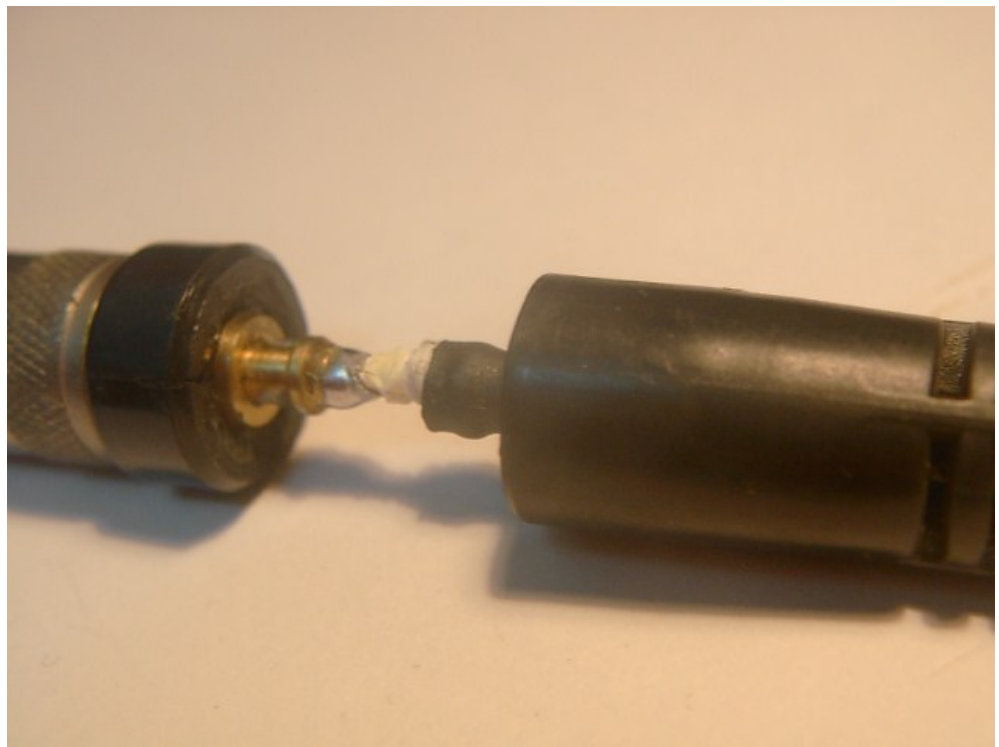
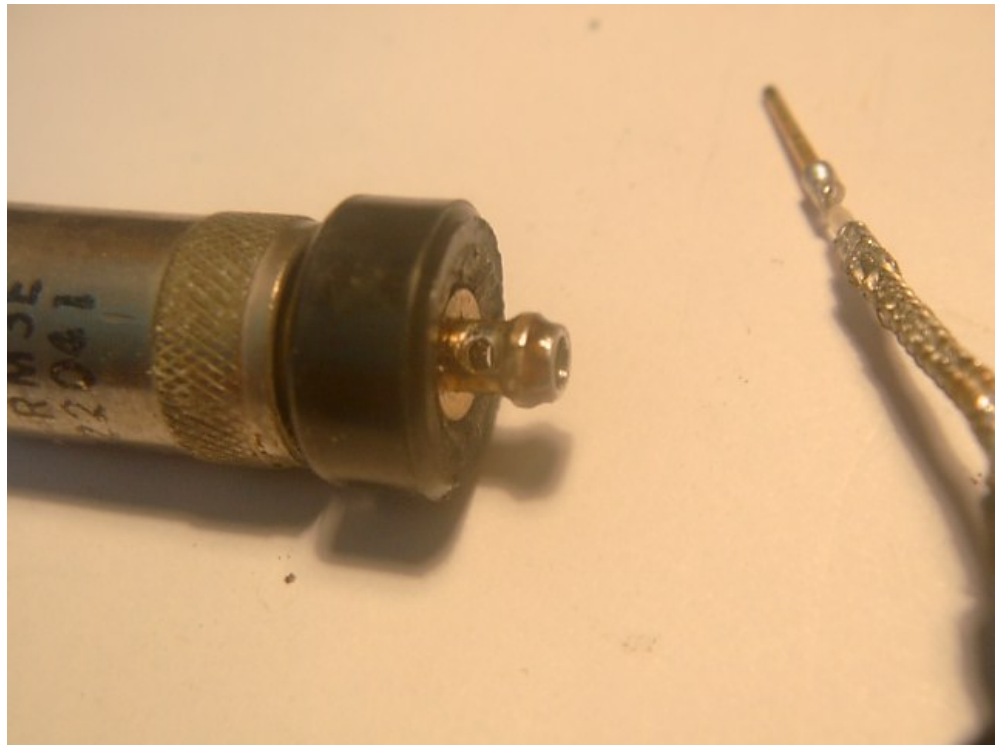
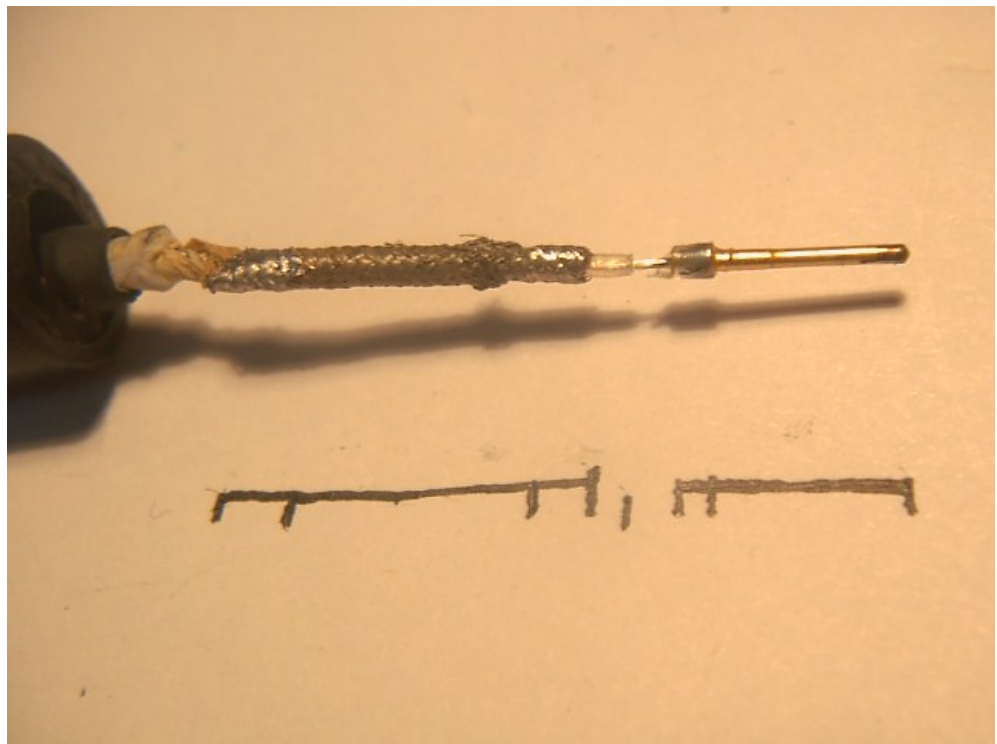
Found these old pics of a disassembled Metcal MX-RM3E <https://imgur.com/a/RvDVu#0>
They were posted in this topic in Oct. 2012: <https://www.eevblog.com/forum/reviews/for-jbc-fans->

The last pictures shows there actually is a small capacitor in parallel with a 22 μ H inductor.
