Complete Flyback/IHVT Testing

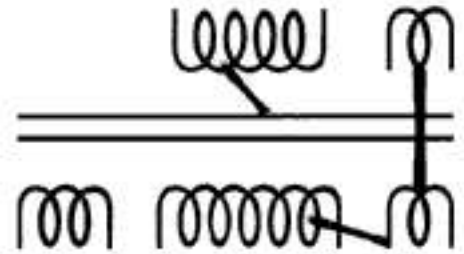
Fig. 3: Example of possible leakage paths in the IHVT.

Another common way that an IHVT can fail is arcing or shorting from winding-to-winding. This is usually caused by overheating of the flyback which leads to cracks in the plastic. These cracks can cause external or internal arcing which

This can be tested with a Sencore Z-Meter. You first need to find two separate windings on the IHVT. Then hook up the leads (one to each winding) and select a capacitor type (doesn't matter which type). Enter the highest voltage amount your Z-Meter will allow and push the leakage button ("00.00" should be displayed). It may take a couple seconds to read out. If any leakage is found, the windings are breaking down and the IHVT is defective. Fig. 3 shows examples of possible leakage paths in the IHVT.

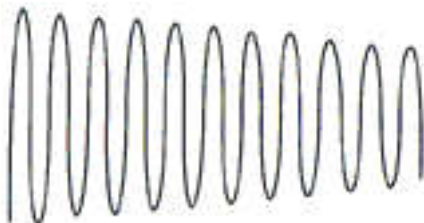
Slow Decay of the Ringer Sinewave

Fig. 1: Represents a typical oscilloscope waveform when a good IHVT is being ringer tested.

The primary coil is usually the best place to ring a flyback. However, if you get 10 rings or better on any winding, your flyback doesn't have any shorted turns. See Fig. 1.

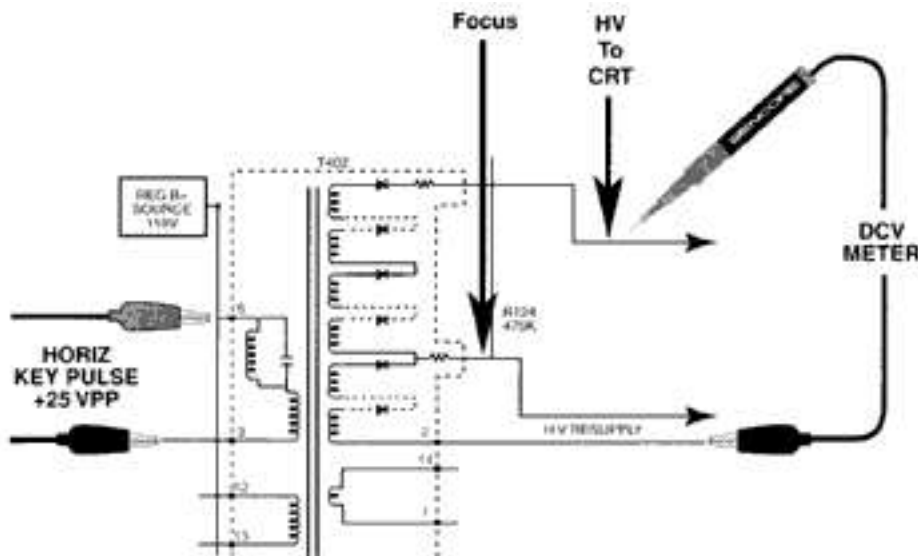
Fig. 4: Shows the proper lead hookups for doing an IHVT Drive Test.

To perform the IHVT test, input a 25 VPP horizontal sync signal to the primary winding of the transformer. This simulates the actual horizontal signal at a reduced

level and the transformer will produce high voltage in proportion. Next, measure the DCV at the anode lead and compare your results with the chart below. See Fig. 4 for the proper lead hookups.
