VINTAGE WORKBENCH

The Tektronix Type 130 LC Meter – Part 2 *Restoration*

By Alan Hampel, B. Eng. (Electronics, Honours)

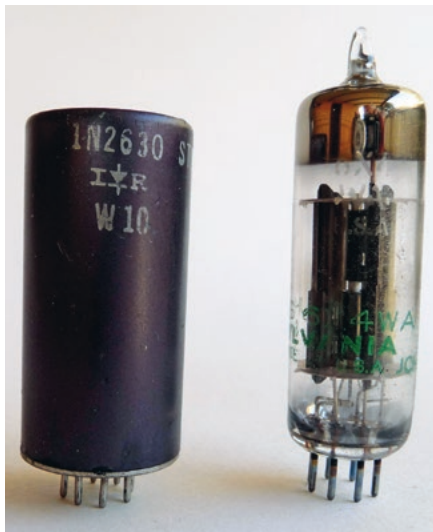
The cause of the clunking noises was immediately apparent – there was no 6X4 in the rectifier socket, but a 1N2630 solid-state valve replacement rectifier was loose amongst the works.

The 1N2630 was no doubt put in the 6X4 socket by a previous owner. But it’s about four times as heavy as the original valve, being solid epoxy and not mostly vacuum. It also has a larger diameter, fouling the socket retaining screws and preventing the socket fully gripping the pins; so it fell out.

The loose 1N2630 smashed one of the 6U8s and bent the plates of a trimmer capacitor. Annoying, but easily fixed. I also noticed the meter clear plastic casing was broken in one corner – the only corner not shown in the eBay photos.

A 1N2630 (left) was used instead of the original 6X4 (right) as the rectifier. Due to its larger diameter and weight, it came loose from the socket in transit, damaging one of the 6U8s.

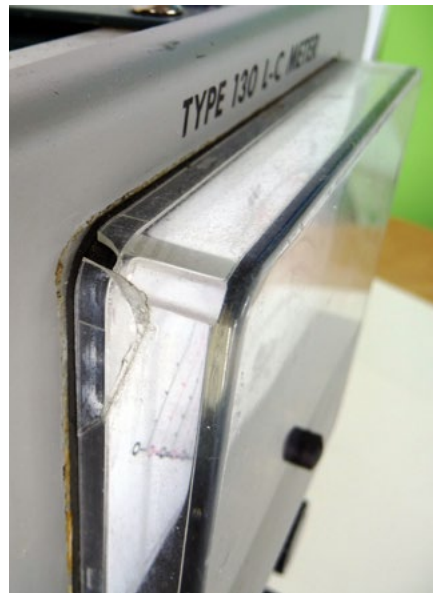
I unwrapped the package from the eBay seller and took the T-130 cabinet sides off. It was covered inside and out with cigarette smoke gunk. That’s not uncommon in old laboratory instruments. Instead of the cabinet being an attractive blue, it was a dull blue-grey.

The front panel glass was cracked along one edge. There was also grime and dirt inside and outside the case.

Cleaning the cigarette smoke condensation off the cabinet was easy. I removed all cabinet parts from the central chassis and washed them, along with the front panel knobs. I did this in the sink with dishwashing detergent.

I used a soft sponge to clean the cabinet parts and a toothbrush for the knobs. I then thoroughly rinsed everything with running water and then Electrolube Saferinse, and dried the parts off. Everything came up like new, except for a few places where the paint had been worn off over the years.

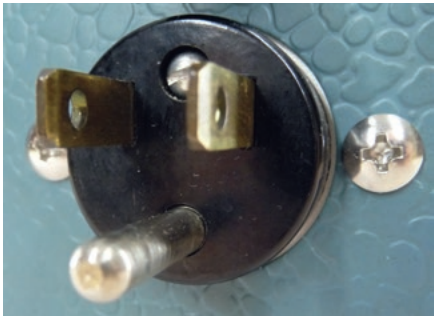
If you have a Tektronix instrument with this AC mains connector on the back, check the Earth pin. It may show high resistance due to a loose retaining nut.

I plugged in the power cord and checked the resistance from the Earth pin of the Australian plug to the T-130 chassis. High Earth lead resistance is a common fault in Tektronix instruments using a protruding NEMA 5-15 mains input connector. If you have one, best check it. Mine had an open-circuit Earth.

As is typical, the nut that secures the Earth pin to the connector back-plate had worked loose. This is why you shouldn't use a mounting screw for an Earth connection, which isn't permitted by most authorities. There was tarnish on the Earth pin as well. I cleaned the pin and tightened the nut, using a drop of thread locker. I checked again with an ohmmeter – no perceptible resistance – good.

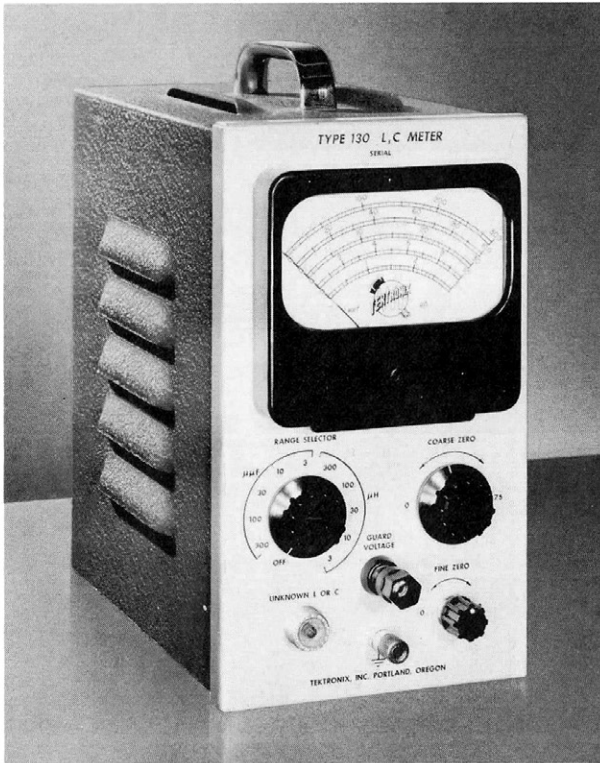
TYPE 130 L,C METER

The unknown value to be measured will determine the frequency of the variable oscillator in the Type 130. This frequency is beat against a 140-kc fixed oscillator. The difference frequency is shaped and counted, causing meter deflection proportional to the difference frequency. The direct-reading meter is calibrated in microhenries and micromicrofarads.

Here is a page from the 1954 Tektronix catalog; when they started to produce the T-130 LC Meter.
