Take the HP10811 dual oven a Look Inside

Intimidated at the prospect of servicing your Z3801A oven oscillator? In this article, Steve Smith, G8LMX (Nottingham, UK) shares his experience in exploring the inner details of the HP 10811 dual oven used in the Z3801A GPS receiver.

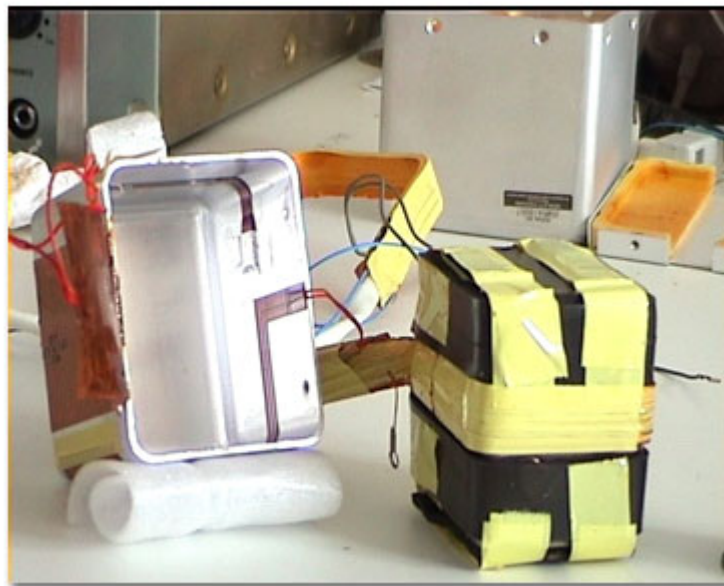
In the photo you can see the outer oven thermistor within the oven can. There were four thin strips of black foam rubber taped to the insulation. I assume these were used as packing. After removal of the insulation the lead-out wires need unwinding, again being careful not to tear the foam backing. You should now be down to the basic HP 10811 oscillator and inner oven.
