The Metrological and Financial Implications of a Clogged Fan-Filter!

BENCH BRIEFS
1st Quarter 1995

Service information from
Hewlett-Packard Company

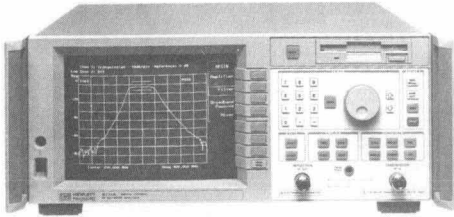
HP 8711A Network Analyzer Spare Parts Kit Is Now Available

Hewlett-Packard has just introduced two new spare parts kits for the 8711A RF Network Analyzer. These kits will allow any user to quickly repair more than 80 percent of any failures. The intended customers are those users who have a medium-to-large installed base and require a minimal downtime.
