## Fixing an HP 3314A function generator - Part 1

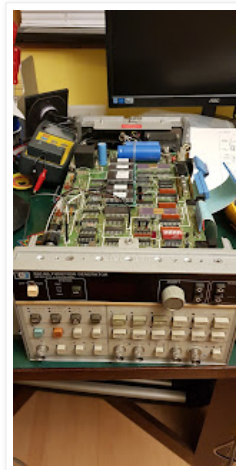
Some time ago I scored a nice looking [HP 3314A](#) function generator of [eBay](#). It was advertised as not powering up, so there was a chance that there is some simple problem. I took a chance and was able to get it for cheap.
