HP3400A Images Date ▲ (<https://groups.io/g/HP-Agilent-Keysight-equipment/topic/93892915?p=Created%2C%2C%2C20%2C2%2C0%2C0>) around Photochopper demodulator (help)

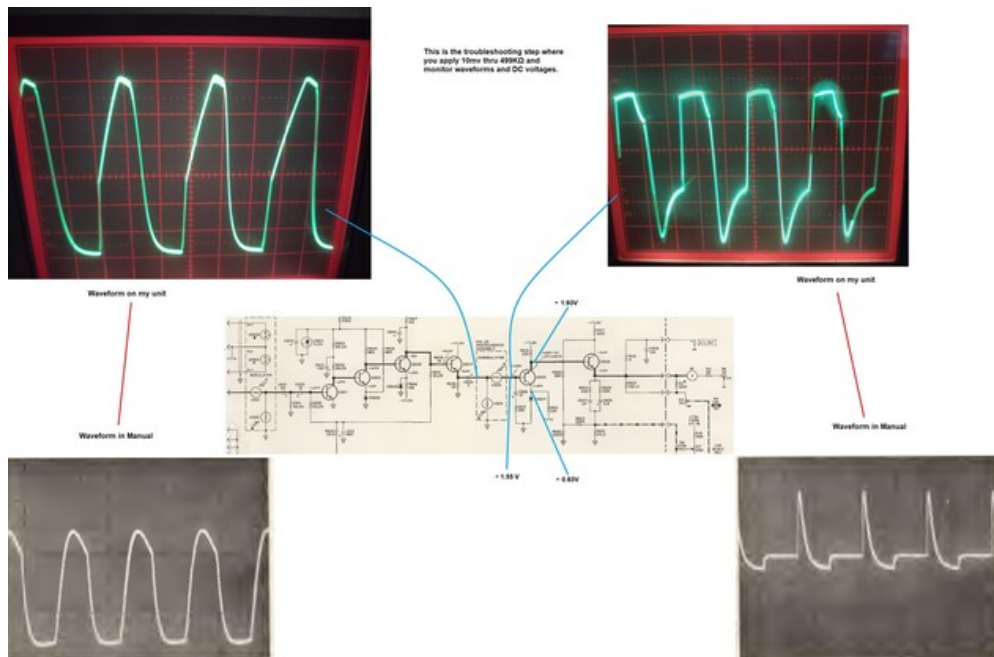
BTW, here are the waveforms and voltages from my 3400A vs the manual.

This is the troubleshooting step where you apply 10mv thru 499KΩ and monitor waveforms and DC voltages.

Looks like V504 is not shorting to ground for half the cycle. This could be a failing photocell or the neon light getting dim with age (it is lit, correct?) there have been a number of discussions on what to replace aging neons with but I don't remember any details.

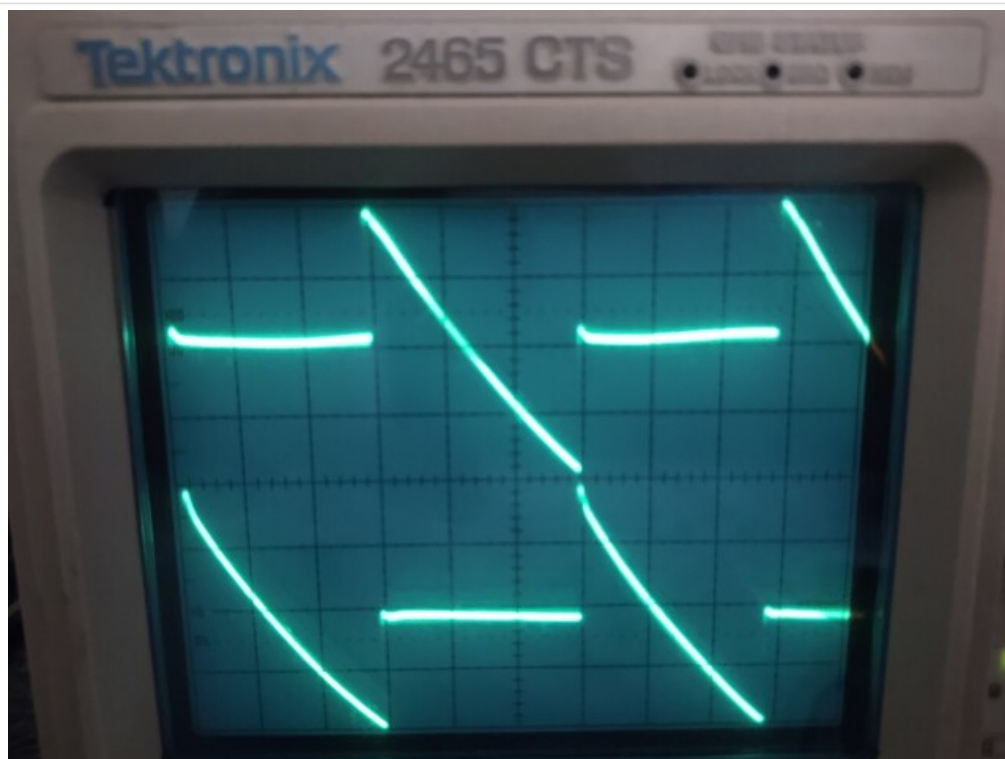
Here is the drive wave form to the neons, I think this is a pretty good waveform, when compared to the manual, making me think my neons are OK.

There is a slight glitch at the top of the bottom waveform.

The initial problem I have is at the very beginning of the calibration 5-22 d. adjustment of the DC output voltage. I can't get it up to 1V (0.844V max) even after adjusting the value of R3 to it's suggested maximum value.

Someone sent me a photochopper modification using a DG403 made by br4av01 (Parker). I tried an email, but it bounced. The last post I see of his is 2013.

After I verify my thermocouples are good, I'll probably go the route of making the modification.

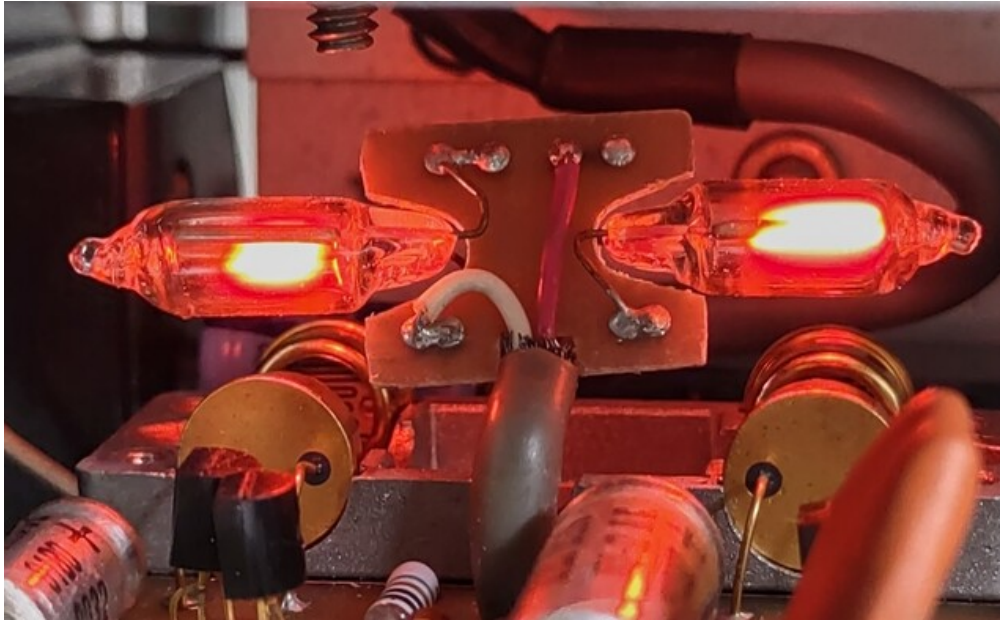
Gas discharge tubes age and begin to strike at a higher voltage.
I would suspect that the Neon bulbs have aged and are striking at a higher voltage.
This would give the appearance of the LDR failing.
With new neon bulbs, you may fix the problem, until they age, but, that would probably be past the time that you would care to use the instrument.

I was suspecting the LDR, but now after viewing the difference in intensity of the Neon bulbs, I'm not as sure. Here is a Dropbox link to a video showing the neon's alternating in brightness (camera modulated).
<https://www.dropbox.com/s/ktrk8p3ikdt69yr/HP3400A%20Neon%20Bulb%20intensity%20video.mp4?dl=0>
 (https://www.dropbox.com/s/ktrk8p3ikdt69yr/HP3400A%20Neon%20Bulb%20intensity%20video.mp4?dl=0)
 Any opinions about LDR vs Neon? I guess I could swap their relative positions to see if that changes the problem from demod side to modulation side.
