## WIZARD WORKSHOP ARTICLES

### CG 551AP SHIPPING

CG 551AP/CG 5001

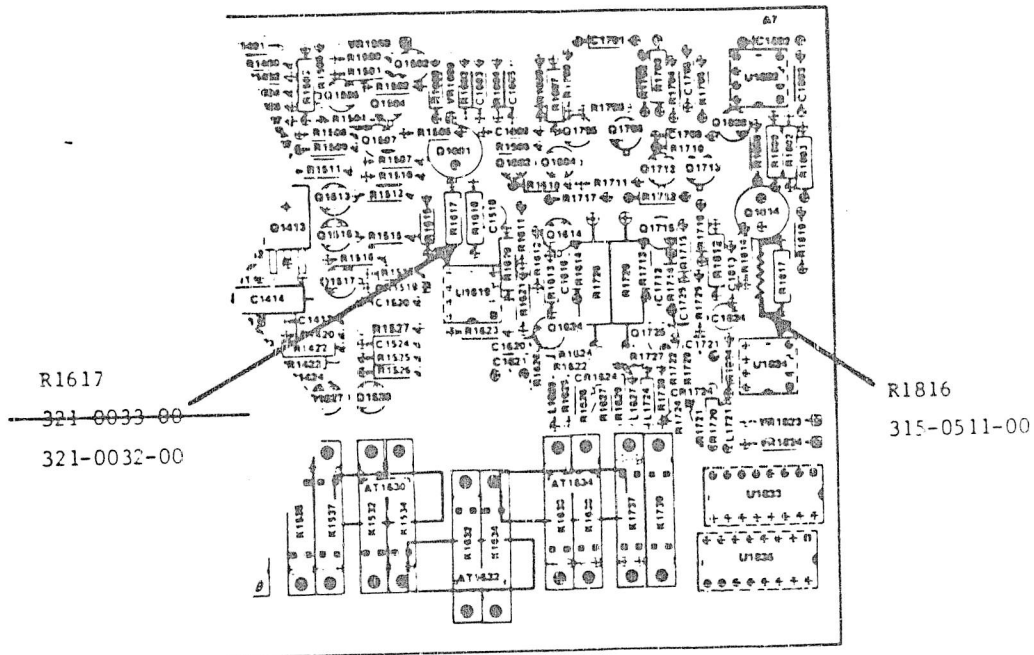
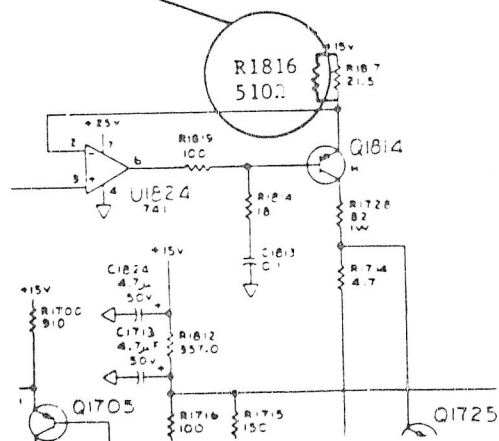
FIGURE 2

4. Low edge generator calibration constant centering. One resistor was changed and one was added to the low edge generator output to prevent the need for entering large cal constants to center the waveform. See Figure 2.

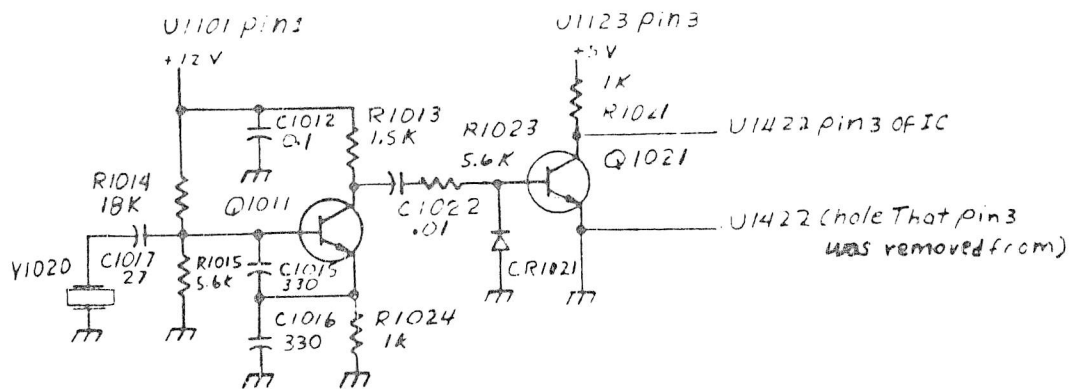
FIGURE 3

1. The CPU Clock has been redesigned to provide a stable reference throughout the temperature range. The timing IC, A9U1422, was sensitive to impedance changes in the crystal, A9Y1431, which occurred at higher temperature. The discrete oscillator circuit on the A9A2 board produces a stable signal over the entire temperature range. See Figure 4 for parts removed and Figure 3 for component location, schematic and parts list.

A9A2 circuit board is located on the back side of the CPU board.
