# **TMS320C6455/54**

## **Digital Signal Processor**

### **Silicon Revisions 3.1, 2.1, 2.0, 1.1**

## **Silicon Errata**

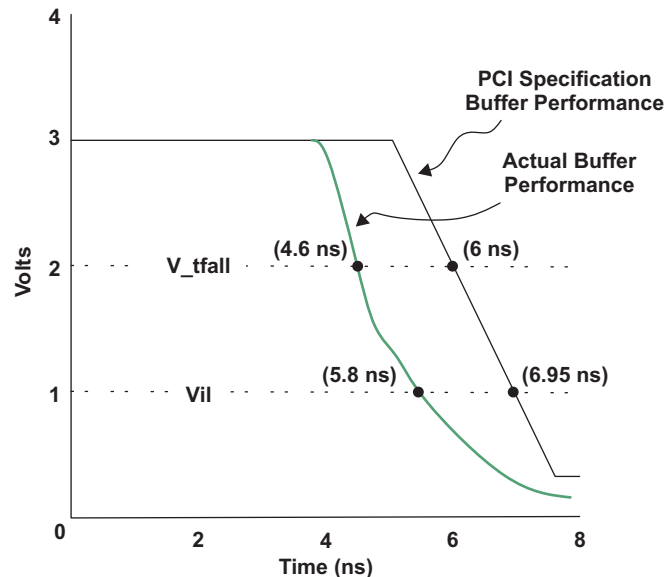
**Figure 11. 66-MHz Buffer Slew and Timing Performance vs Specification Performance**

Although the actual minimum slew rate is below the specified minimum, overall PCI timings are within the bounds permitted by the PCI specification. As shown in [Table 11](#), actual values for the valid signal delay ( $T_{val}$ ) are well below the permitted maximum. This allows additional time for system propagation delay to compensate for the reduced slew rate. [Figure 11](#) shows the buffer slew and timing performance versus the specification performance in the 66-MHz environment. The 33-MHz environment has even more timing margin than the 66-MHz environment, making 66 MHz the worst case.

[Table 12](#) shows the system timing budget for 66-MHz PCI with values from the specification and values in a system where the device is driving with reduced slew rate.
