# ***TDA2x SoC for Advanced Driver Assistance Systems (ADAS) Silicon Revision 2.0, 1.1***

## *Errata*

This document describes the known exceptions to the functional specifications for the device.

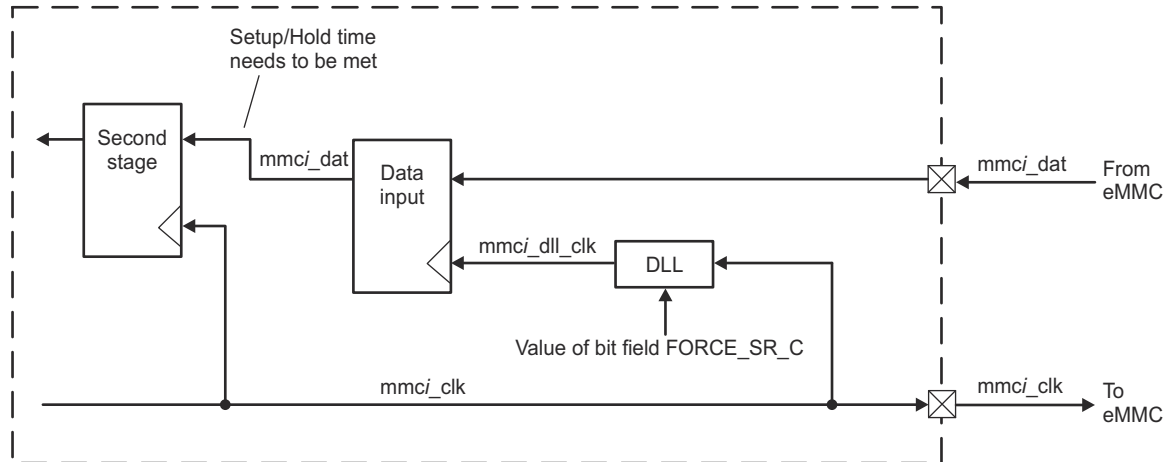
**Figure 2-2. Simplified SoC 192-MHz Mode DLL Block Diagram**

Internal to the MMC module, a second stage latch is used to recapture data captured by DLL delayed CLK, MMC\_DLL\_CLK. The second stage latch captures with the original transmitting clock, MMC\_CLK.

MMC\_DLL\_CLK and MMC\_CLK both run at the same clock frequency. This results in a narrow range of tuning ratio elements, where the delayed MMC\_DLL\_CLK comes in phase with MMC\_CLK. If the clocks are in phase, the data captured by the first clock violates the setup and hold time requirements needed for the second stage latch, resulting in incorrectly read data. This is known as tuning re-timing errors.

A DLL tuning algorithm has been implemented that can avoid the tuning re-timing errors. More details on this can be found in App Note [SPRACA9](#). The following notes summarize the updated algorithm:
