TMS320C6674
Multicore Fixed and Floating-Point Digital
Signal Processor
Silicon Revision 1.0, 2.0

Silicon Errata

Literature Number: SPRZ341H
January 2011–Revised June 2015

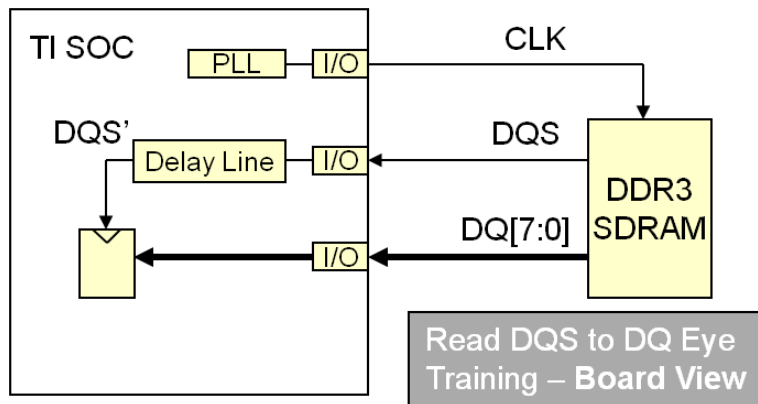
Figure 2. Read DQS to DQ Eye Training - Board View

The leveling feature with the problem is the Read Data Eye Training. Depending on the jitter seen on the DQ and DQS signals, this leveling feature will fail to converge on a good data eye, resulting in corrupted DSP to DDR3 SDRAM reads.

The intended purpose of the Read Data Eye Training feature is to align the DQS sampling transitions in the middle of the DQ data eye within individual byte lanes of the DDR3 memory interface. As seen in [Figure 2](#), the DQS signal can be delayed relative to the DQ signal within the DDR3 PHY.

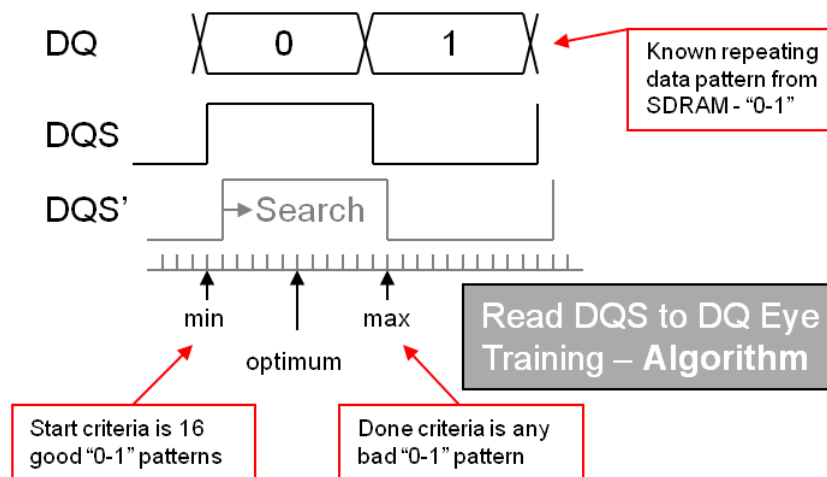
Figure 3. Read DQS to DQ Eye Training - Algorithm

As shown in [Figure 3](#), the Read Data Eye Training algorithm should correctly detect the extents of the DQ data eye. The SDRAM are put into a DQS to DQ eye training mode and read back an alternating 0, 1 pattern.

The DDR3 PHY uses this pattern to detect good or bad data being sampled by the DQS transitions. The DDR3 PHY searches by delaying DQS relative to DQ until these constraints are found.
