Keysight E8257D/57N, E8663D PSG Signal Generators Add Option 1E1 (Attenuator)

Installation Note

Add Option 1E1 (Attenuator)

This upgrade kit adds Option 1E1 (Attenuator) to the E8257D (Analog) PSG Signal Generators.

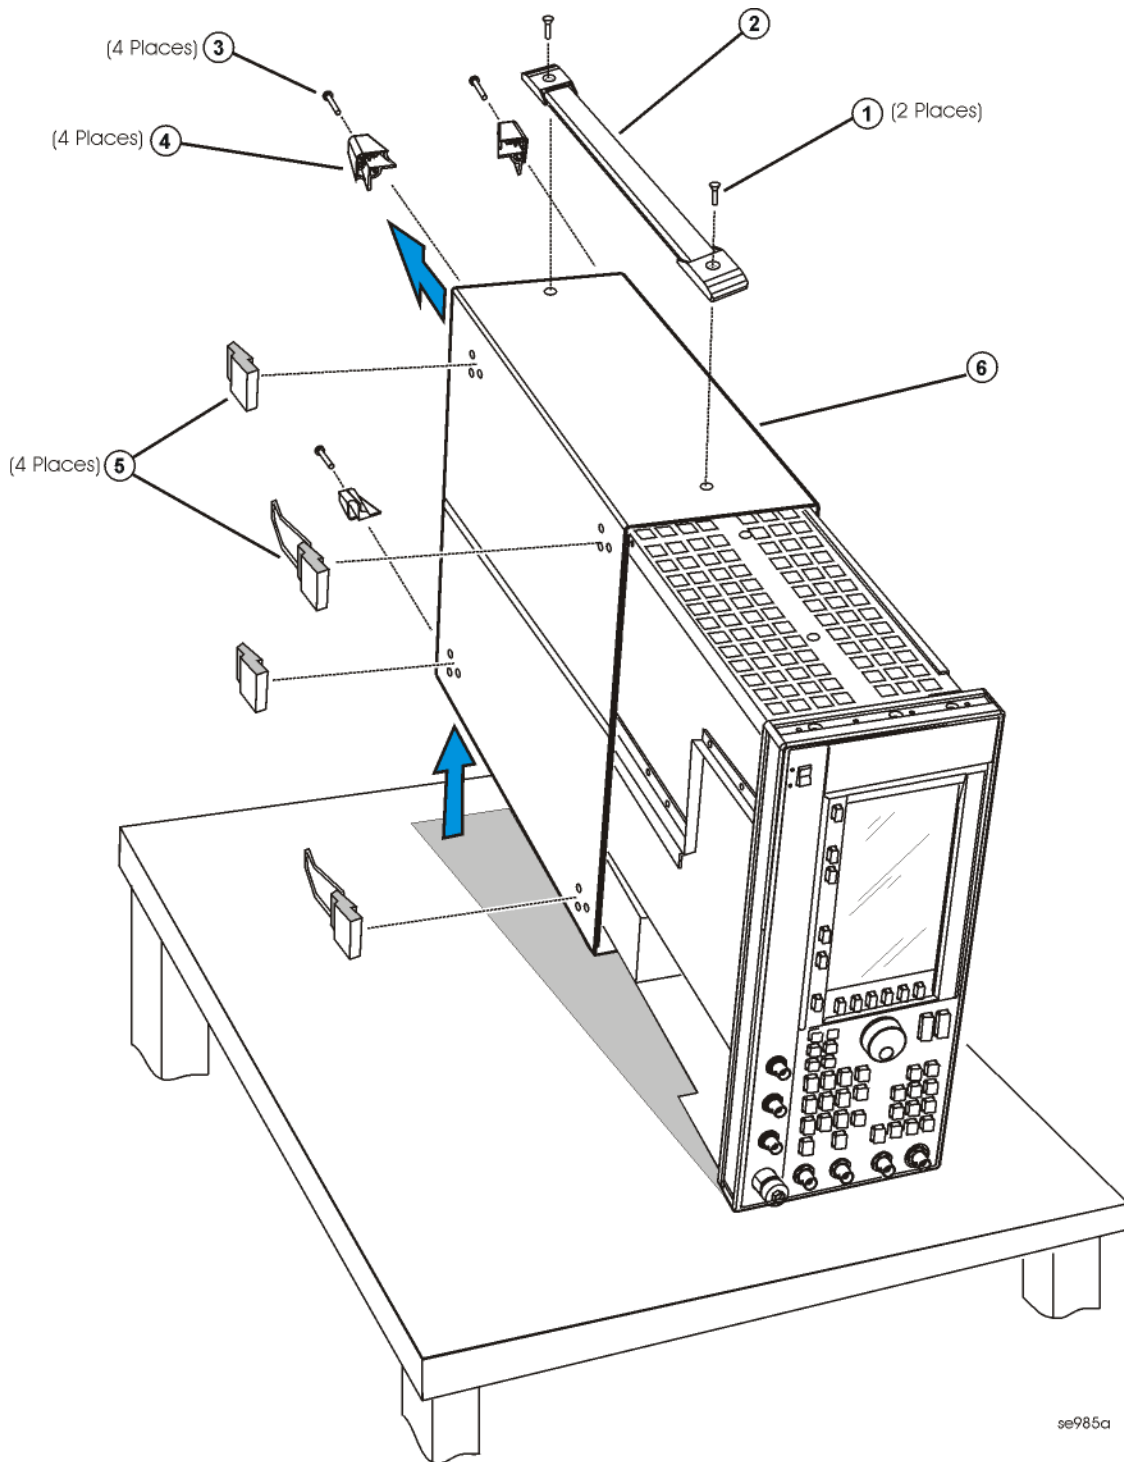
Figure 1

1. Disconnect the power cord.
2. Using a T-20 driver, loosen the two screws (1) and remove the strap handle (2).
3. Using a T-15 driver, remove the center screws (3) on the four rear-panel feet (4).
4. Remove the four bottom feet (5) from the cover by lifting the tab and sliding the foot toward the tab.
5. Place the signal generator on its side.
6. Tilt the signal generator forward and slide the outer cover (6) back to remove it from the frame.

Outer Cover Removal

Refer to [Figure 1](#).

Refer to [Figure 1](#) and [Figure 2](#).

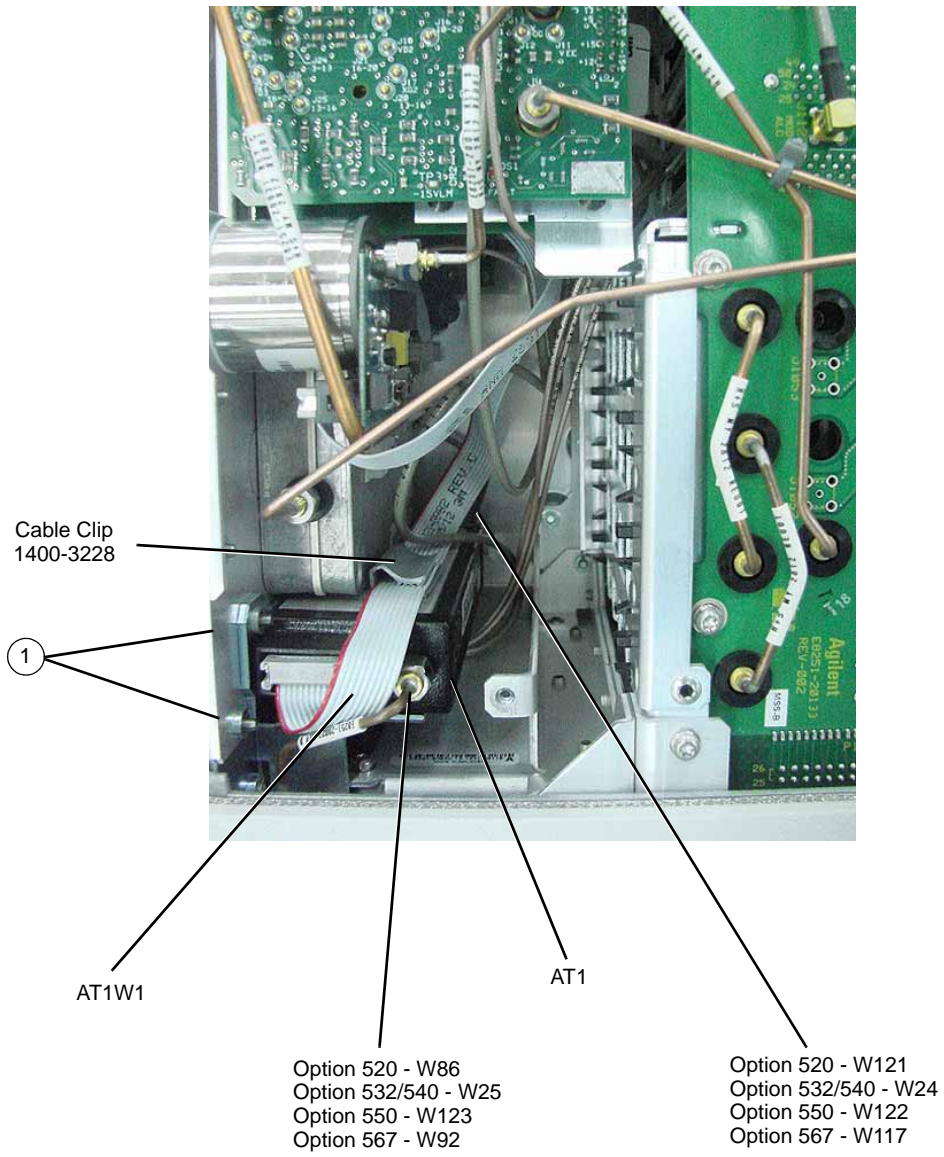
Figure 3

3. Refer to [Figure 3](#). Position the attenuator so it can be attached to the RF deck.
4. Using the T-10 driver, insert the two screws (1) through the side deck into the metal bracket that is attached to the attenuator. Torque these screws to 9 in-lbs.

8. Refer to [Figure 3](#). Install the cable clip 1400-3228 to the attenuator body and clamp AT1W1 ribbon cable as shown.

Option 1E1 (Front Panel RF Output)

- Option 520: W73 (E8251-20095)
 - Option 532/540: W85 (E8251-20072)
 - Options 550/567: W94 (E9251-20322)
7. Install AT1W1 ribbon cable to A26J13.
8. Refer to [Figure 3](#). Install the cable clip 1400-3228 to the attenuator body and clamp AT1W1 ribbon cable as shown.

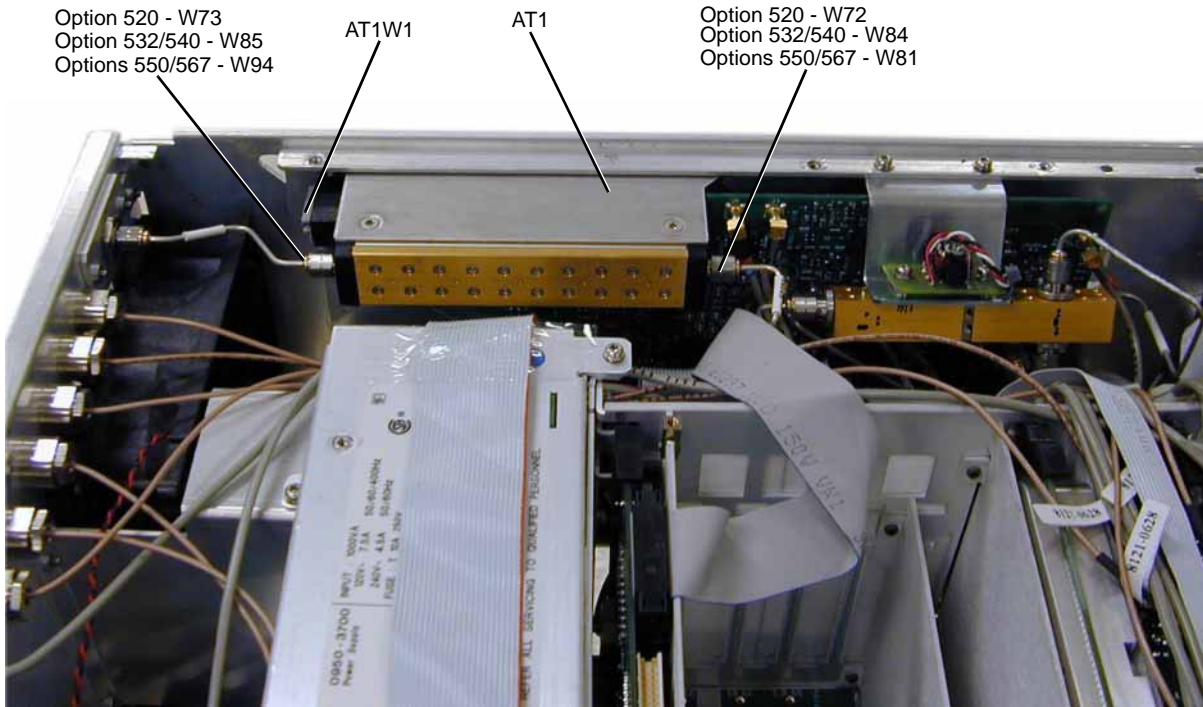
3. Refer to [Figure 4](#). Position the attenuator so it can be attached to the RF deck.
4. Using the T-10 driver, insert the two screws through the side deck into the metal bracket that is attached to the attenuator. Torque these screws to 9 in-lbs.

Figure 4 **Option 1E1 (Rear Panel RF Output)**
