Keithley Instruments
28775 Aurora Road
Cleveland, Ohio 44139
1-800-833-9200
tek.com/keithley

This firmware is used on the following Keithley Instruments product models:

Model 2450 Interactive SourceMeter® Instrument, 2450-NFP, 2450-RACK, 2450-NFP-RACK

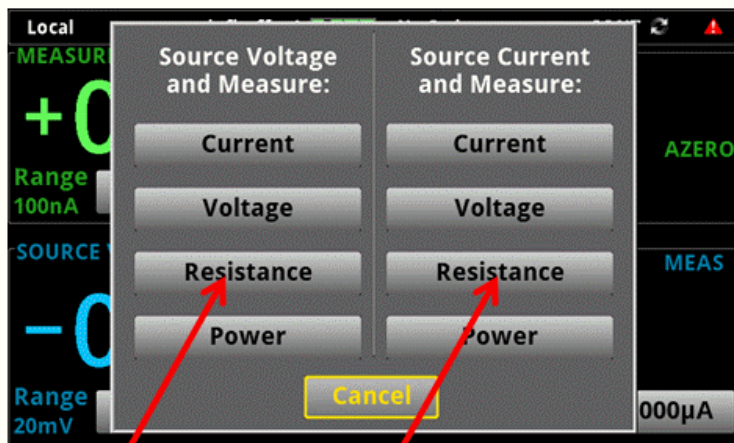
- g. New SCPI Command Usage:
 - i. "Manual Ohms" (see definition above)
 - SOURce:FUNC VOLTage
 - [SENSe[1]]:FUNC "CURRent"
 - [SENSe[1]]:CURRent:UNIT OHMOR
 - SOURce:FUNC CURRent
 - [SENSe[1]]:FUNC "VOLTage"
 - [SENSe[1]]:VOLTage:UNIT OHM
 - ii. "Auto Ohms" (see definition above)
 - [SENSe[1]]:FUNC "RESistance"
- h. Front panel user interface setting of Manual vs. Auto Ohms measurements
<see the following figure for details>

SVMI (Ω)

SIMV (Ω)

Exhibits "Auto" Ohms behavior

SVMR

- `smu.source.func = smu.FUNC_DC_CURRENT`
 - `smu.voltage.func = smu.FUNC_DC_VOLTAGE`
 - `smu.measure.unit = smu.UNIT_OHM`
 - ii. “Auto Ohms” → Measures resistance by sourcing current, measuring voltage, and calculating the resistance reading. In this case, the source current and source limit are automatically calculated and set.
 - `smu.measure.func = smu.FUNC_RESISTANCE`
