Errata

# CC1310 SimpleLink™ Ultra-Low-Power Sub-1 GHz Wireless MCU Silicon Revisions B, A

This document describes the known exceptions to functional specifications (advisories) for the CC1310 SimpleLink™ device.

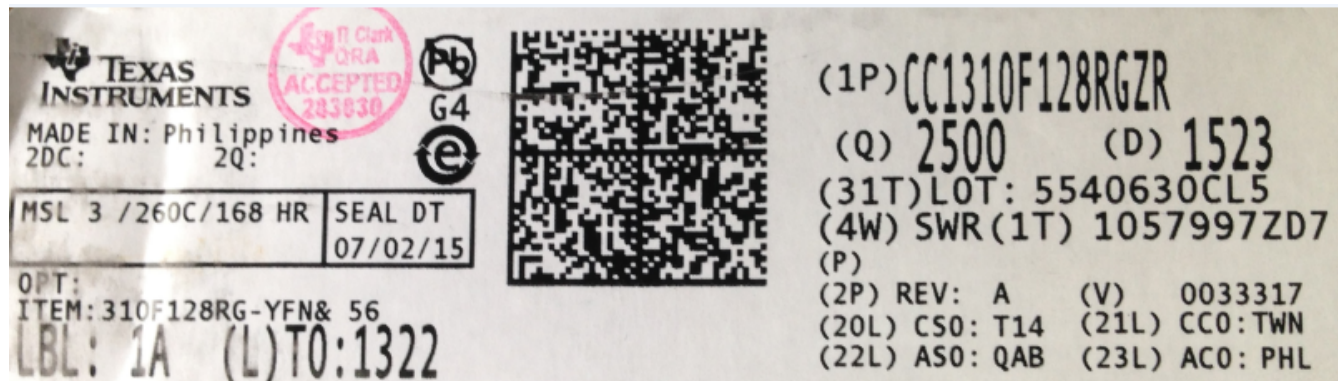
**Figure 2-3. Sample Product Shipping Label for CC1310 Device**

- Package label:
  - The die revision name is shown on the tape and reel label as shown in the example label in [Figure 2-3](#).
  - Entry (2P) lists the revision (either A or B).
